STAR ONLINE PUBLICATION

Case Number: S2608000019

Symptom/Vehicle Issue: High Voltage Connector Seal And Fastener Service Parts Are Now Available

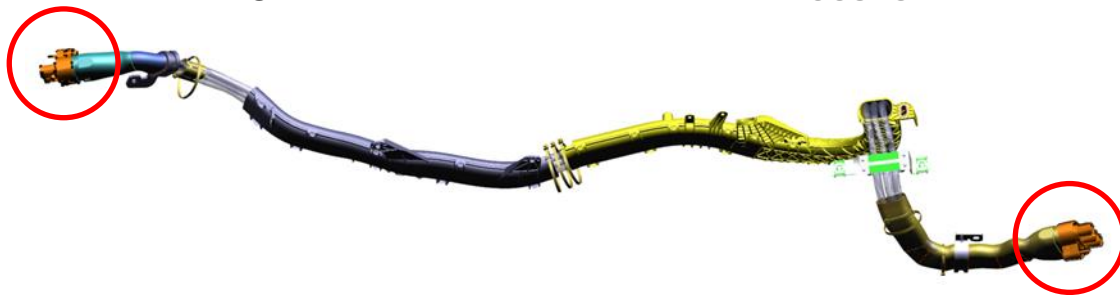
STAR Parts example for JL PHEV P1 to P1M Harness part number **68593175AB**:
 P1M Mod connector - Amphenol 3-way 8mm connector
 Service Connector Seal Part Number **68584363AA**
 Service Connector Fastener Part Number **06513772AA**

***On this harness both ends share a common connector design**

Discussion: High Voltage (HV) connect seals and fasteners are commonly damaged during the diagnostic and repair process. Replacement seals and fasteners are Now Available for ALL HV harnesses on 4XE. You no longer need to replace the entire HV harness for damaged seals or fasteners.

These replacement seals and fasteners are currently available; the required part number can be looked up using STAR Parts.
