April 22, 2026

Version 3

Front Suspension Noise While Turning

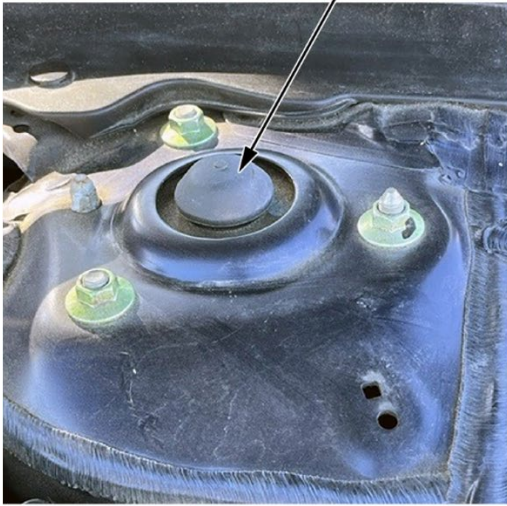
Front Damper Dust Cap

1. Open the hood and remove the Front Damper Dust Caps. Attach the chassis ear clip on the top of the damper shaft on each side.

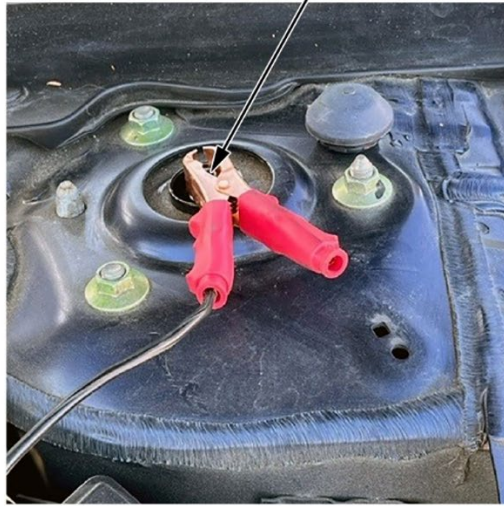
Attach the chassis ear to damper shaft

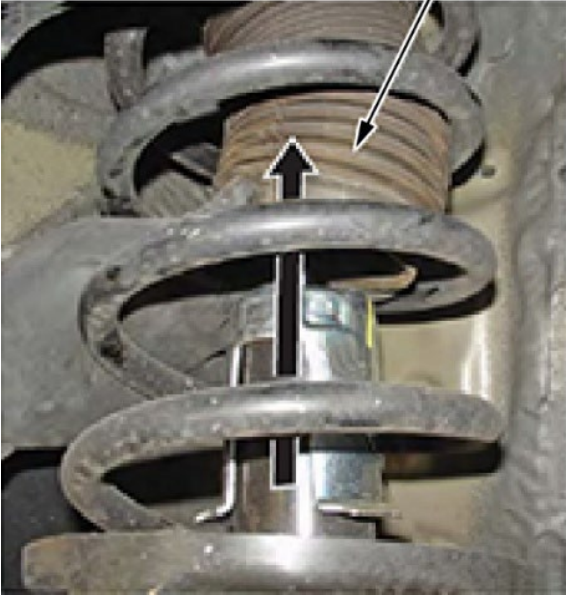
DAMPER DUST COVER

1. Raise the vehicle.
 - Accord – [Lift and Support Points](#)
 - Civic – [Lift and Support Points](#)
2. Remove the front wheels.
3. Lift the front damper dust cover to expose the damper shaft and the bump stop.

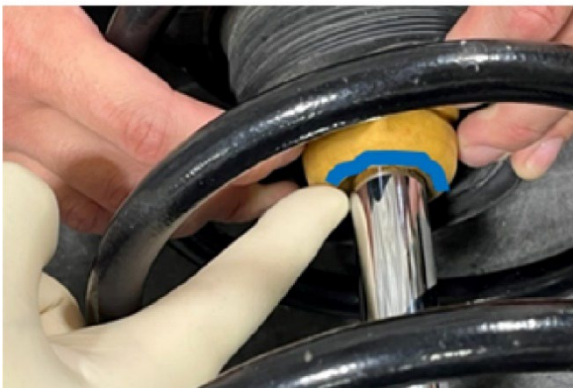
0.5 GRAM OF SILICONE GREASE

4. Dispense approximately **0.5 g**, or about a finger-tip dab of Shin-Etsu silicone grease. Apply the grease around the bottom of the bump stop (shown in blue).

NOTE: Make sure to wipe off any grease from the shaft.

The bump stop contacts the top of the front damper body.

Apply Shin-Etsu silicone grease to the bump stops on the front dampers.

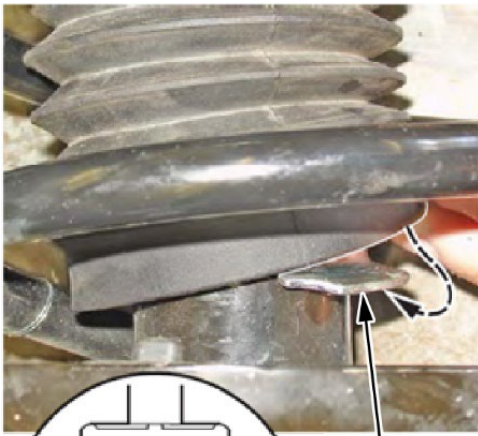
5. Install the damper dust cover.

The dust cover hooks onto the tabs at the base of the damper body.
