**TECHNICAL SERVICE BULLETIN, VIN:  
WSB-10 Midas 7-Way Plug Installation**

## Technical Service Bulletin WSB-10 Repair Instructions

**Purpose:** To install a 7-way electrical plug to operate tow lights.

**Models involved:** 2026 Midas Motorhomes

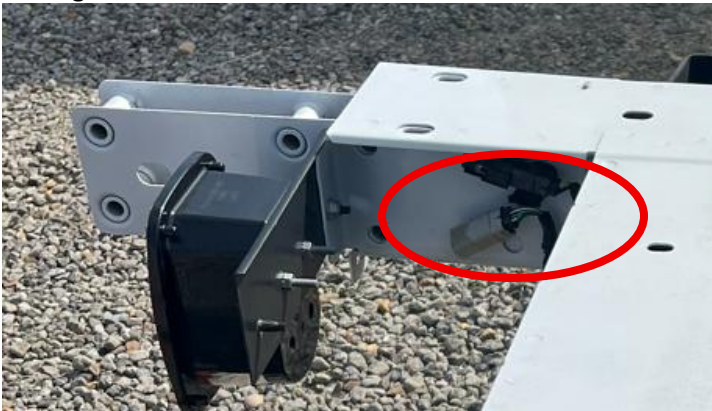
Figure 1

1. Access the Ford harness under the body of the motorhome, located behind the driver side taillight assembly. See Figure 1.

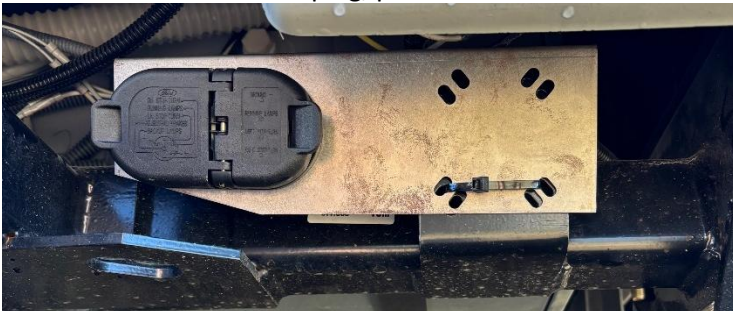
2. Connect the cable assembly, Tiffin part number 5190161, or Ford's part number LK4Z-13A576-B, to the Ford harness chassis connection and route the cable along the top of the hitch to the area where the bracket will be installed, securing with zip ties as needed.
3. Install the bracket for the plug, part 5190160 to the hitch with screws . See Figure 2

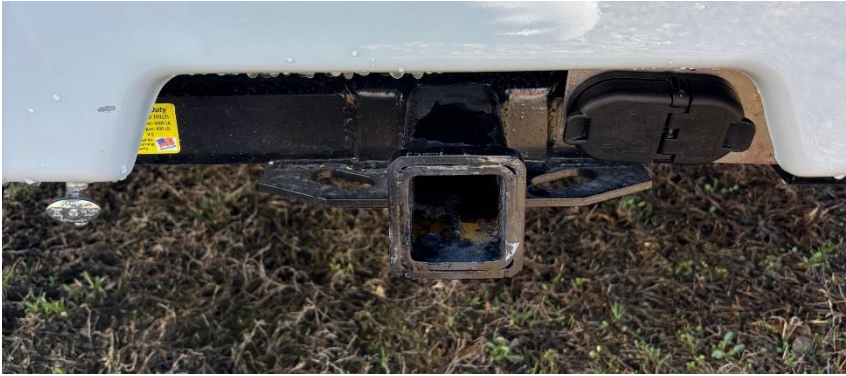
4. Secure the brake control harness connector, part 5191850 or Ford OEM part # 9U5Z-14489-MAA into the bracket for the plug, 5190160. See Figure 3

5. Install the tow capacity label on the hitch as shown in figure 3
