# SS 306 TBB HDX DEF Header Service Replacement Additional Parts

TBB HDX

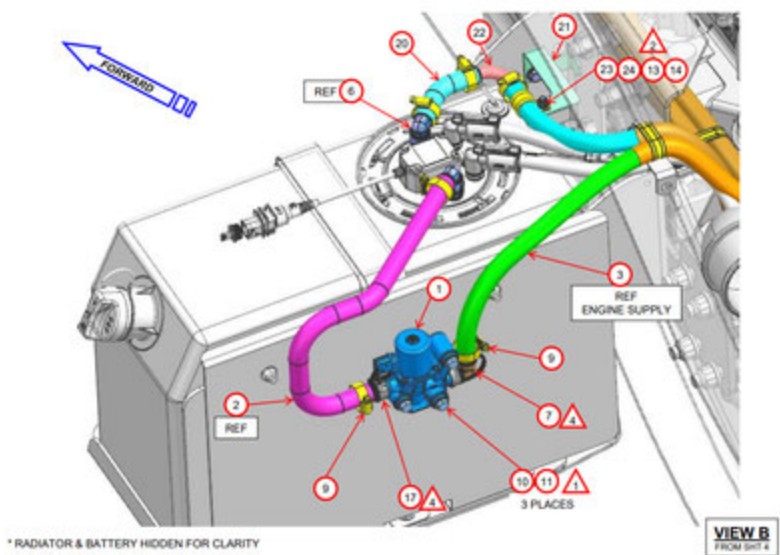
There are no longer SSI DEF Header replacement parts. If the vehicle came equipped with an SSI DEF Header, and that SSI DEF Header has failed, then a replacement KUS DEF Header 04 37614 000 must be used. The replacement requires some additional parts and re routing of DEF Pump Supply Coolant line. Refer below for how item 20 and 22 is routed.

Order additional parts

Pump Supply Coolant line. Refer below item 20 and 22 is installed.

TBB 248554 Formed hose Silicone

TBB 248552 Formed hose BS 5/8 ID

TBB 248782 Pipe

Hose Clamps TBB 61190163 (4)
