# Service Alert

<b>Subject:</b> HYBRID SYSTEM WARNING LIGHT ON WITH DTC(S) P143B,U04C0, U3008:01 BPS U3003:17 BPS - BAD SUB BATTERY (UNDER PASSANGER FLOOR)	<b>Service Alert No.:</b> SA-030/26
	<b>Last Issued :</b> 04/21/2026

2024-2026 CX-90 PHEV  
2025-2026 CX-70 PHEV

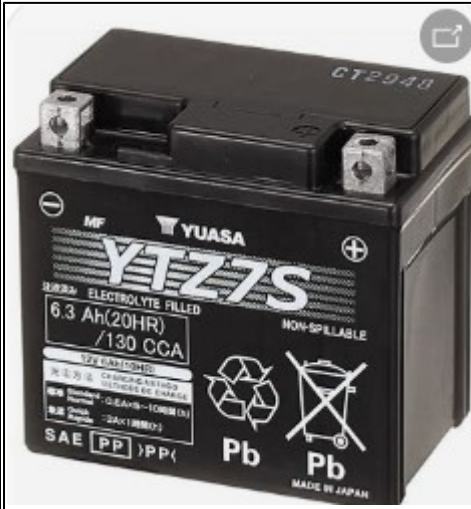
## Yuasa YTZ7S (AGM battery)

Sub Battery	QTY
PXFV185EZA Yuasa YTZ7S	1

**NOTE:** If the sub battery is not available or on backorder, it is acceptable to source a battery using the same manufacturer and model (commonly used for motorcycles).

3. Install a new sub battery.
