## SERVICE BULLETIN

**APPLICABILITY:** 2024-26MY Impreza & Crosstrek 2.0L Japan Built      **NUMBER:** 06-97-26  
 2025MY Forester Japan Built      **DATE:** 04/30/26

**SUBJECT:** Front Brake Pad / Design Change

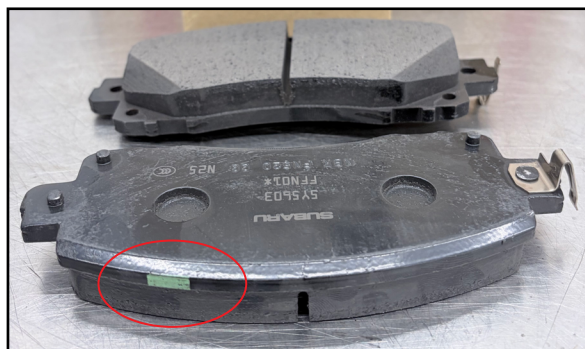
The redesigned brake pads are marked with a green rectangle on the top side of the pad, as shown in the image below.
