Preview Solution CBR-2562-15

Electric Pneumatic Module (EPM) Fault Code C10C256 - AN (4) - PR - VN (4)

Published 17 April 2026

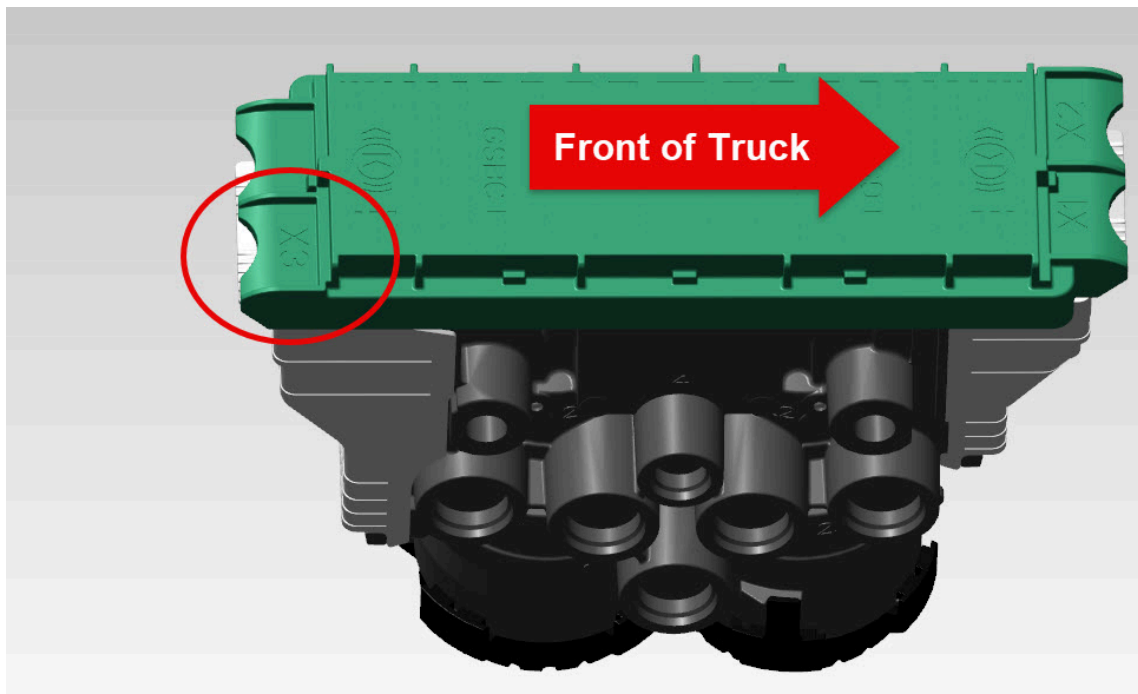
X3 location

When fault code C10C256 is active please inspect X3 on the Electronic Pneumatic Module (EPM) for corrosion. (see pictures below.)

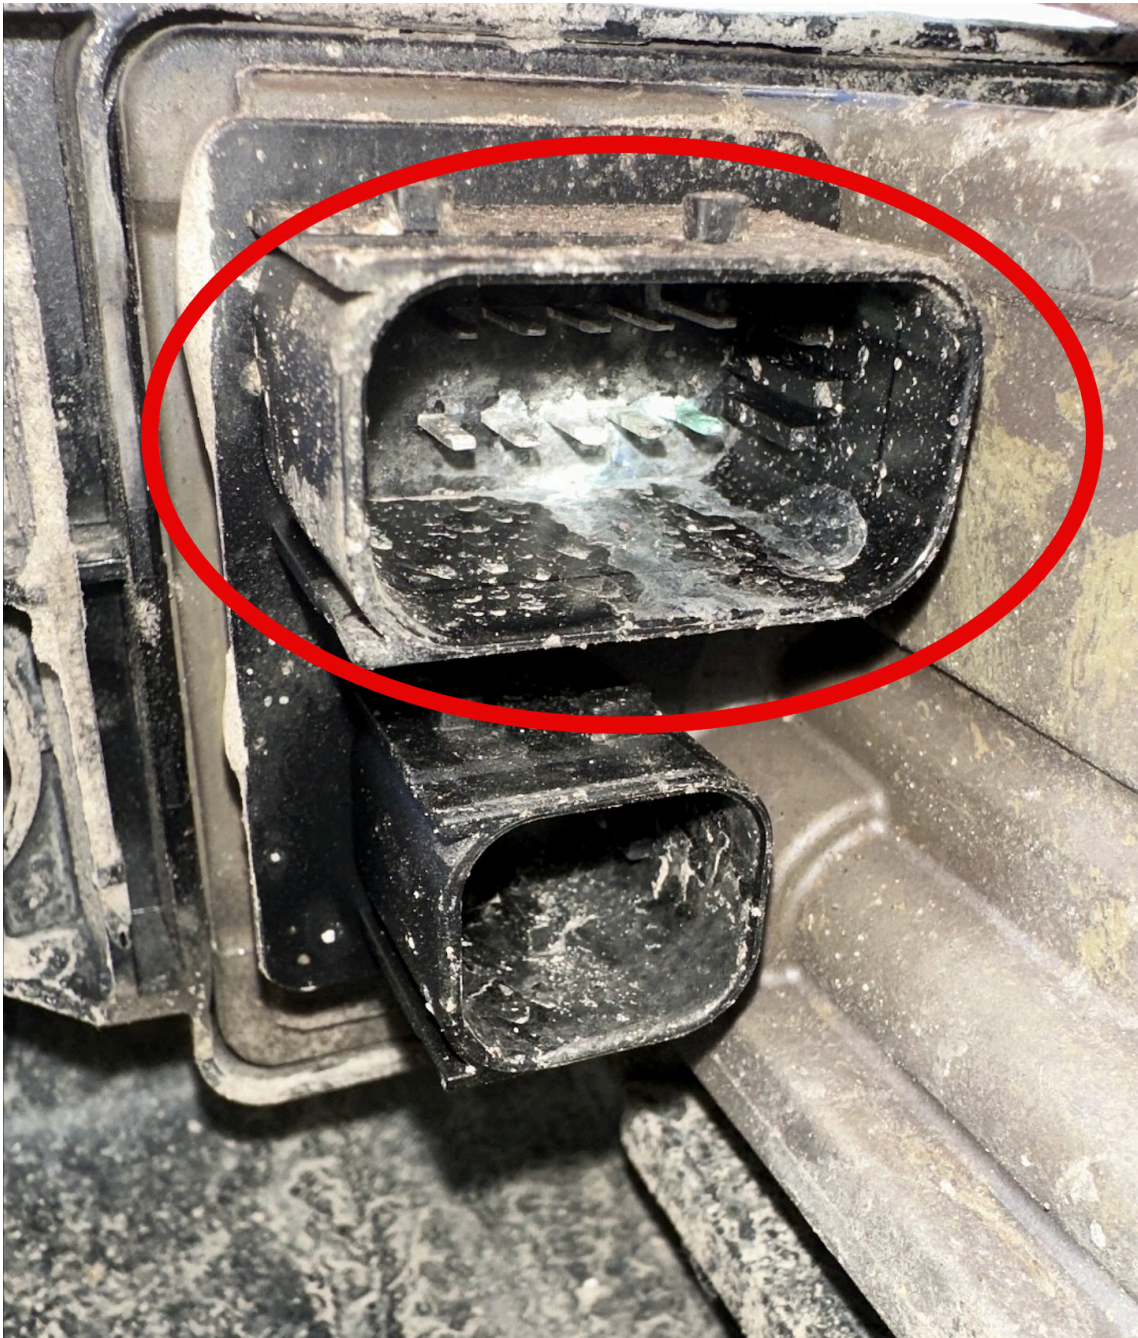
Corrosion present in connector.

Corrosion Found:

Please order a new EPM and cover part number **995115**. Replace the EPM with the new part and install cover on new EPM X3 port.

NOTE: DO NOT USE DIELECTRIC GREASE BEFORE CAPPING X3.
