Model(s)	Year(s)	VIN Range	Vehicle Specific Equipment
e-tron GT, and RS e-tron GT	2022 – 2025	All	With PR Code: GP0 00C0 – Actuator for exterior noise Software version: 0031

Software issue in the control unit for external sound (diagnostic address 00C0).

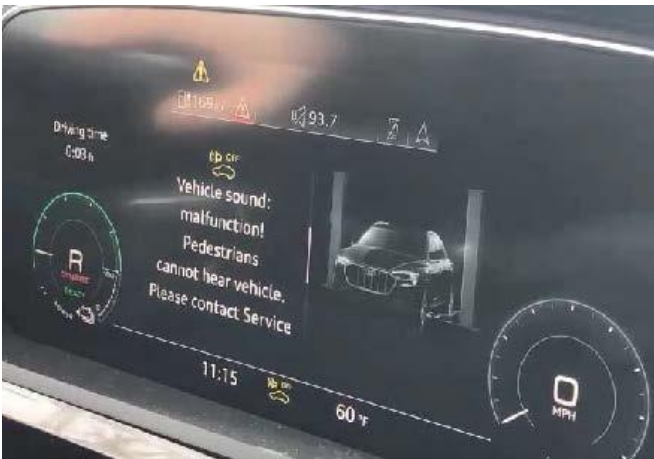
Figure 1. A warning message is displayed in the instrument cluster.

However, the external sound works correctly. The message may appear sporadically when starting up the system or when exceeding or dropping below a speed of approx. 43 mph (70 km/h).

A software update for the control unit for external sound (diagnostic address 00C0) is available.

The required SVM code is: **C0A002**
