**Vehicle-specific service**

Transaction No.: **2081643/1**

91 PSS MMI system: continued loading of user settings when MMI is started (VR 28.13.01)

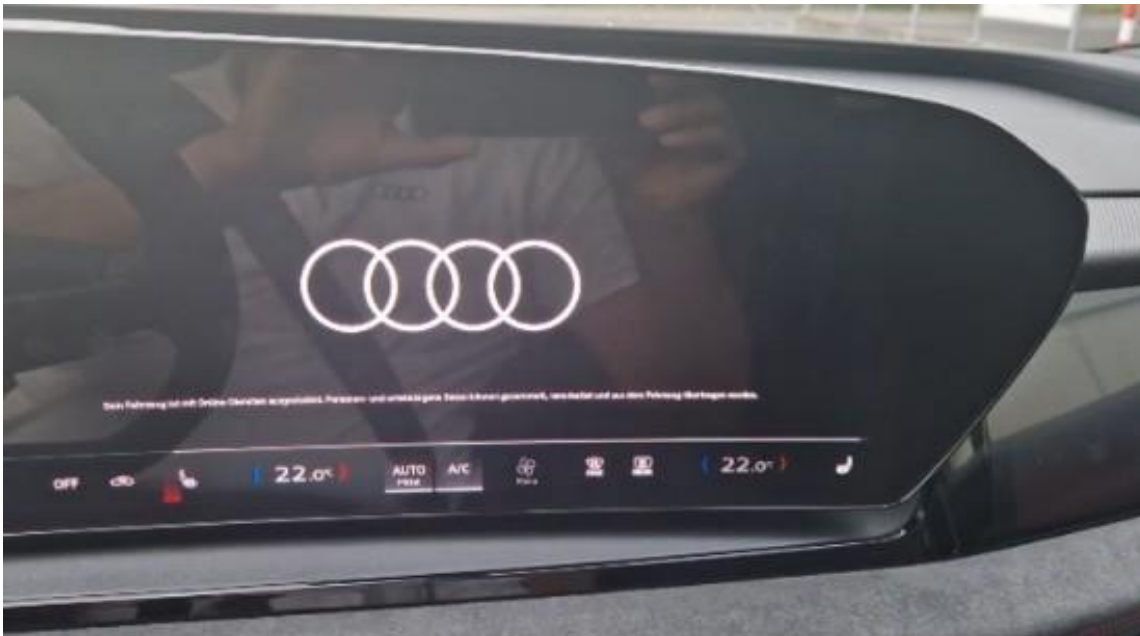
When the MMI starts, the Audi rings animation is shown for an extended period in the center display.

At the same time, a message stating that user settings are loading appears in the driver display.

It is not possible to operate the MMI during this time.

**Figure 1.** Loading continues for several minutes. It is not possible to operate the MMI during this time.

The issue may resolve itself after a few minutes. It can also be remedied by performing a soft reset (pressing and holding the volume control) or a bus sleep cycle.)

1. Explain to the customer that a solution is currently being implemented. The solution will be rolled out in stages for the different models. All information about the current schedule and availability of the measure can be found in TSB 2081477, *00 Service info: central overview of combined software update 03.11.00/C PPE/PPC - KD2\**.
2. Do not replace any components for this condition since this will not resolve the customer's concern.
3. Create a PSS record in the PSS application through the Pending Service Solutions (PSS) link in Audi Now; *Service | AU-US > Pending Service Solutions (PSS)*.
