Oil Pump Housing Improvement

The oil pump housing may crack.

Inspect the oil pump and replace if applicable.

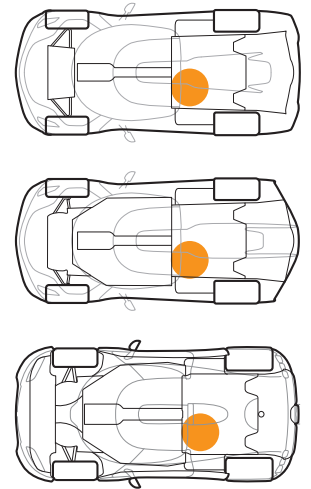
PARTS	REFERENCE	QUANTITY
Oil pump Jesko - 35mm cylindrical PRV housing	1096240	1
M8x15 -1.25 Ti flanged hex	130-149-0815	1
M8x25 -1.25 Ti bolt hex flanged	130-149-0801	3
M8x28 -1.25 bolt hex flanged	130-149-0828	3
Nord lock washer M5	130-198-5005	3
Nord lock washer M6	130-198-5006	2
O-ring 25.12x1.78 Viton	130-199-3047	4
O-ring 20.35x1,78 Viton	130-199-3049	8

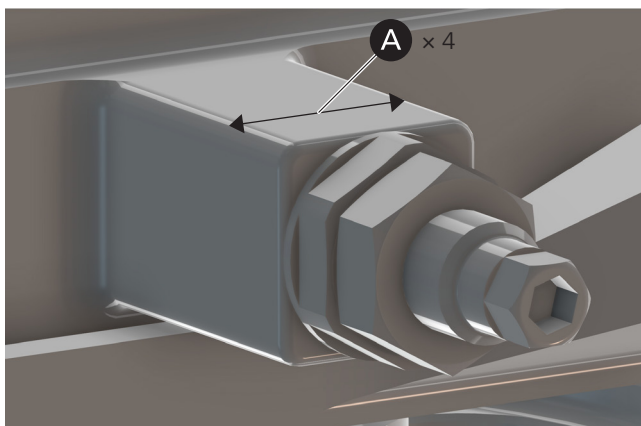
1. Do a check of all four sides **A** of the oil pressure adjustment screw housing. There should be no cracks or oil in the area:

- If you find that there are no cracks and no oil leakage in the area, then no further action is required. Continue to **Install**.
- If you find that there are cracks and/or oil leakage in the area, continue to **Remove** to remove the oil pump and then install a new one.
