**Volvo Car USA LLC**
**Technical Journal**

Technical Journal Title Rear Sun Curtain Button missing in CSD		Ref. No. TJ 37801.1.0	
Issuer (Dept.) Technical Service		Issue Date 3/27/26	Status Date 4/3/26
Car Market United States and Canada	Partner 3 US 7510 Volvo Car USA	Function Group 8590	
Function Description Miscellaneous		Page Page 1 of 3

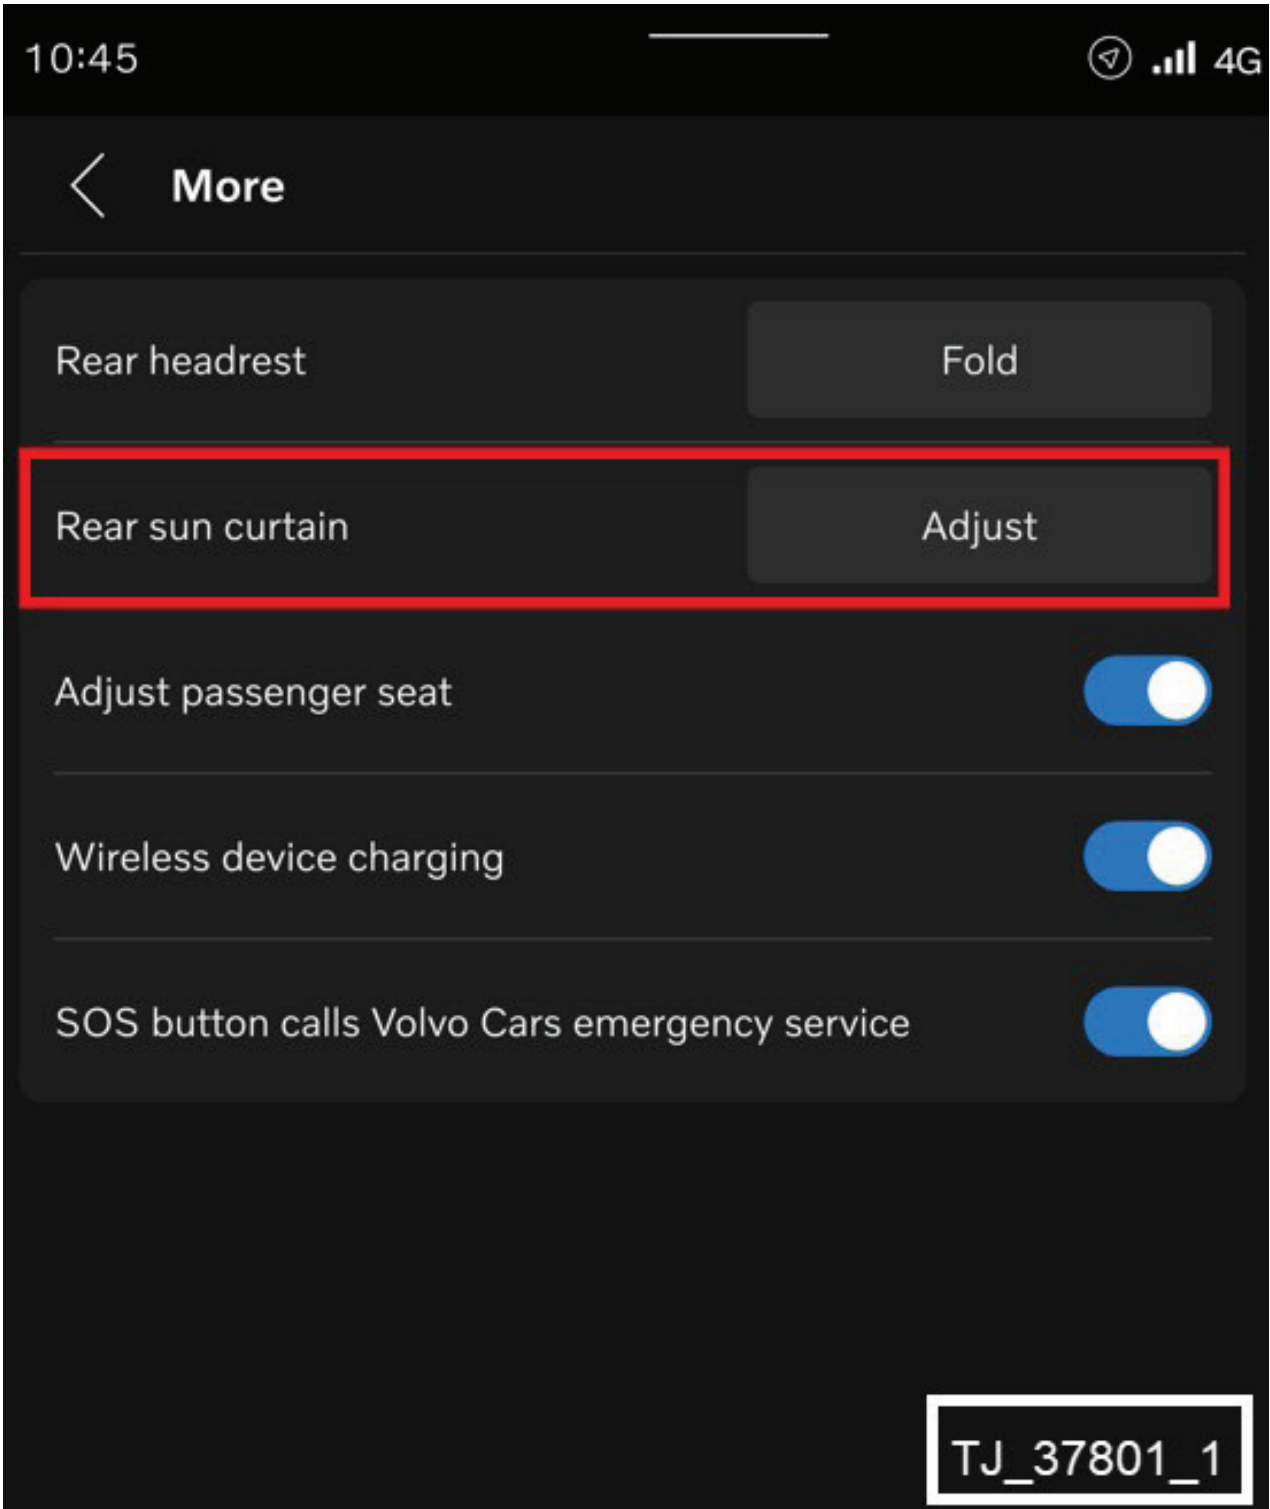
File Name	File Size
TJ_37801_1.jpg	0.0381 MB

If customer complains that the rear sun curtain button is missing in CSD, see red marking in attachment TJ\_37801\_1.jpg, then follow advice in Service. Only valid for S90/S90L with VDN PL03.

This issue is planned to be corrected during year 2026 quarter 3 in a software update.

**S90L:** Advise the customer to operate the rear sun curtain using the button on the door panel. See User Manual - Support/All cars/S90L 2026/User manual/Interior comfort and climate/Windows and glass panes/Using the sun curtains.
