## Battery Isolation Manager Connections

<b>Bulletin Type:</b>	TSB	<b>Publication Date:</b>	May 2026
<b>Bulletin #(s):</b>	26-019	<b>Make(s):</b>	Jayco & Entegra Coach
<b>Job Code(s):</b>	9803655	<b>Model(s):</b>	Melbourne Prestige & Qwest
<b>Flat Rate(s):</b>	9803655 - .50 HR – Bim Connections Repair	<b>Model Year(s):</b>	2026

## BIM CONNECTIONS REPAIR INSTRUCTIONS

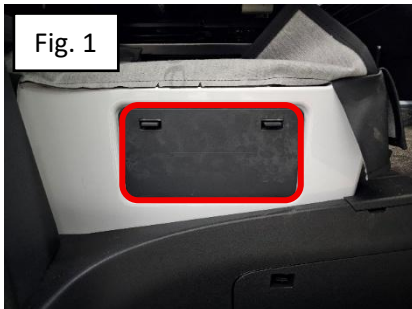
1. Remove the access cover on the side of the passenger seat base and locate the BIM. (Figure 1)
