Replacement Requirement for Wire Harness for Rear-View Mirror/Front Door or Front Main Wire Harness: Rework Signal Line for Mirror Camera (22/26)

Model Line: **Taycan (Y1A/Y1B/Y1C)**

Concerns: **Plug contacts of the signal line for the mirror camera on the new mirror wire harness/front door/front main wire harness**

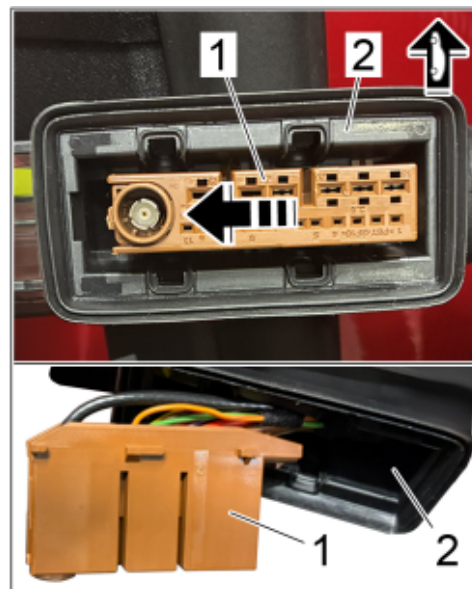
Example illustration of connector housing for door connection point

- 4 Release connector housing for door connection point ⇒ *Example illustration of connector housing for door connection point -1-* in ⇒ *Example illustration of connector housing for door connection point -Arrow direction-* and pull it out of the mounting housing ⇒ *Example illustration of connector housing for door connection point -2-*.

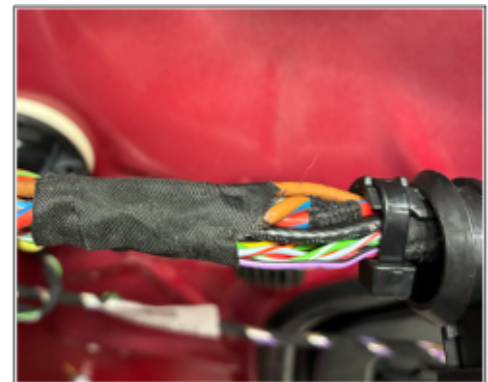
Fabric tape

If fabric tape has been opened or removed from the electric wire harness in the area below the grommet, re-attach it.
⇒ *Fabric tape*

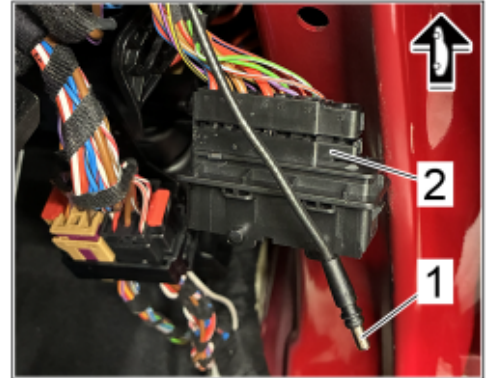
Example illustration of signal line at door connection point

- 2 Release plug contact of the signal line ⇒ *Example illustration of signal line at door connection point -1-*, pull ⇒ *Example illustration of signal line at door connection point -2-* it out of the connector housing and replace it with a **new** plug contact.
For work procedure, see: ⇒ *Workshop Manual '912841C8 Repairing antenna cable'*
- 3 Install a corresponding **new** main wire harness for section front left/right.
