### G-Class 463 & 465 - Parktronic Erroneous Warnings From Front Due to Brush Guard

| Topic number | LI54.70-P-080191 |
| Function group | 54.70 - Proximity warning system |
| Validity | 463 with Front Brush Guard<br>465 with Front Brush Guard |

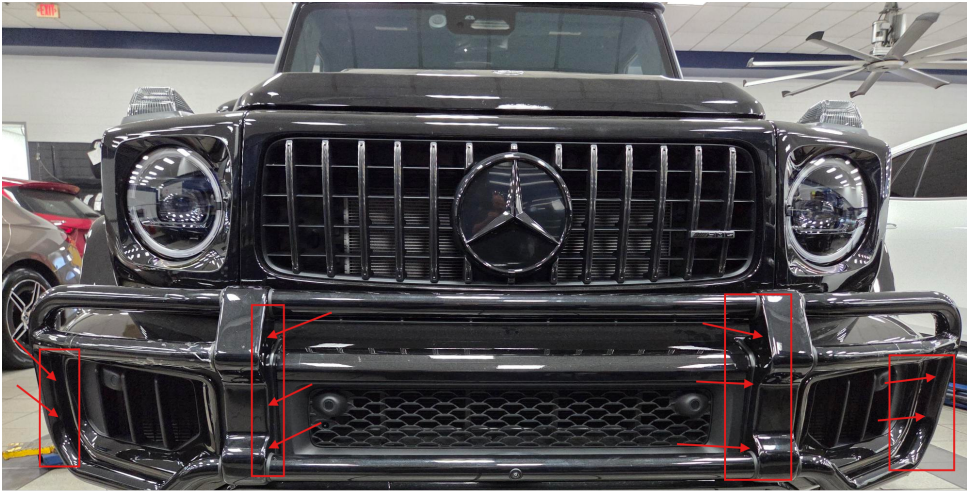
If the concern is still consistently reproducible, please apply clear matte film to the locations as shown below at a minimum, although the clear matte film may be applied to the whole brush guard.

Picture: Above shown is the 465 brush guard variant. Although similar to the 463, there are some key differences such as the 465 being fitted with a front camera. The methods above should

1. Determine if the complaint is reproducible only in high ambient temperatures. If complaint does not occur in cooler ambient temperatures, it is due to system limitations. You may proceed with the below work but the vehicle may be released afterwards as it is due to system limitations.
2. Remove the brush guard and verify the park distance sensors function as expected.
3. Reinstall brush guard and adjust so that it is as far away from the park sensors as possible. Typically only small adjustments are possible.
4. Check function.
