# SS 583788 FCCC2011-2026 MT45,MT55,MT50E Updated Front Brake Line & Bracket Clamping Enhancements

FCCC 2011 2026 MT45, MT55, MT50E step vans.

## Install - Brake Line Service Kit

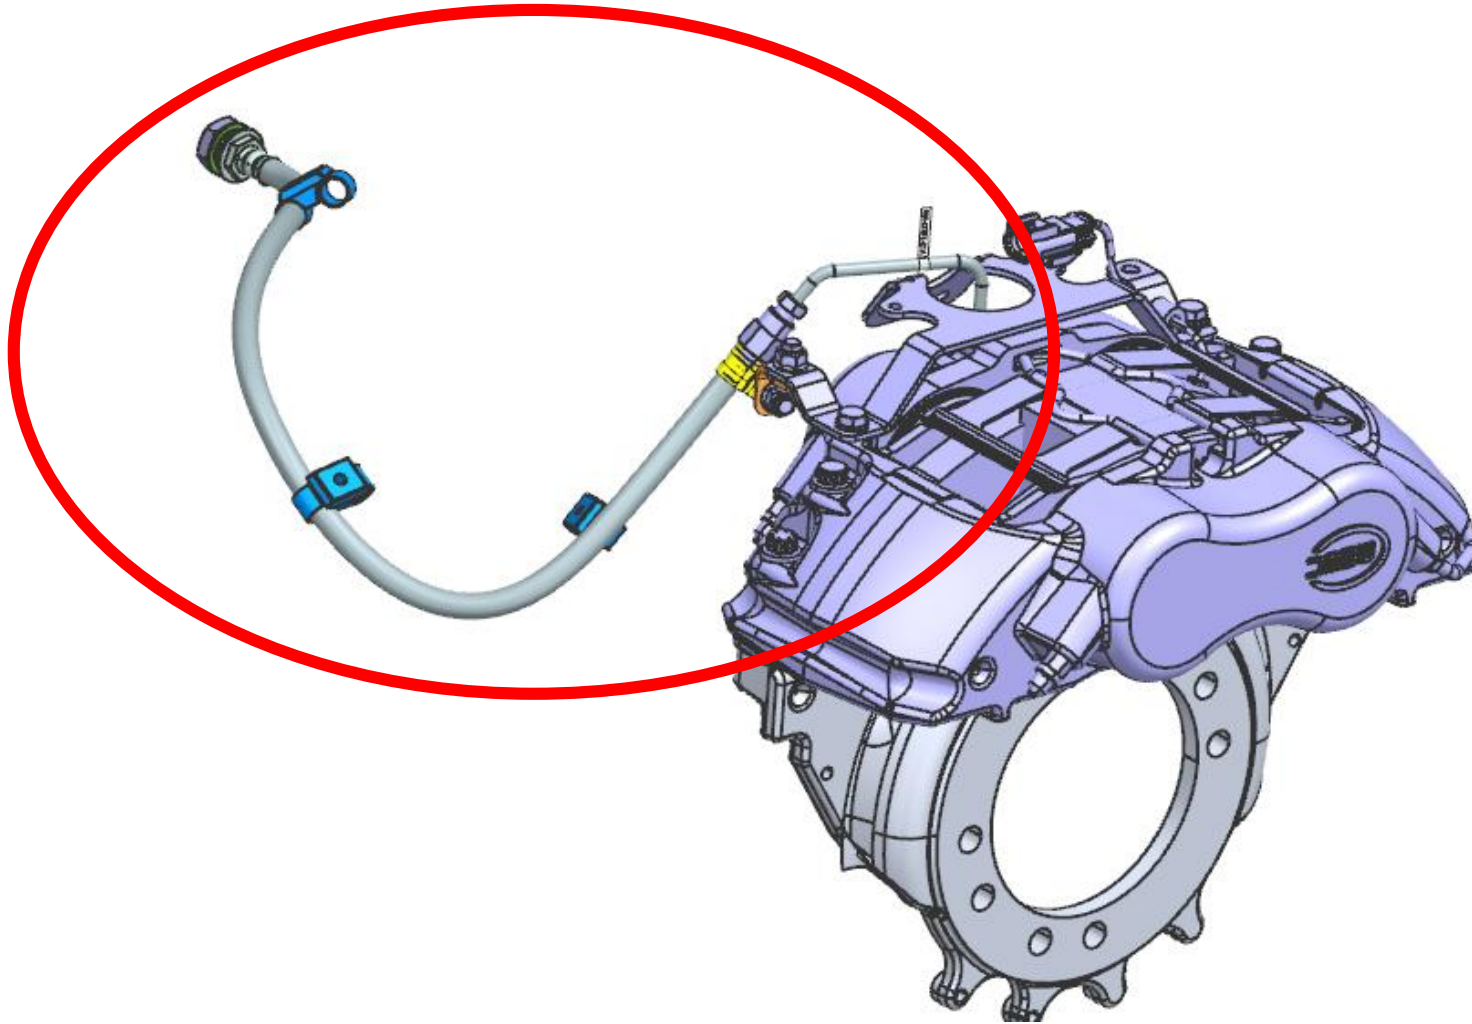
**Purpose:** Update brake hose service kit.

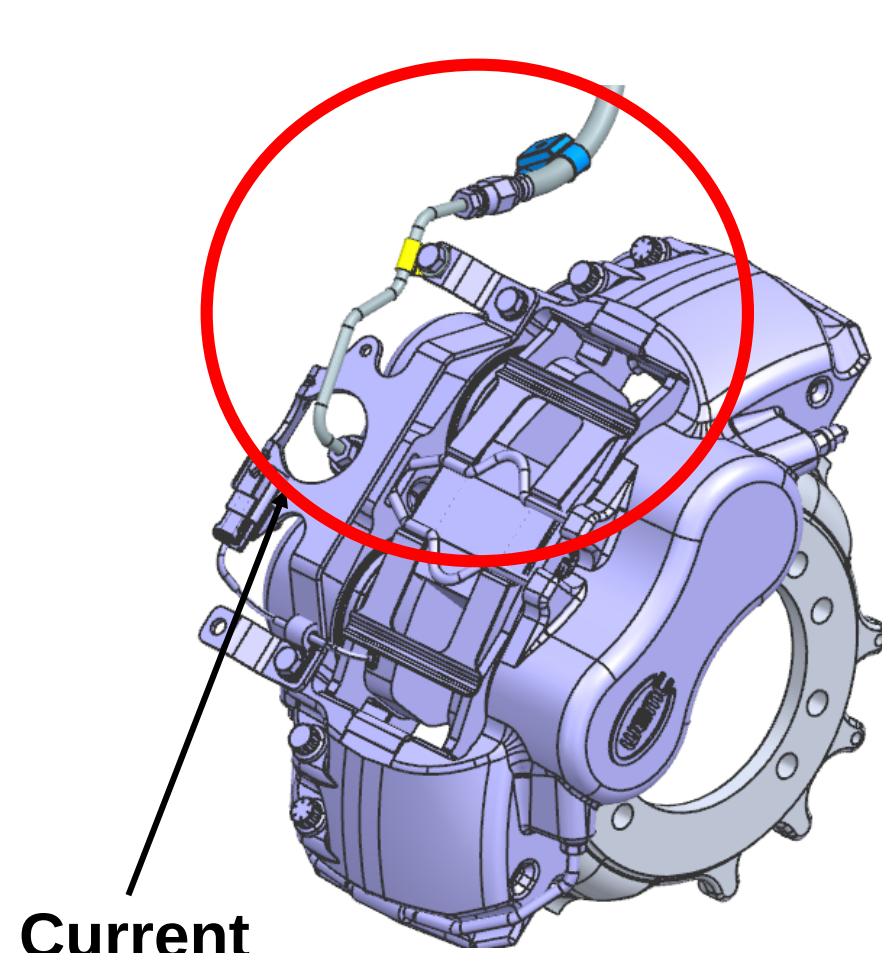
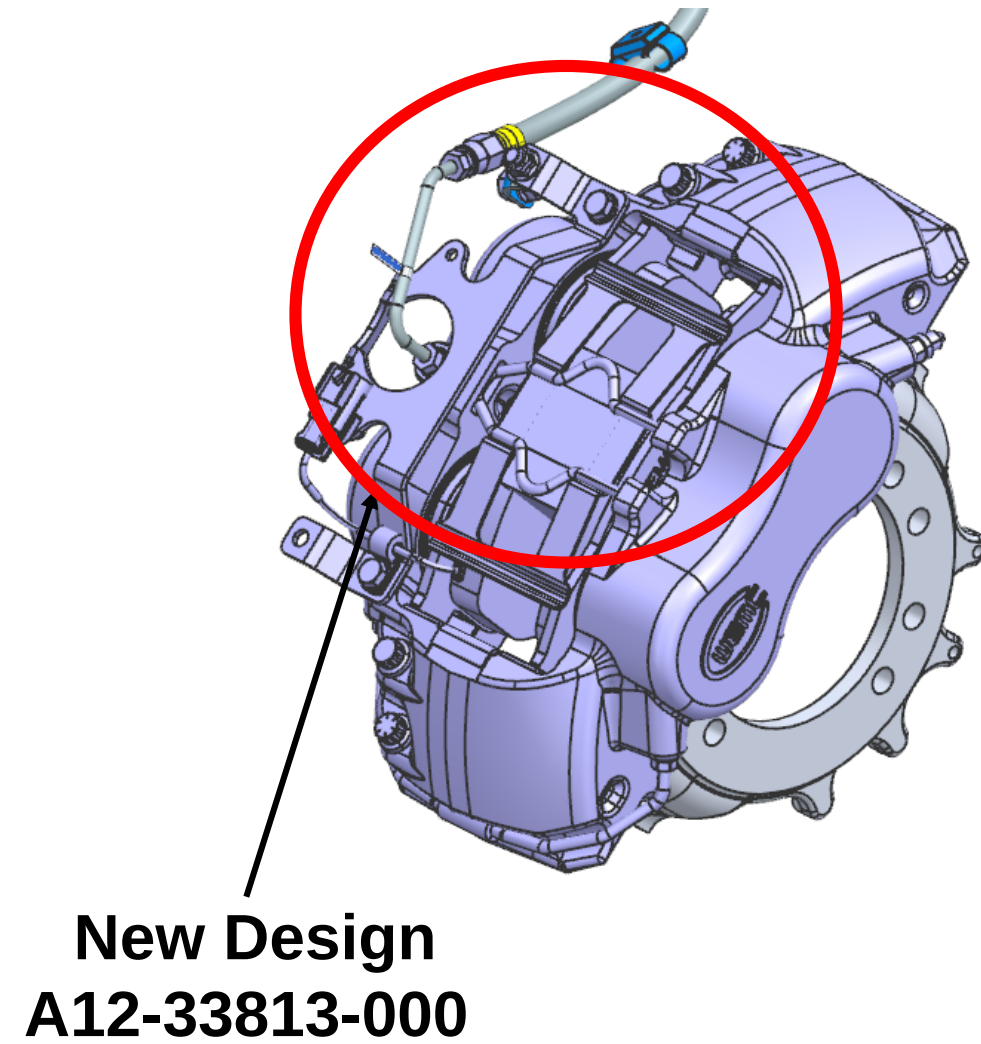
## Install – Brake Line Service Kit

1. HYDRAULIC LINES MUST BE ROUTED TO PREVENT CONTACT WITH CHASSIS COMPONENTS.
2. TORQUE 7/16" BRAKE LINE NUTS TO A RANGE OF 12 - 15 FT-LBS.
3. TORQUE 5/8" JAM NUT TO TARGET 82.5 FT-LBS, RANGE 80 - 85 FT-LBS
4. TORQUE 5/16" HARDWARE TO 13FT-LBS
