## Technical Service Bulletin

Transaction No.: 2071790/3

91-23-04 - MIB3 Recovery Solution

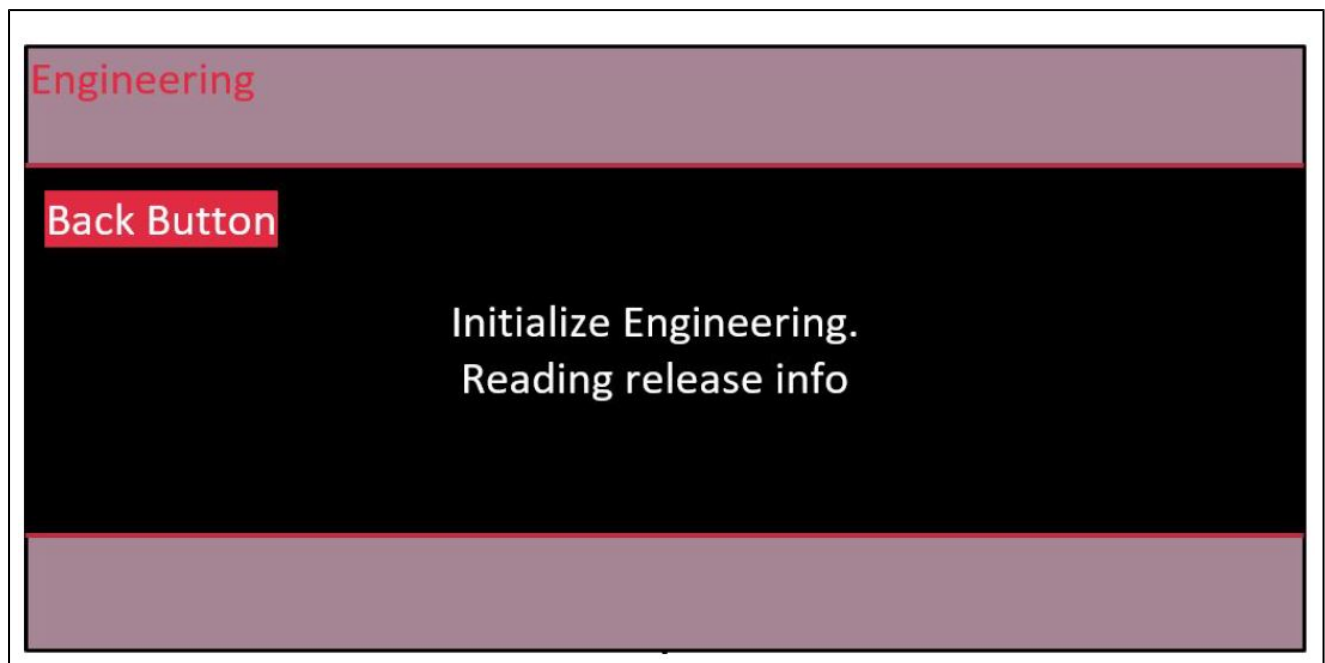
- Refer to Technical Bulletin 00-19-04 (2054866) Set up SD/USB Creator to Obtain Software Updates.
- Use USB part number **3G0.919.360.SE**.
- Switch the ignition to the OFF position.
- Connect the MTRMSP0702 battery maintainer/charger to the vehicle's battery.
- Insert the USB **3G0.919.360.SE** into the front USB-C connection.
- Switch the ignition to the ON position.
- Hold the "On/Off" button on the MIB display for a minimum of 10 seconds, then release.
- At this point, it may take up to 5 minutes to the system to start and initialize.
- If after 5 minutes, there is no response from the system, the above process may be repeated.
- If the recovery attempt is successful, the following screen may appear on the MIB display and additional files may install at this time.
