## Technical Service Bulletin

Transaction No.: 2081598/1

93-26-04 - Electrical System Error Message with DTC P0A1B00 or P06A900

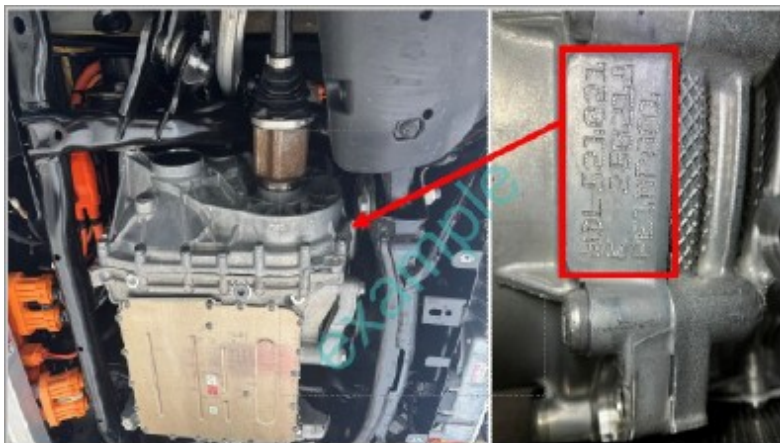
- If the gearbox production date (see illustration 1, in red) is in between 18.09.2025 and 14.03.2026, proceed to step 2.
- If the gearbox production date (see illustration 1, in red) is not in between 18.09.2025 and 14.03.2026, proceed to step 3.

Figure 1) example: Gearbox production date (in red)

Be sure to take a photo of the gearbox production date for documentation!

## 2. Replace Electric Drive Power and Control Electronics with Three-Phase Current Drive:

- Replace the rear Electric Drive Power and Control Electronics -JX1- with Three-Phase Current Drive - VX54- as an assembly according to the Repair Manual and Parts Catalogue.
- No further steps are required in accordance with this bulletin.
