## Technical Service Bulletin

Transaction No.: **2043424/20**

40 Creaking/squeaking noises from the front end on uneven roads

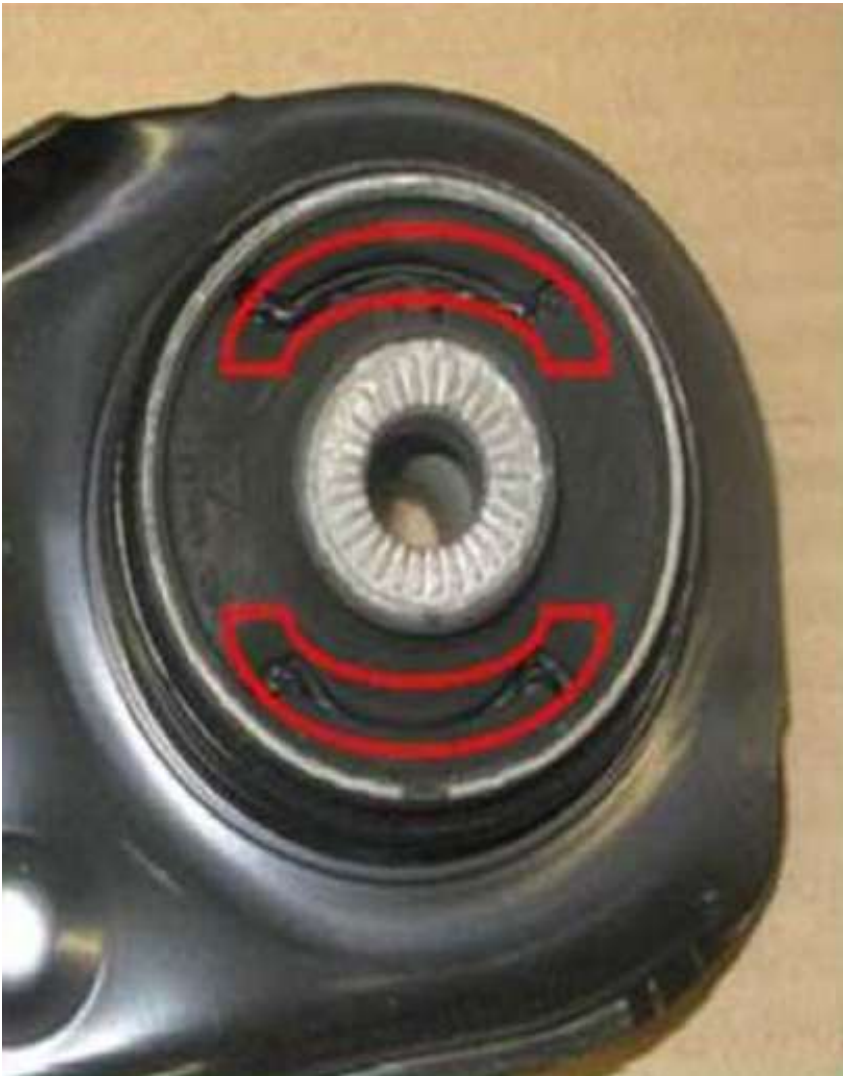
The rear elastomer bush of the control arm on the front axle has kidney shape slits. When driving on uneven roads this can cause noise due to relative movements in the elastomer bush.

Figure 1. Lithium grease is applied on the red highlighted area.

- 1. Try to reproduce the customer complaint (in accordance with the customer statement/technical background) so that it can be clearly assigned to this TSB. The repair described below must only be performed if the specified criteria apply. For a permanent remedy to the noise complaint, the control arm must be removed. For the parts to be replaced and the required additional work, refer to the Workshop Manual. Apply Lithium Grease (part number G052 150 A2) to the kidney shape slits of the rear elastomer bush from above (with bush removed). The lithium grease must only be applied within the areas shown in red. (Figure 1).
- 2. Do this on both sides of the front axle.

20 g lithium grease (part number G052 150 A2) is needed for both control arms.
