# HYUNDAI

## Technical Service Bulletin

| GROUP<br><b>CAMPAIGN</b> | NUMBER<br><b>26-01-039H</b> |

**SUBJECT:** ECM SOFTWARE UPDATE – DTC P132700  
(SERVICE CAMPAIGN 9D3)

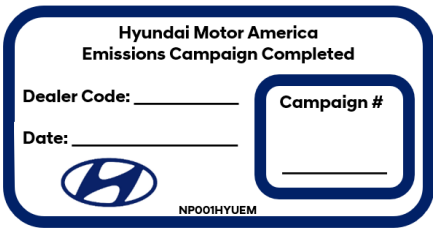
| Model | Part Name | Part Number | Figure | Remarks |
|---|---|---|---|---|
| Elantra (ADA) | Hyundai Emissions Label | NP001-HYUEM | | Apply to all vehicles regardless of state. |

1. Fill in the Campaign ID, Dealer Code, and Date on the emissions label, and apply adjacent to the existing label, on the underside of the hood, as shown.

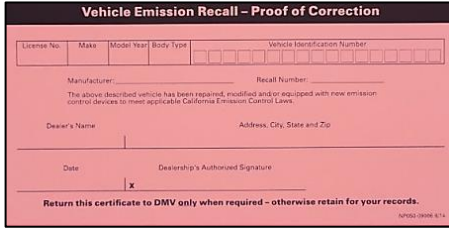
| Model | Part Name | Part Number | Figure | Remarks |
|---|---|---|---|---|
| | Vehicle Emission Recall - Proof of Correction Card | NP050-09006 | | Order only for states:<br>CA, CO, CT, DE, ME, MD, MA, NJ, NY, OR, PA, RI, VT, WA |

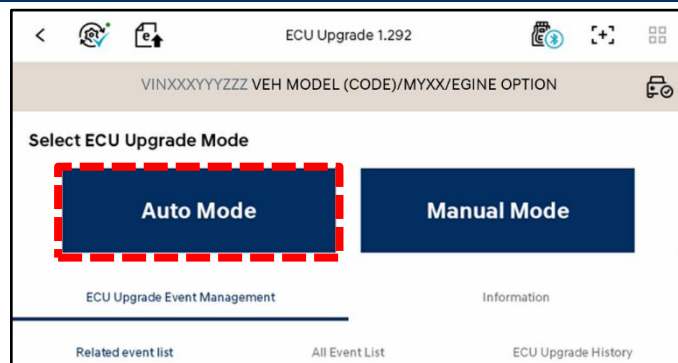
1. Perform the ECU update in **Auto Mode**.

Refer to **TSB # 25-GI-011H**, “**ECU Update Procedure for Tablet-Based GDS-Smart**”, for additional information.

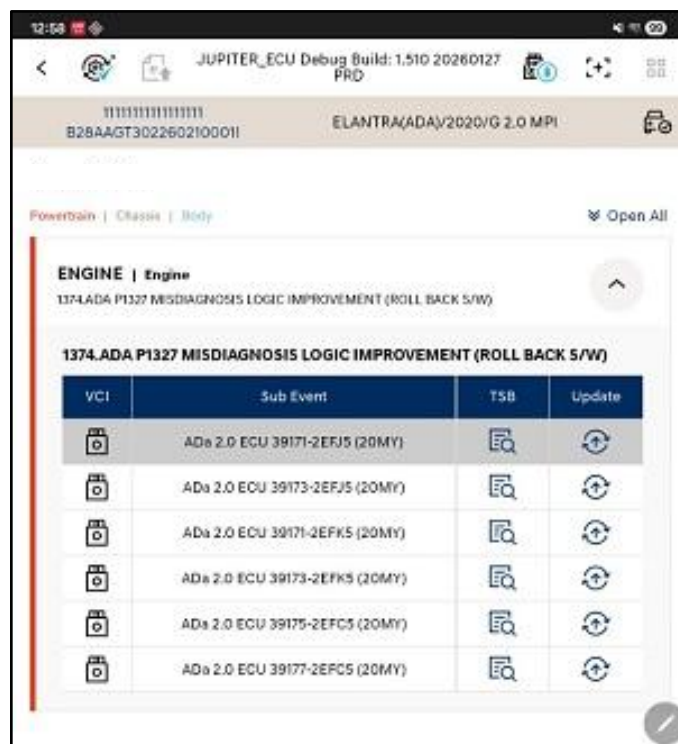
2. Verify the ROM ID by selecting the **ENGINE** system to scan the vehicle's current ROM ID.

Check the current ROM ID version and compare it to the ROM ID Information table before attempting to perform the software update.

If the update fails, remove the power connector from the in-cabin fuse box for at least **5 seconds**. Reassemble and retry the update.

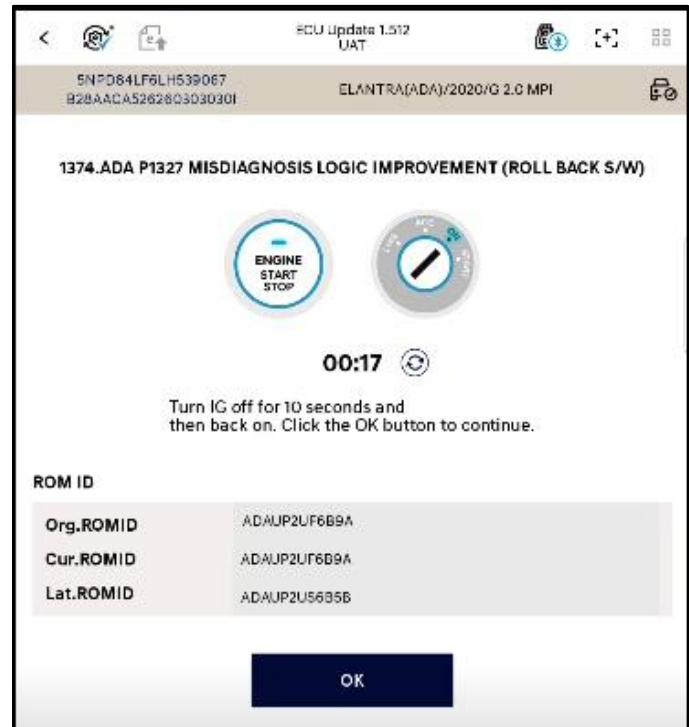
3. After the ECU update process shows 100% complete, follow the prompts on the screen to cycle the ignition **OFF** for at least **10 seconds** to reset the control unit (certain models may take up to **30 seconds**).

Use the **Refresh** button to reset the timer.

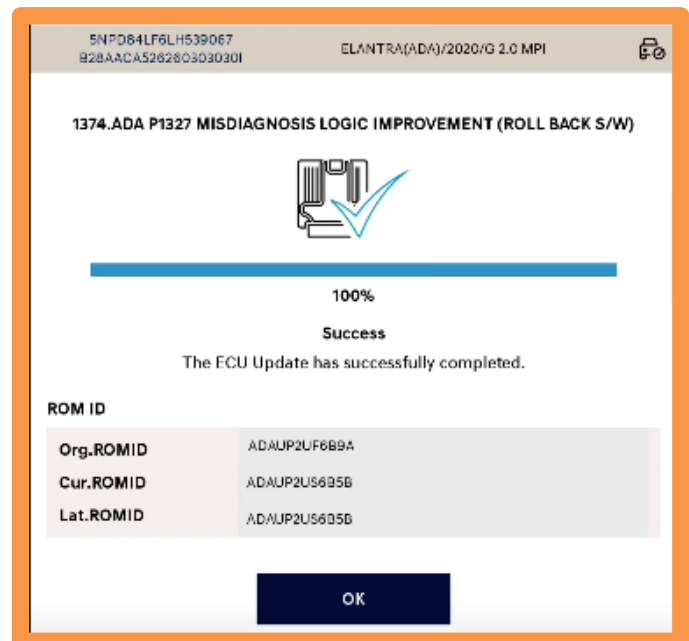
Using the tablet or GDS screen capture function, take a screenshot of the ECU Update "Success" result screen.

Upload the photo to STUI.

**NOTE:** The VIN/Date/Time/Mileage photo imprint is **NOT** required for GDS screenshots.

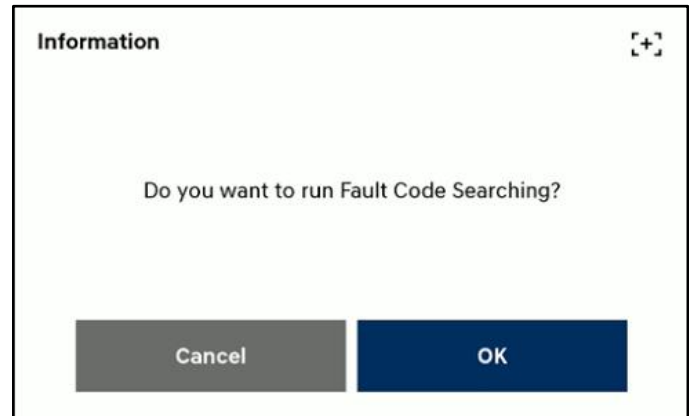
5. Perform an **All Systems Fault Code** search and erase DTC history that had incidentally occurred from the ECU update.

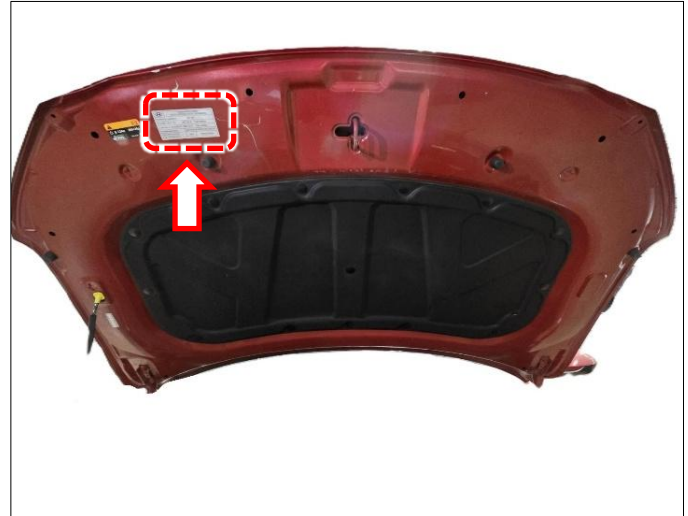
Be sure to clean the mounting surface to ensure proper label adhesion.

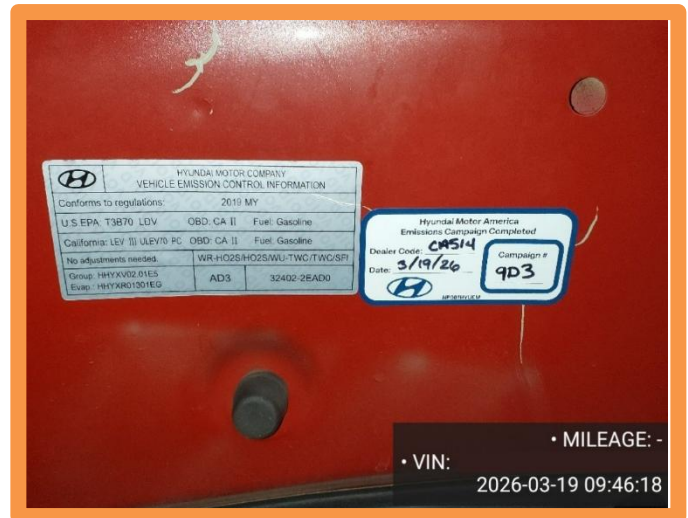
Using the STUI camera function, take a photo of the emissions label attached to the vehicle.

Upload the photo to STUI.

**NOTE:** If the STUI camera function is **NOT** used, write the last 6 digits of the VIN and date of repair on a piece of paper to include in the photo.
