# Technical Service Bulletin

**POWER LIFTGATE (PLG) WILL NOT OPEN OR CLOSE, WARNING BUZZER ON WITH DTCs B144F:11 OR B144F:13**

**Bulletin No.: 09-024/26**

2022-2025 CX-5 vehicles equipped with Power Liftgate

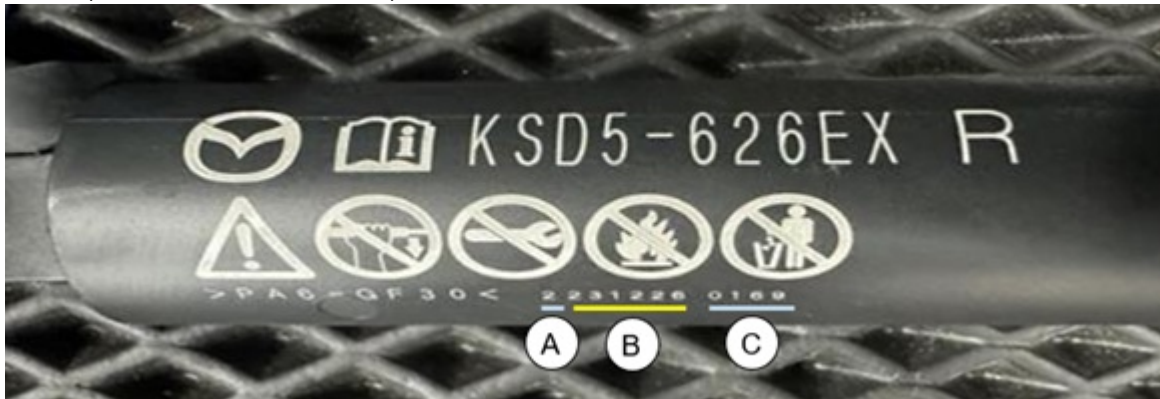
read it (Lot Number Identification).

**NOTE:** The lot number is located on the PLG drive unit. Refer to the following for the location and instructions on how to

- (A) Production Line No.  
 (B) Production Date: YY MM DD  
 (C) Tracking No.

1. Confirm that the power liftgate does not move when operating.
2. Check for DTCs B144F:11 or B144F:13 using M-MDS.
3. Check whether the manufacturing date from the lot number on the power liftgate drive unit is on or before February 10, 2025.

☐ If the lot number is on or before February 10, 2025 replace the power liftgate drive unit according to the instructions on MGSS POWER LIFTGATE (PLG) DRIVE UNIT REMOVAL/INSTALLATION.
