## Technical Service Bulletin

Transaction No.: **2067132/4**

46 Service Info : Corrosion on friction surface of steel brake disc - All models

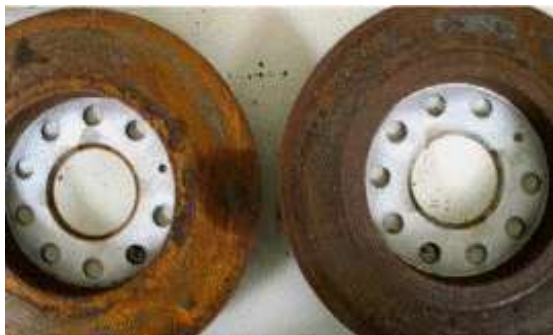
Rust layer on brake disc. Noises and/or vibrations when braking.

- Corrosion on the friction surface can occur due to the effects of moisture and road salt, if the vehicle is stationary for long periods or if the brakes are only used lightly on short journeys (insufficient brake cleaning). (Figure 1 and 2).
- (Customer Information):
  - Brake discs are exposed to environmental influences such as water, salt, snow, and dirt.
  - The brake disc material, *flake graphite cast iron*, is not resistant to corrosion.
  - It is not possible to apply an anti-corrosion coating to the friction surfaces.
  - The brake discs must be maintained according to the Owner's Manual (remove corrosion regularly, do not overuse by intensive braking).

**Figure 1:** Example of excessively rusted disc brakes. **Figure 2:** Example of rusted disc brake surface.

- Perform an extensive test drive with several brake operations.
- Check that the pads make contact with the disc correctly so that they are cleaning the entire surface of the brake disc.
- If the complaint persists after the discs have been intensively “braked clean”, replacing the parts is the only option.
- Please explain to the customer the importance of cleaning the brakes according to the Owner’s Manual.
