## Porsche Mobile Charger Plus (PMC+) Red LEDs and Fault B191E49

**Bulletin #: 2315.1**

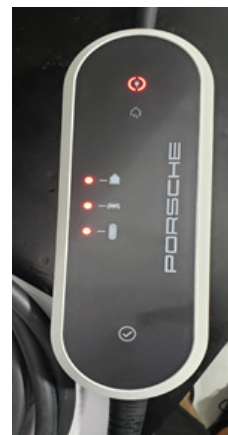
The PMC+ performs continuous self-monitoring. If the PMC+ repeatedly detects an issue while charging, then fault B191E49 (DTC 100102) is set as Active. The device then stops charging as a precaution, and all LEDs are illuminated red. The LEDs will remain red – even after unplugging and plugging back in – until the device is reset.

1. Connect the PMC+ to the wall outlet and wait approximately 15 seconds for the charger to power up.
2. Cancel the error stored in the device.
  - Press and hold the multifunction button (minimum 2 seconds). All lights should cycle off and back on as the device resets and the error stored in the device is cleared.

3. Check the charger for normal operation; check that the device successfully charges multiple vehicles.
  - If all LEDs again light up red after the reset

- a Connect a different supply cable; plug in the device; **reset the device as described in Step 2 above**; check operation.
    - b Connect the charger and supply cable to another receptacle on a different infrastructure branch circuit; **reset the device as described in Step 2 above**; check operation.

4. If all LEDs light up red following a change of the supply cable and different infrastructure along with a device reset, then the PMC+ will require replacement.
