## PARTS FLASH

REFERENCE NO.: RF-26-04

APPLICABLE MODEL(S): 2024-2026 CX-90 and 2025-2026 CX-70

SUBJECT: ORDERING REQUIREMENT FOR AT COMPONENTS FOR H3T (INLINE 6)

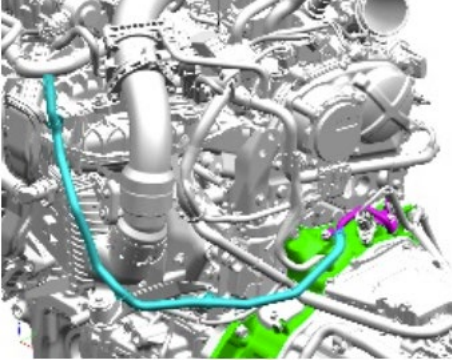
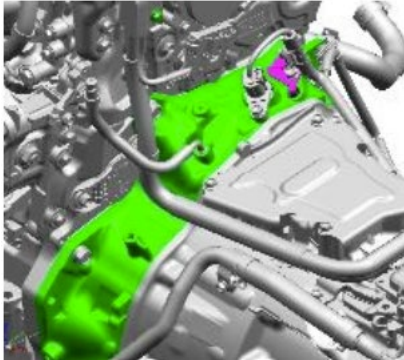
Early production vehicles were equipped with a water hose that was later discontinued. When replacing the AT component on vehicles that require water hose removal, remove the water hose. Current service AT components do not include a provision for water hose installation, and the hose does not need to be reinstalled.

| <b>Prior to water hose discontinuation<br/>(water hose shown in purple)</b> | <b>After water hose discontinuation<br/>(harness bracket shown in purple)</b> |

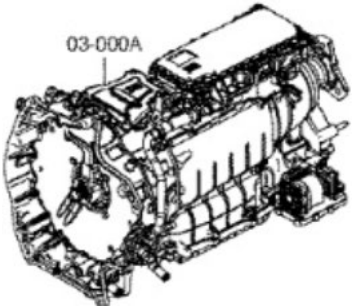
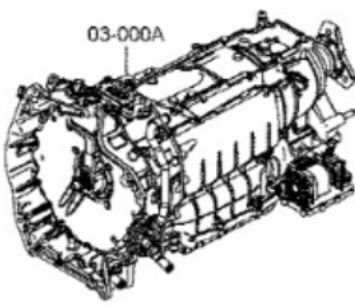
The inverter is reused and is not included with service AT components. Before ordering, check the AT component part number in GEPC and use Table A or Table B to order all required parts together.

| <b>AT component with inverter</b> | <b>Service AT component without inverter</b> |

**IMPORTANT: If DTCs for inverter are present or WSM indicates inverter replacement is needed, order inverter separately.**

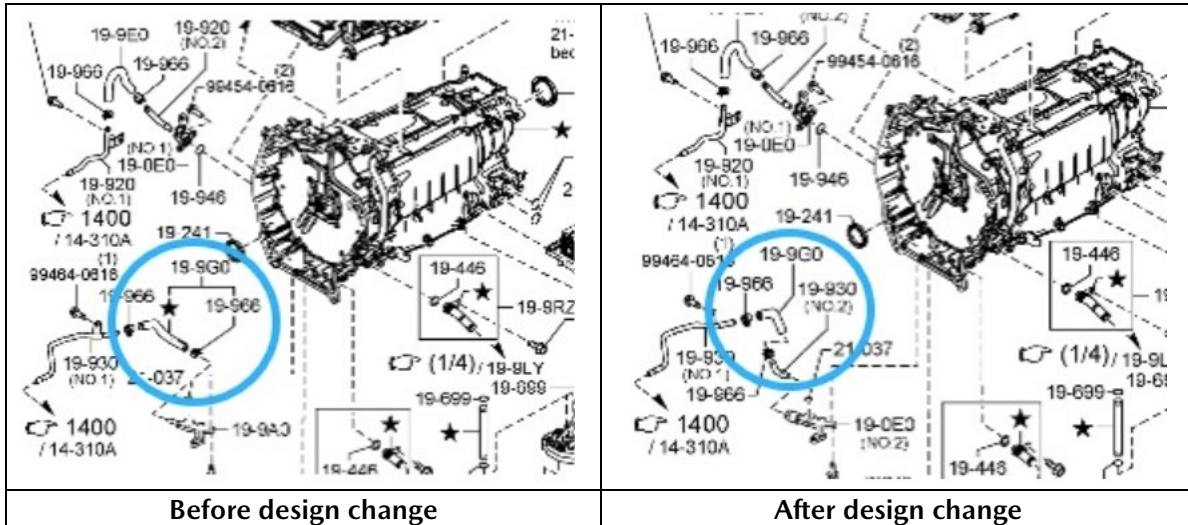
The oil hose and oil pipe were redesigned and are not interchangeable with previous-design parts. When replacing the AT component, the oil hose and oil pipe must be replaced together with the AT component.

**IMPORTANT:** If the oil hose and oil pipe are not ordered, the repair cannot be completed.
