| Technical Journal Title<br>Vehicle Fails to Charge on All AC and DC Chargers | | Ref. No.<br>TJ 37436.4.0 | |
| Car Market<br>United States and Canada | Partner<br>3 US 7510 Volvo Car USA | | Function Group<br>3234 |
| Function Description<br>Onboard charger, high voltage | | Page<br>Page 1 of 3 | |

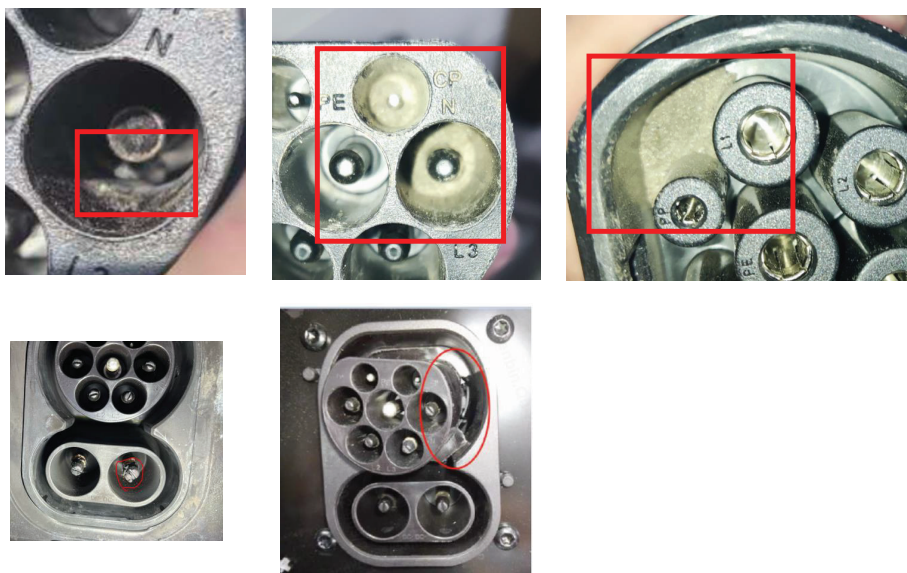
1. The condition of the EVI for damage and/or foreign objects.
  - Sample images can be found on page 1 of the attached PDF file.
2. The connectors at the CDD: unplug, then plug them in again.
  - Relevant connectors are numbers 1, 2, 6, and 9 on the drawing on page 2 of the attached PDF file.
  - \* Note: The High Voltage Battery must be disconnected according to VIDA before unplugging the connectors.

If no deviations are found at the EVI or at the connectors at the CDD, continue fault tracing in VIDA.
