**Vehicle Owner's Questionnaire**  
**To Report Vehicle Safety Defects**  
**1-888-DASH-2-DOT**  
**(1-888-327-4236)**  
**INTERNET: www.nhtsa.dot.gov/hotline**

3N1BC13E68L Make  
NISSANModel  
VERSAModel Year  
2008

**From:** [REDACTED]  
**To:** [Chan, Steve \(NHTSA\)](#)  
**Subject:** Re: Your report to NHTSA (ODI #10610795); Ref: 2008 Nissan Versa Airbag Inadvertent deployment  
**Date:** Wednesday, November 19, 2014 7:37:15 PM

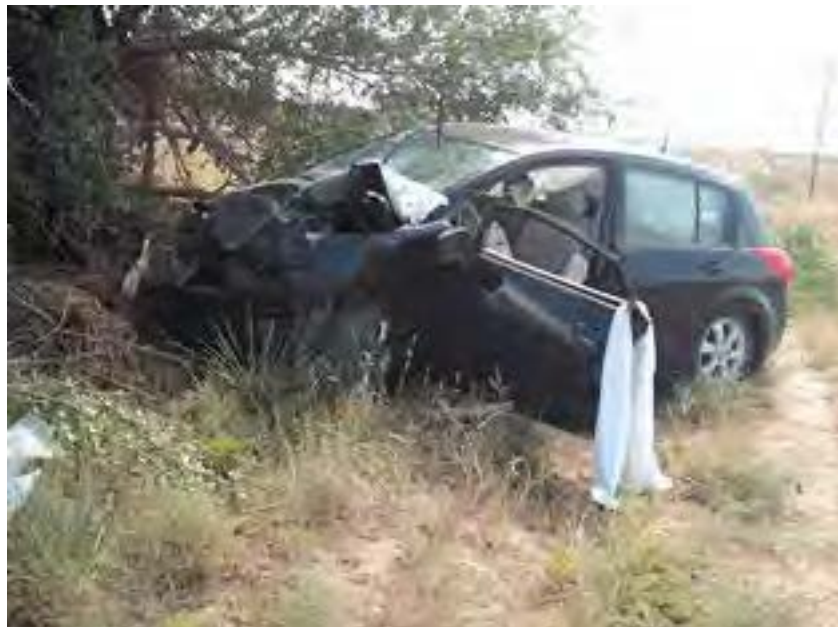
**PHOTO #2**

PHOTO DEPICTING UNIT 1'S LEFT SIDE (ANGLED)

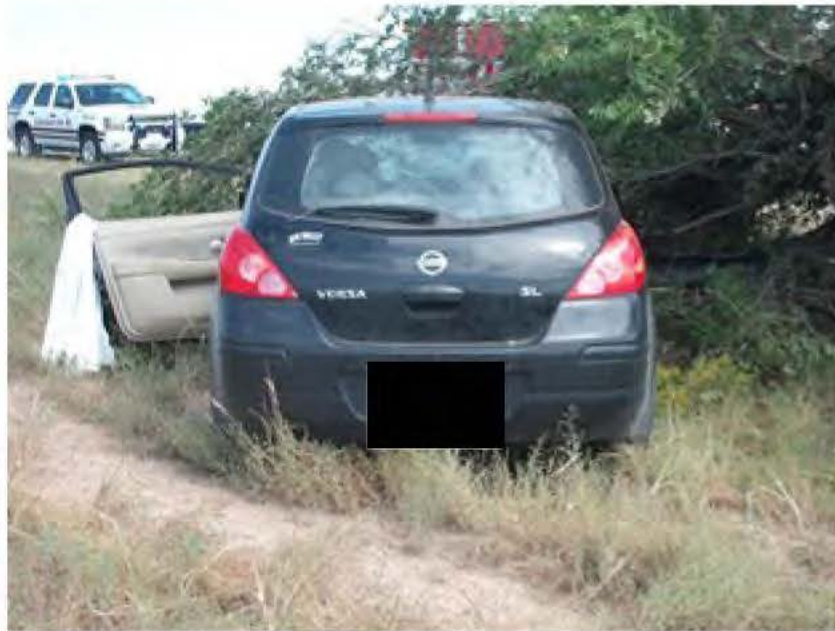
**PHOTO #5**

PHOTO DEPICTING UNIT 1'S REAR VIEW

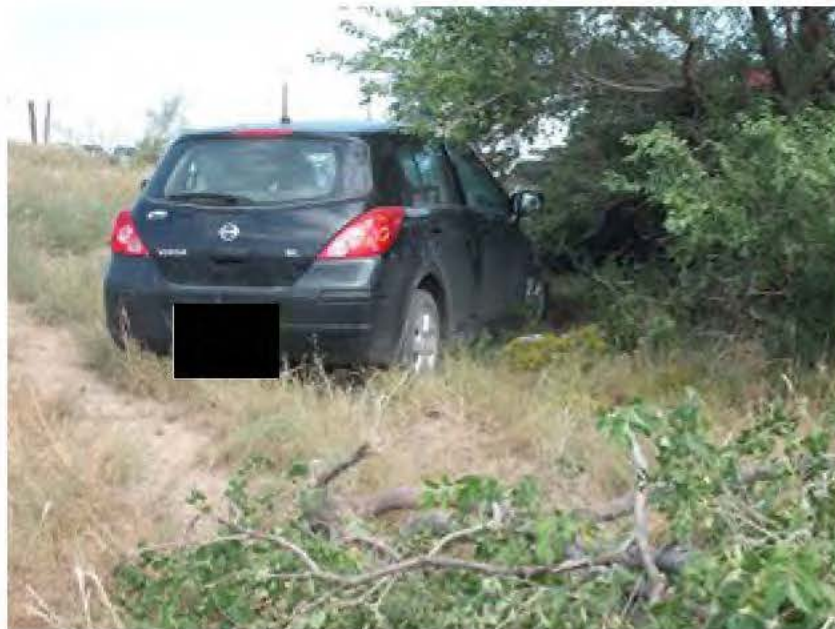
**PHOTO #6**

PHOTO DEPICTING UNIT 1'S RIGHT (PASSENGER) SIDE

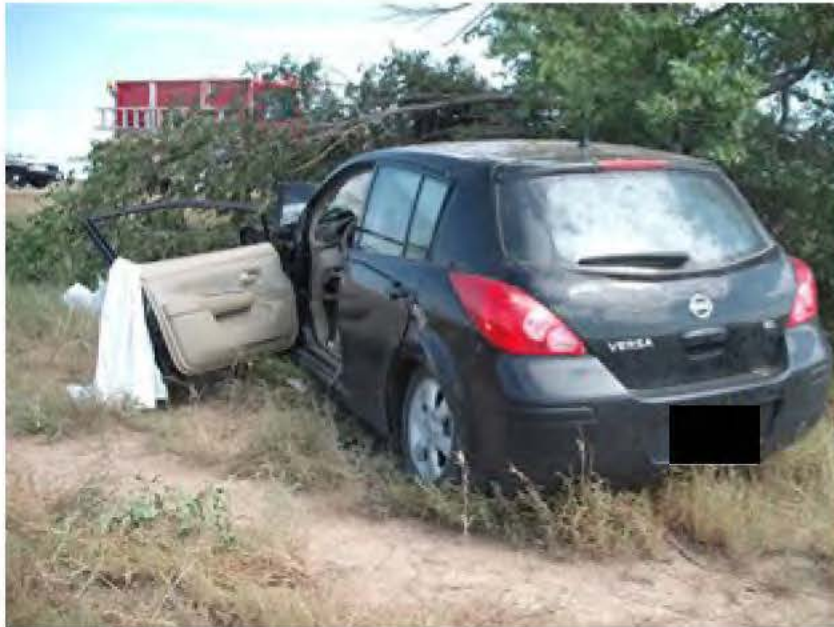
**PHOTO #7**

PHOTO DEPICTING UNIT 1'S REAR VIEW AND DRIVER SIDE

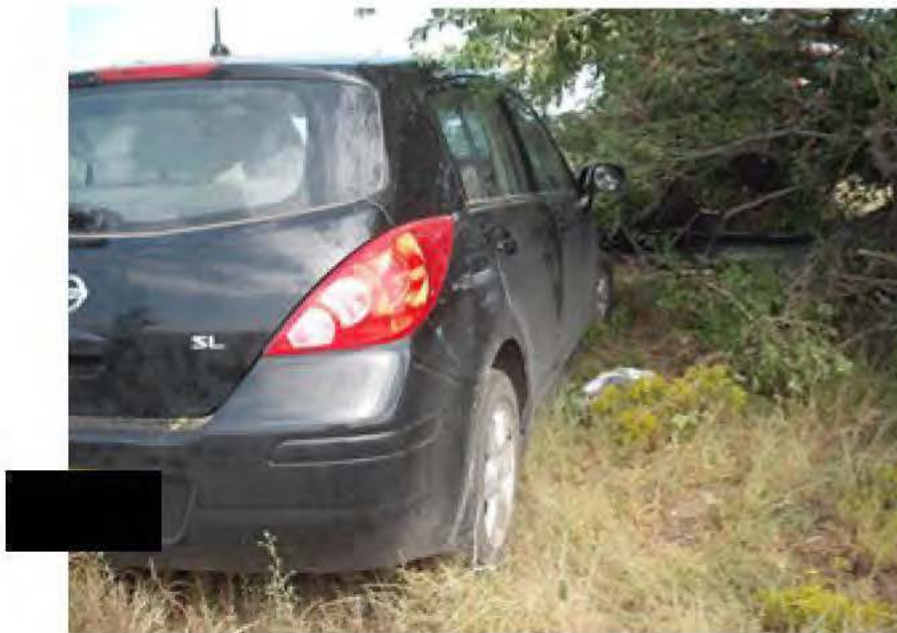
**PHOTO #8**

PHOTO DEPICTING UNIT 1'S REAR VIEW AND PASSENGER SIDE

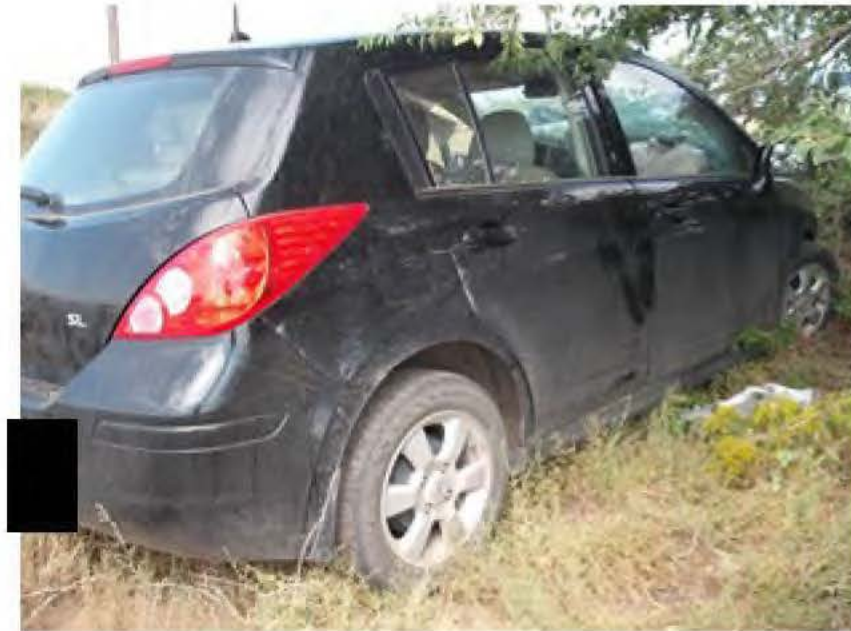
**PHOTO #9**

PHOTO DEPICTING UNIT 1'S PASSENGER SIDE & WINDOWS

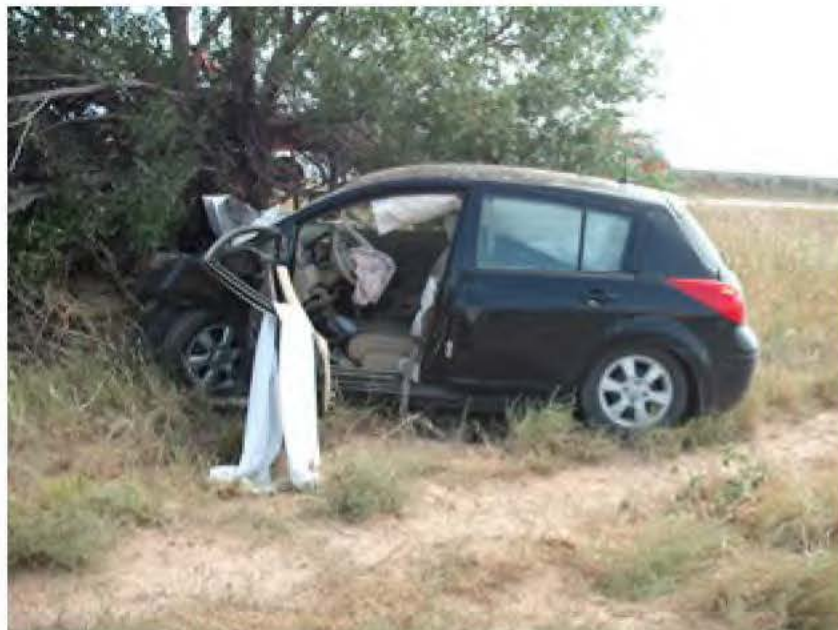
**PHOTO #10**

PHOTO DEPICTING UNIT 1'S DRIVER SIDE AND WINDOWS

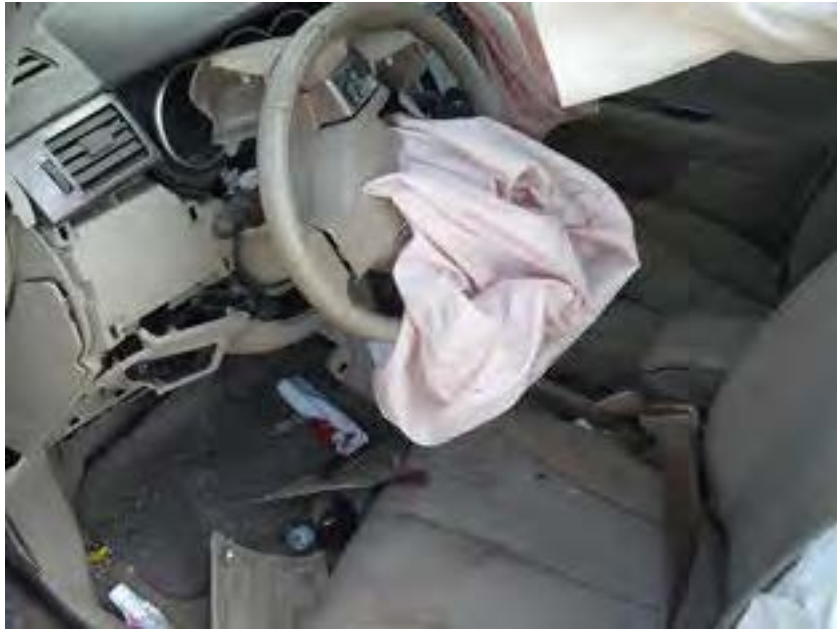
**PHOTO #12**

PHOTO OF UNIT 1 DEPICTING UNIT 1'S AIR BAG DEPLOYMENT & DRIVER SAFETY BELT

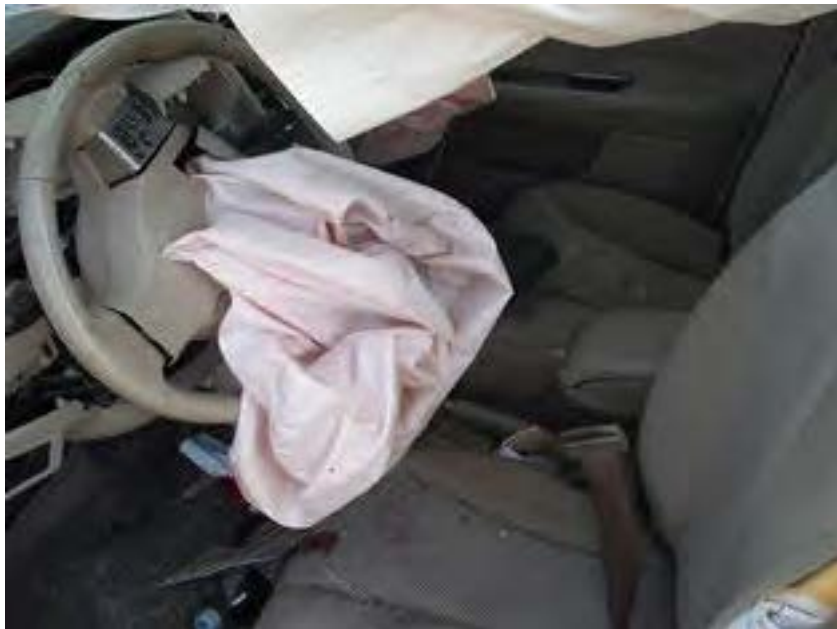
**PHOTO #14**

PHOTO OF UNIT 1 DEPICTING BLOOD ON DRIVER AND PASSENGER SEATS, AS WELL AS ON THE DRIVER AIR BAG

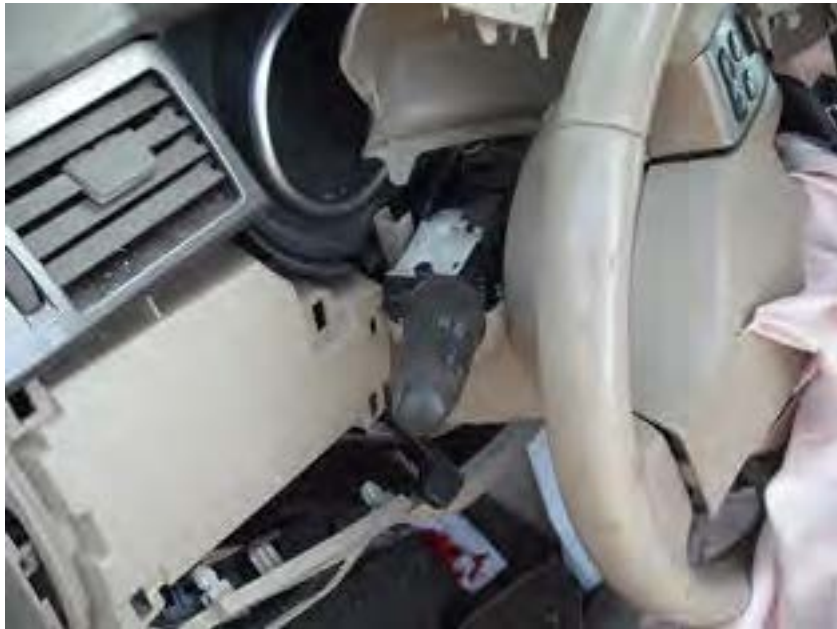
**PHOTO #15**

PHOTO OF UNIT 1 DEPICTING STEERING COLUMN AND TURN SIGNAL INDICATOR

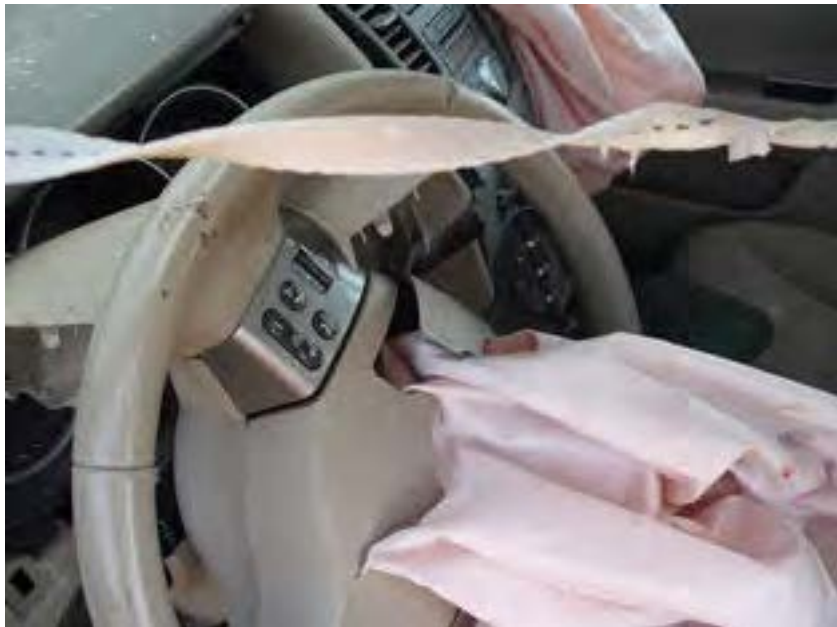
**PHOTO #16**

PHOTO OF UNIT 1'S STEERING WHEEL DEPICTING BLOOD EVIDENCE

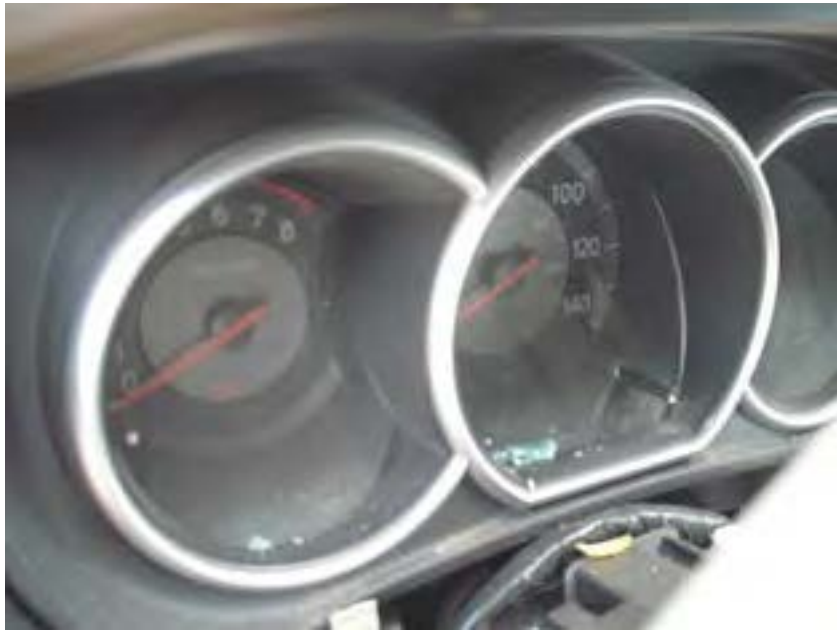
**PHOTO #17**

PHOTO OF UNIT 1'S INSTRUMENT PANEL DEPICTING NO POWER & LACK OF SPEED INDICATION

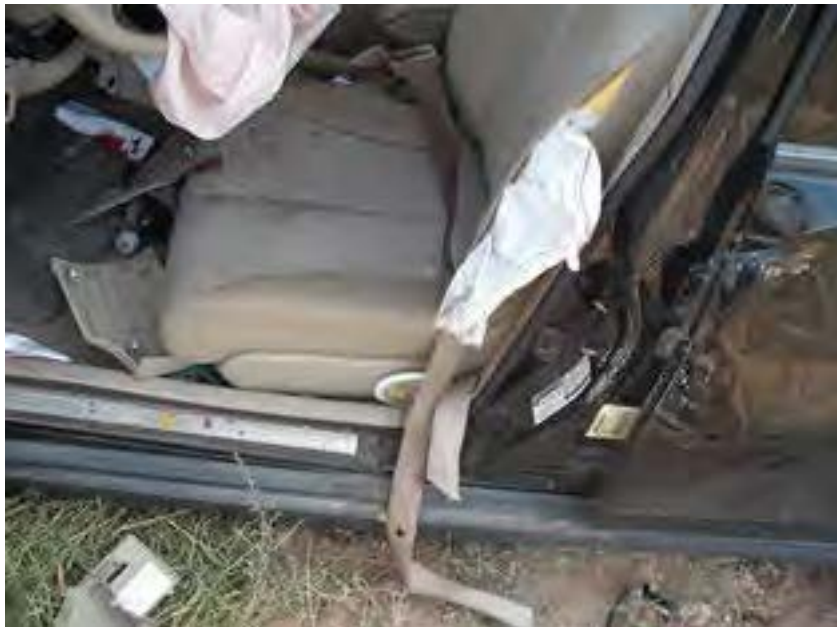
**PHOTO #22**

PHOTO OF UNIT 1'S DRIVER SIDE SAFETY BELT DEPICTING WHERE IT WAS CUT BY  
EMERGENCY SERVICE PERSONNEL

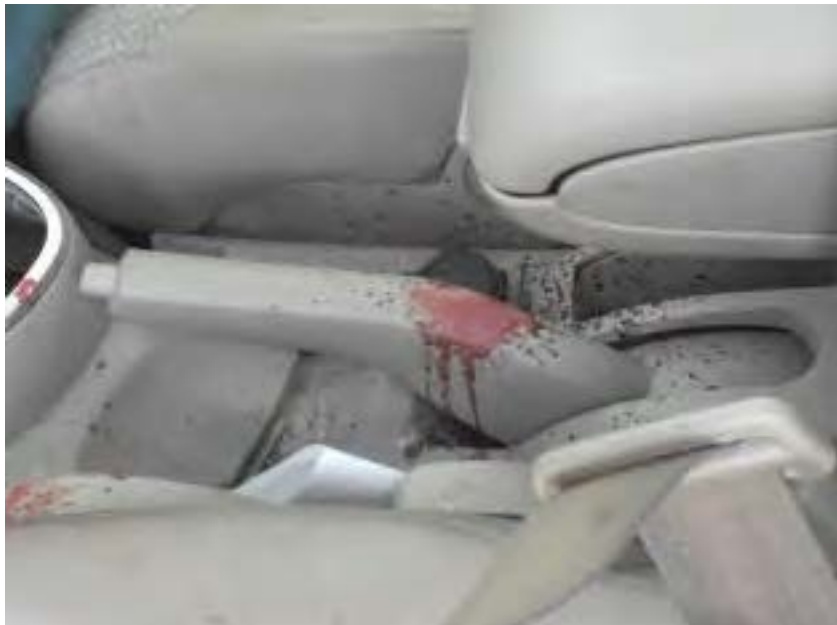
**PHOTO #24**

PHOTO OF UNIT 1'S EMERGENCY BRAKE HANDLE DEPICTING LOCATION OF BLOOD EVIDENCE  
AND DRIVER SAFETY BELT ANCHOR

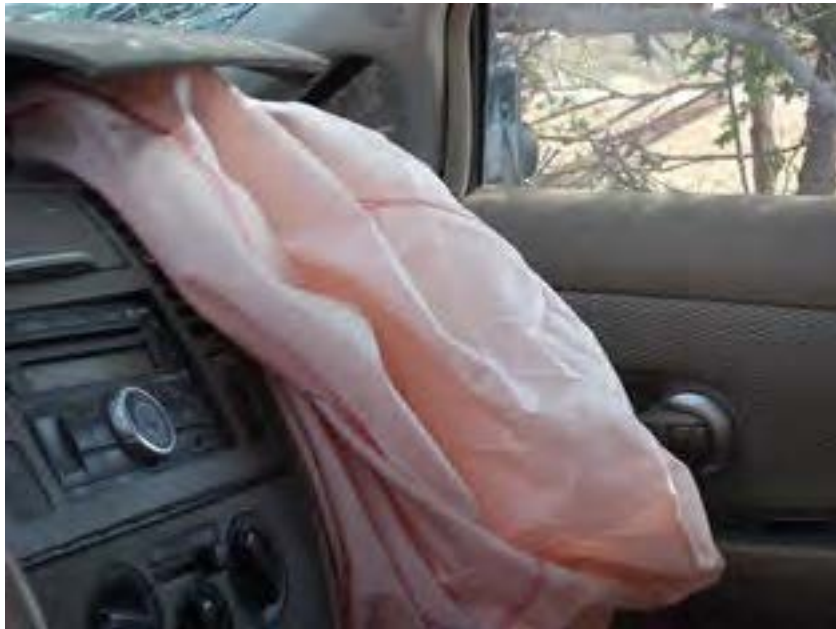
**PHOTO #26**

PHOTO OF UNIT 1'S PASSENGER SIDE AIR BAG DEPLOYMENT

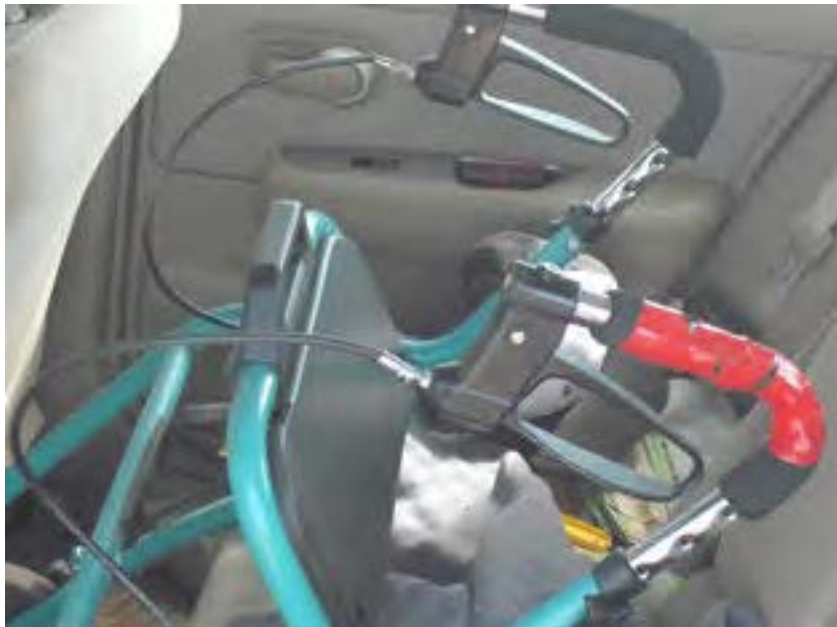
**PHOTO #28**

PHOTO OF UNIT 1'S BACK SEAT DEPICTING NON-USE OF SAFETY BELTS AND VEHICLE CONTENTS

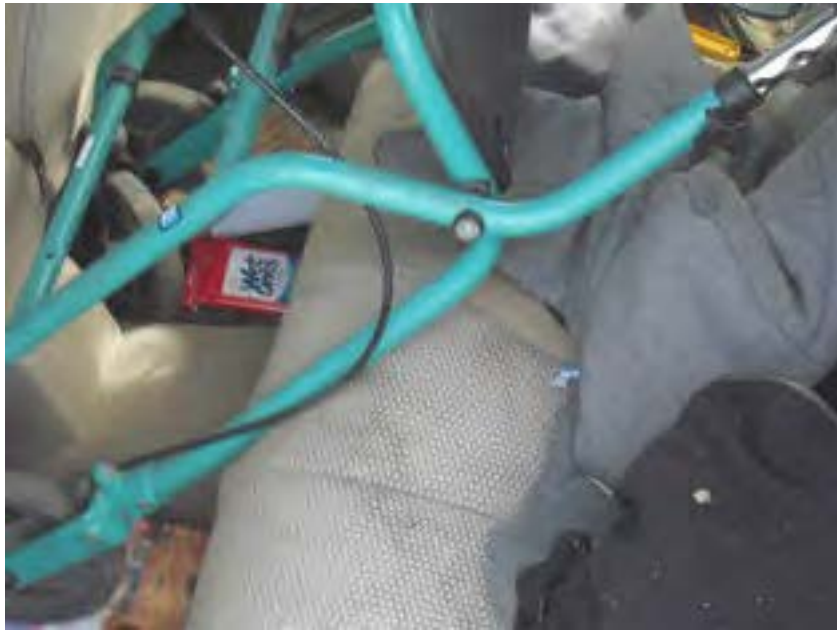
**PHOTO #29**

PHOTO OF UNIT 1'S BACK SEAT DEPICTING NON-USE OF SAFETY BELTS AND VEHICLE CONTENTS

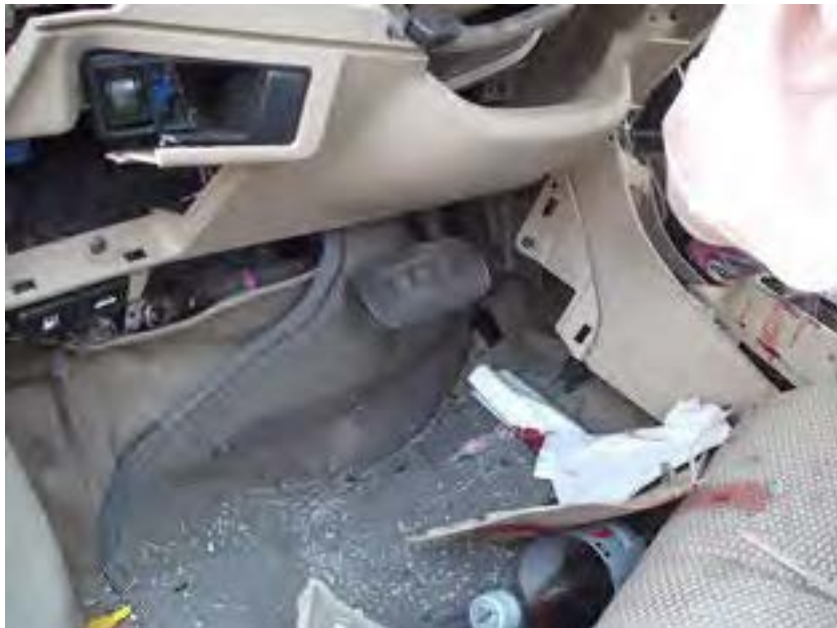
**PHOTO #30**

PHOTO OF UNIT 1'S DRIVER SIDE FLOOR BOARD DEPICTING PEDAL PLACEMENT POST CRASH & INTRUSION INTO THE VEHICLE

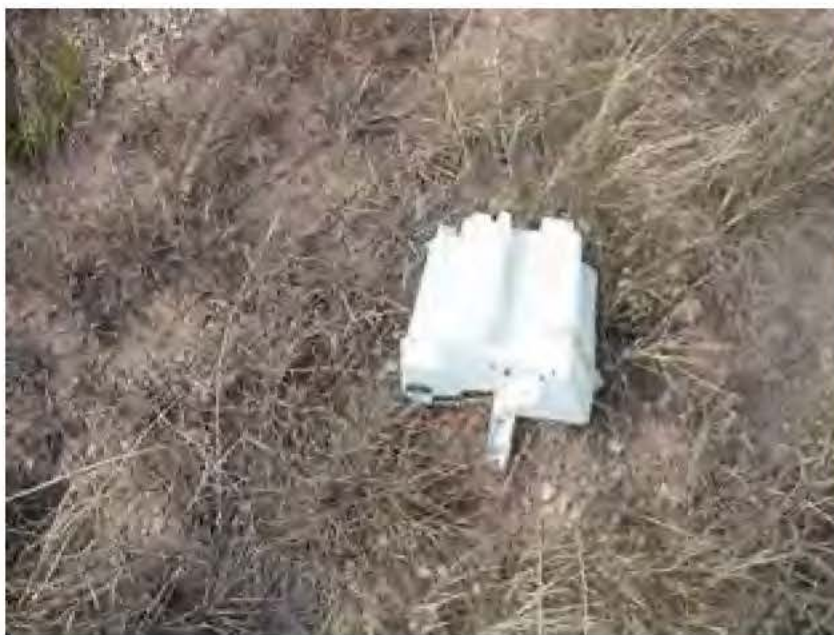
**PHOTO #35**

PHOTO OF UNIT 1'S WINDSHIELD WASH SYSTEM RESERVOIR DEPICTING ITS DISPLACEMENT FROM THE VEHICLE

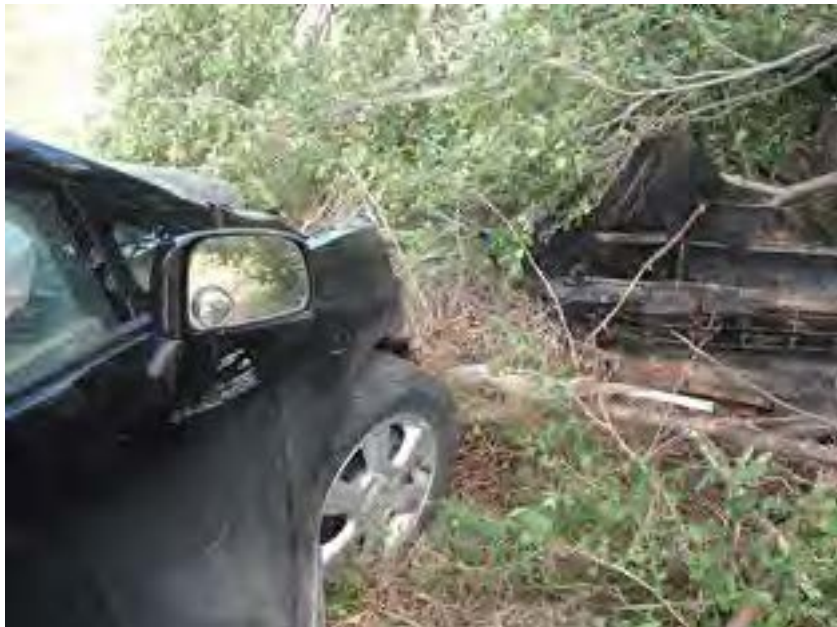
**PHOTO #40**

PHOTO OF UNIT 1 DEPICTING ITS RELATIONSHIP TO THE STRUCK TREE

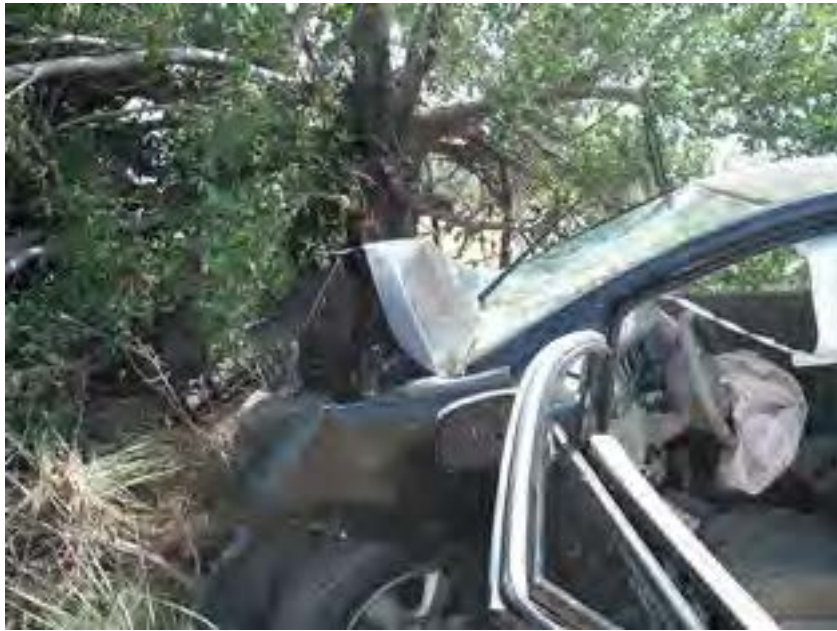
**PHOTO #41**

PHOTO OF UNIT 1 DEPICTING COLLISION DAMAGE FROM SIDE ANGLE VIEW

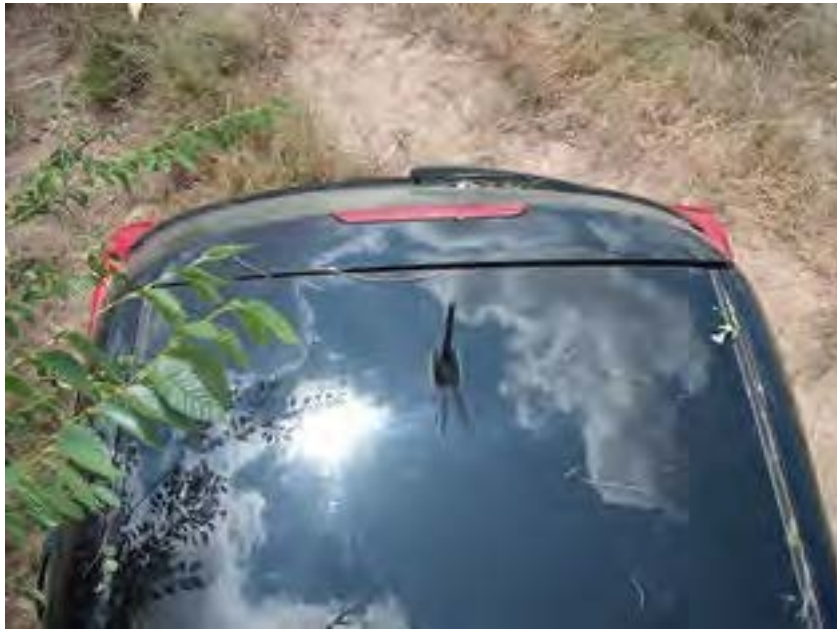
**PHOTO #43**

TOP VIEW OF UNIT 1 DEPICTING UNIT 1'S REAR END

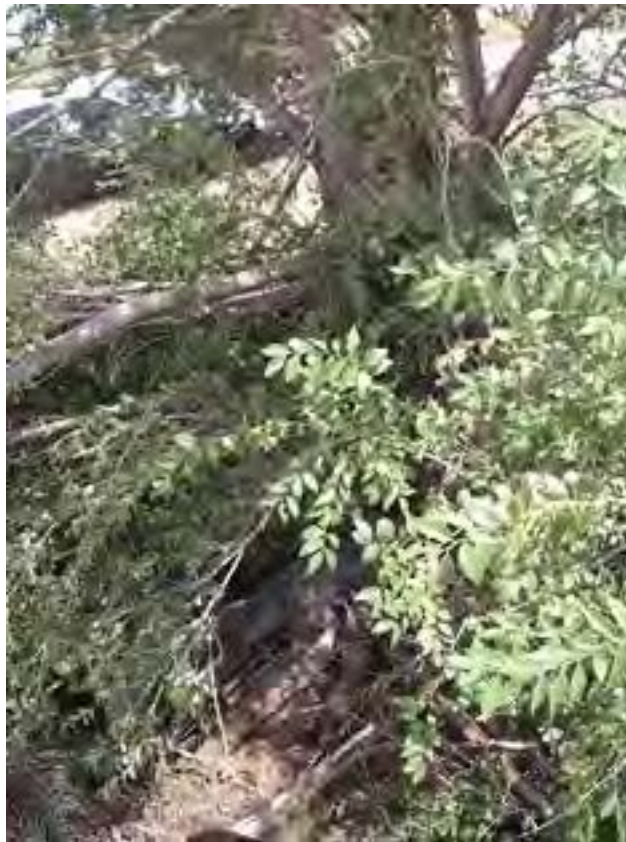
**PHOTO #48**

VIEW OF DAMAGE TO TREE FROM A HIGH LEVEL ANGLE

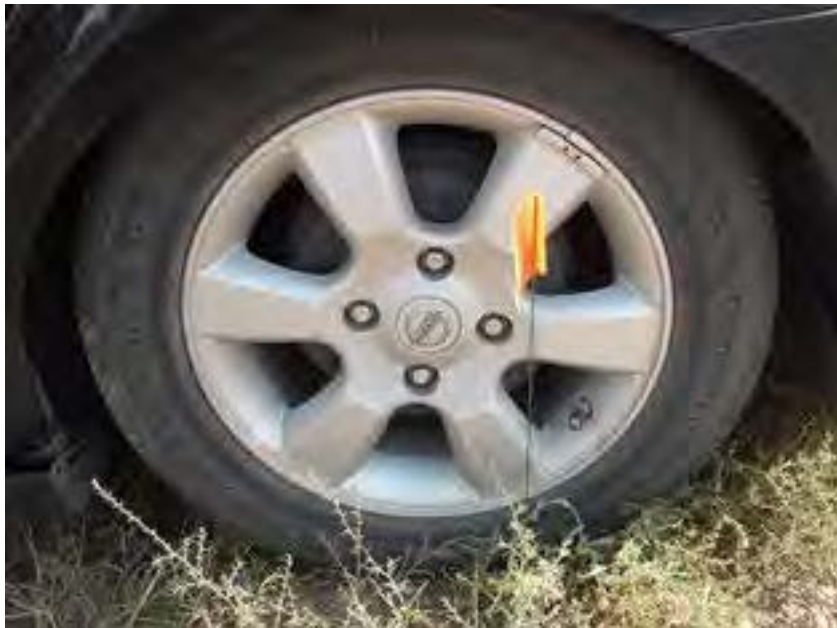
**PHOTO #52**

PHOTO OF UNIT 1'S LEFT REAR TIRE AND WHEEL DEPICTING TYPE AND SIZE

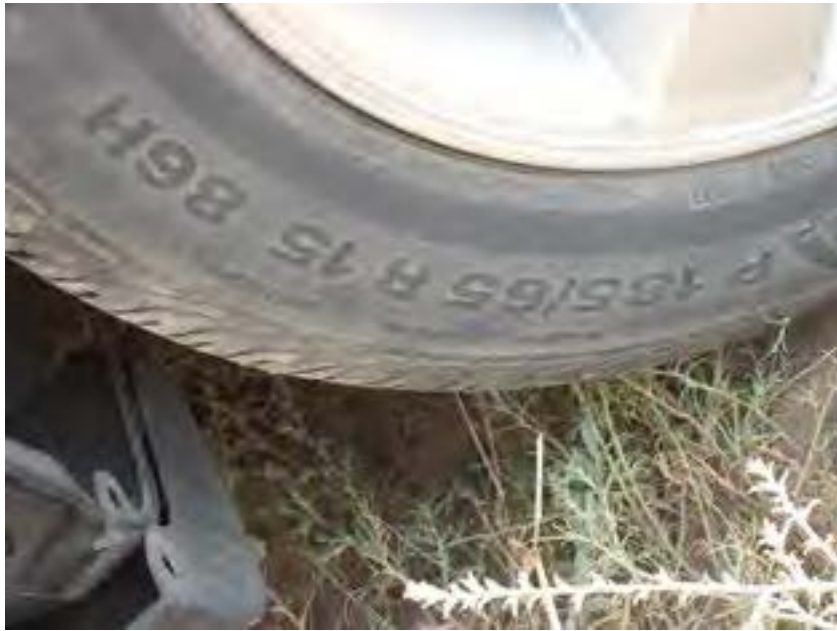
**PHOTO #53**

PHOTO OF UNIT 1'S LEFT REAR TIRE DEPICTING THE TIRE SIZE

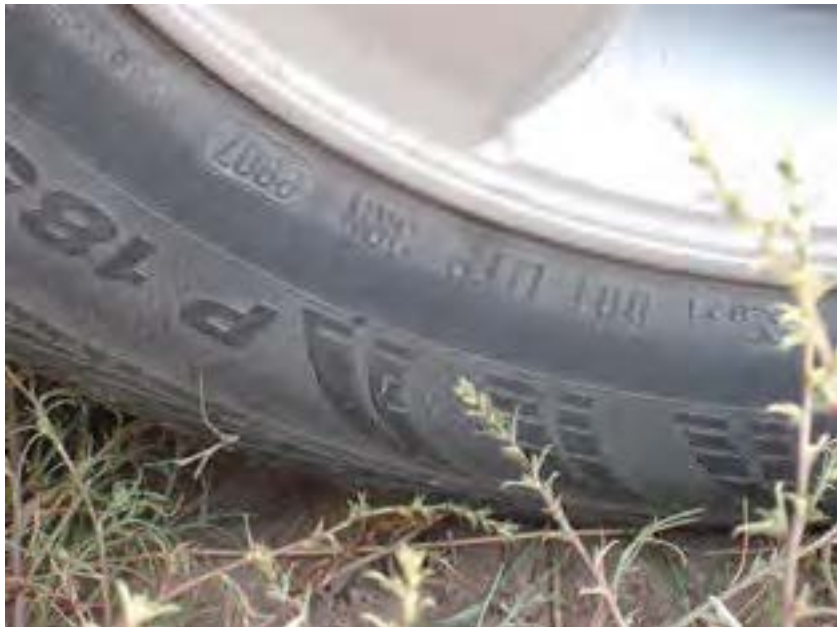
**PHOTO #54**

PHOTO OF UNIT 1'S LEFT REAR TIRE DEPICTING THE TIRES "DOT" NUMBER

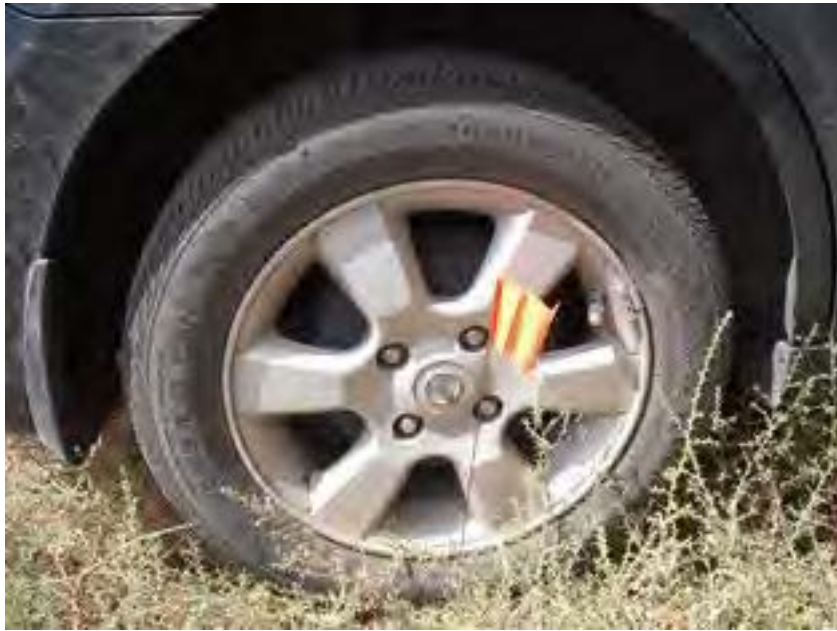
**PHOTO #55**

PHOTO OF UNIT 1'S RIGHT REAR TIRE DEPICTING THE VEHICLES TIRE TYPE, SIZE, AND "DOT" NUMBER

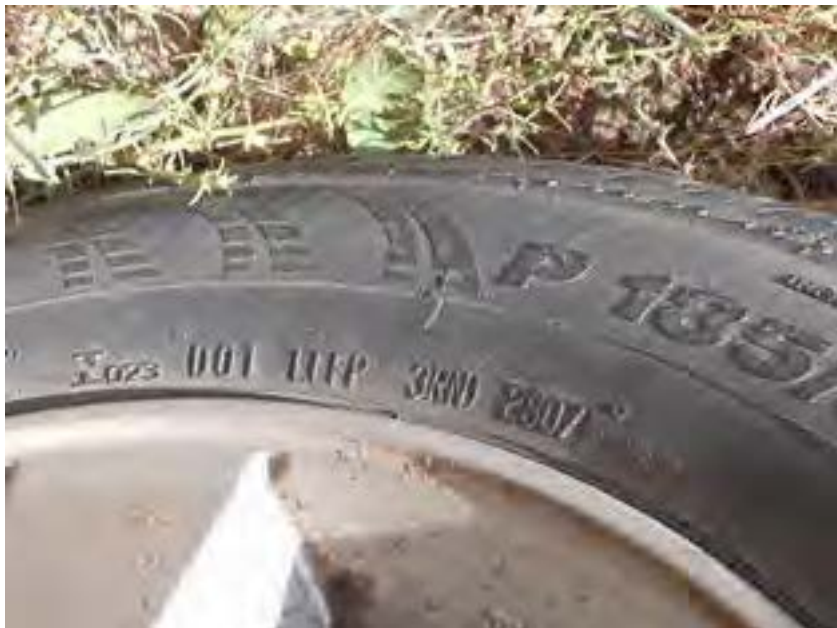
**PHOTO #56**

PHOTO OF UNIT 1'S RIGHT REAR TIRE DEPICTING THE VEHICLE'S "DOT" NUMBER

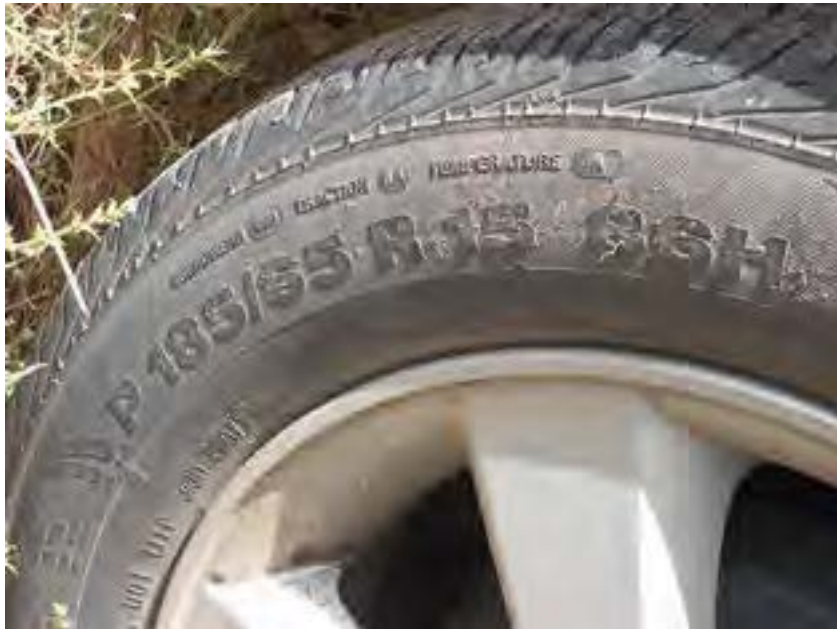
**PHOTO #57**

PHOTO OF UNIT 1'S RIGHT REAR TIRE DEPICTING THE VEHICLE'S TIRE SIZE

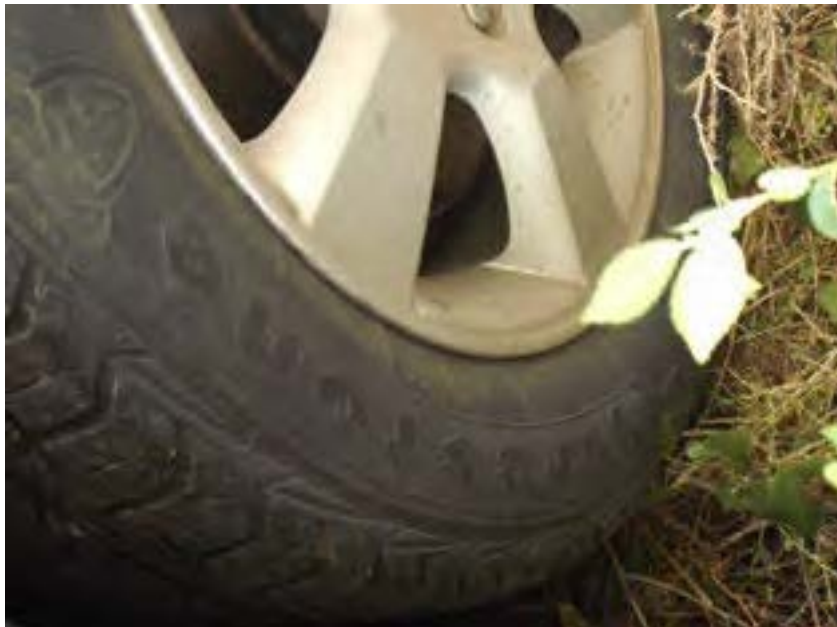
**PHOTO #58**

PHOTO OF UNIT 1'S FRONT RIGHT TIRE DEPICTING THE VEHICLES TIRE TYPE, SIZE, AND "DOT" NUMBER

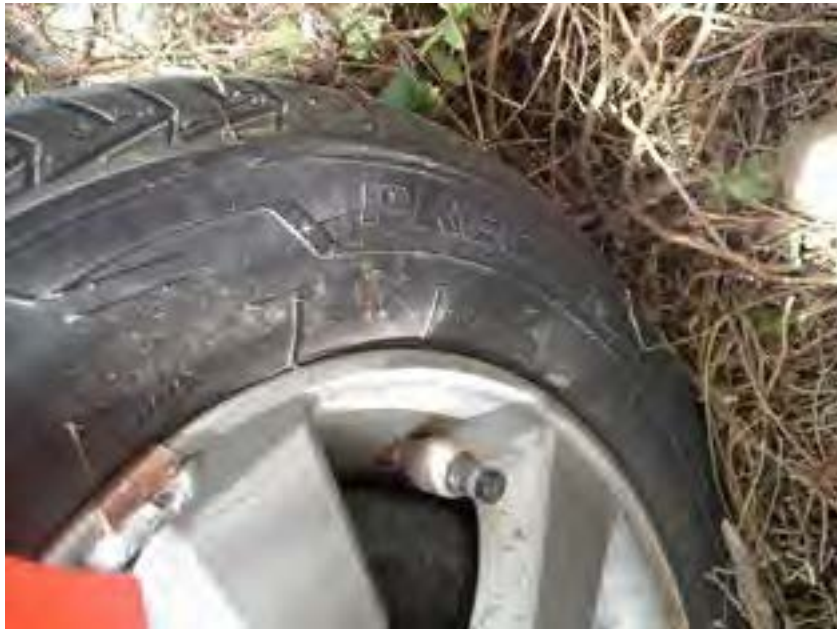
**PHOTO #59**

PHOTO OF UNIT 1'S FRONT RIGHT TIRE DEPICTING TYPE AND STYLE OF TIRE

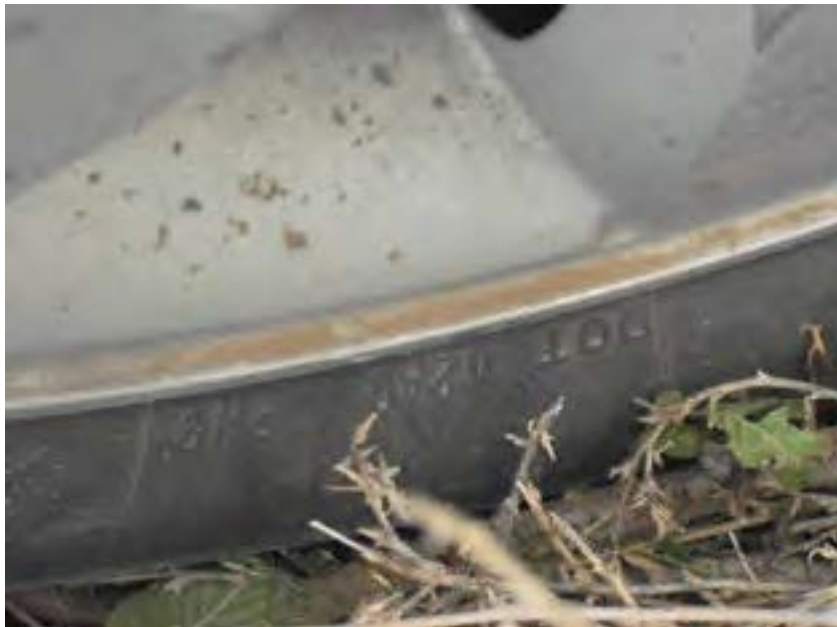
**PHOTO #60**

PHOTO OF UNIT 1'S FRONT RIGHT TIRE DEPICTING THE TIRE'S "DOT" NUMBER

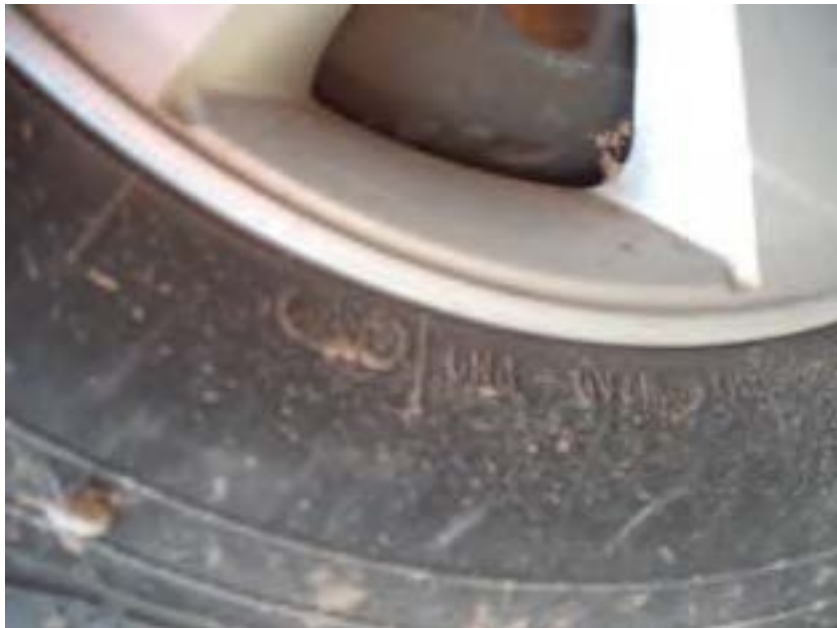
**PHOTO #62**

PHOTO OF UNIT 1'S FRONT LEFT TIRE DEPICTING THE TIRE'S "DOT" NUMBER

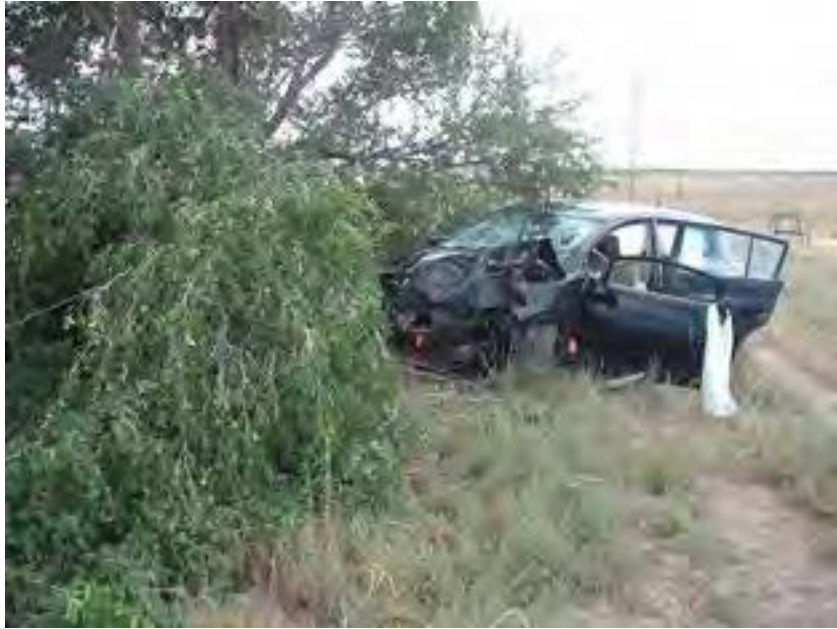
**PHOTO #63**

VIEW OF UNIT 1, LOOKING EAST, AT FINAL REST

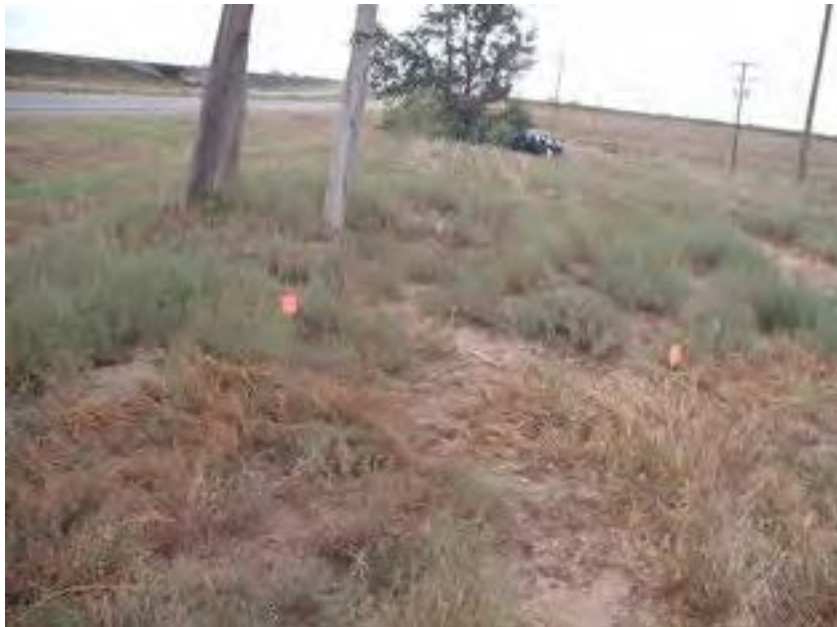
**PHOTO #66**

PHOTO OF UNIT 1, LOOKING EAST, DEPICTING ROLLING TIRE INDICATION AND STRUCK FENCE POST

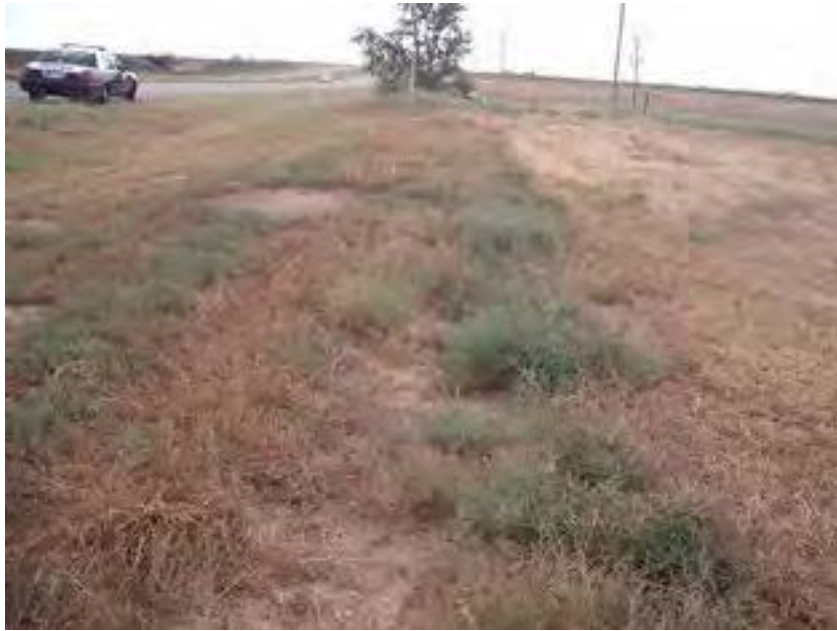
**PHOTO #67**

VIEW OF UNIT 1'S ROLLING TIRE INDICATION AND PATH OF VEHICLE

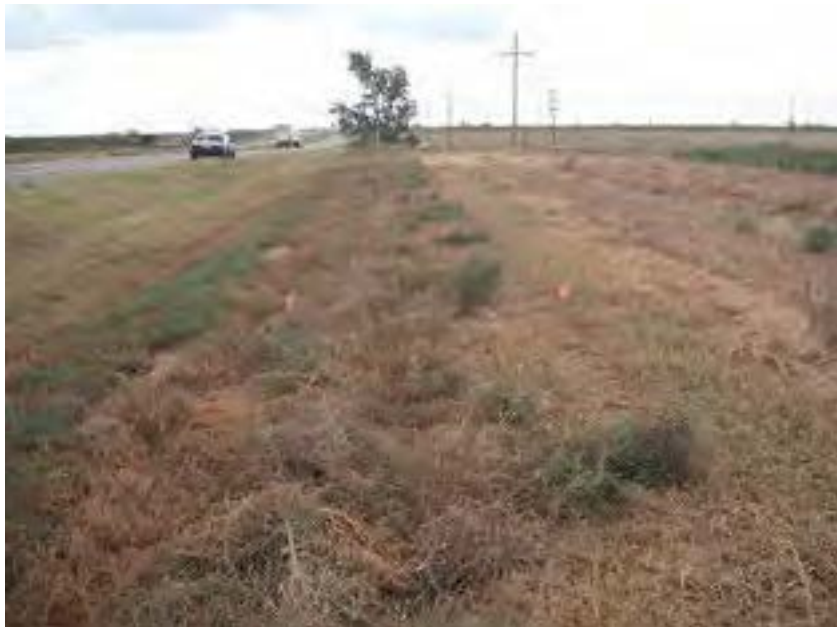
**PHOTO #68**

VIEW OF UNIT 1'S ROLLING TIRE INDICATION AND PATH OF VEHICLE

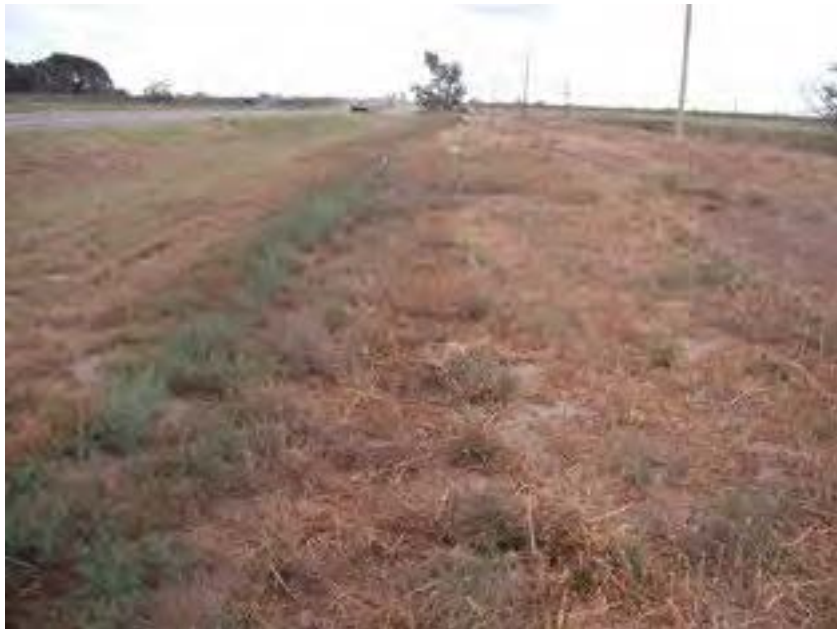
**PHOTO #70**

VIEW OF UNIT 1'S ROLLING TIRE INDICATION AND PATH OF VEHICLE

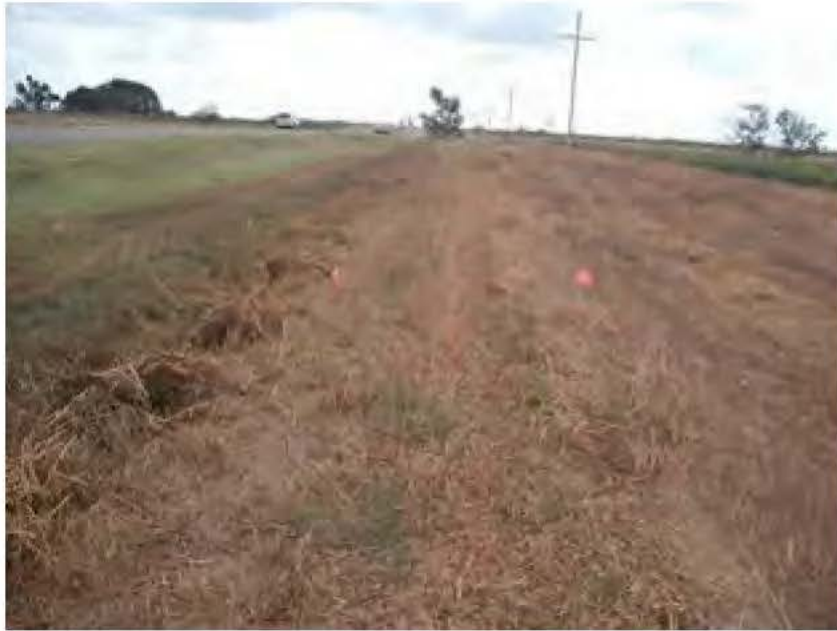
**PHOTO #71**

VIEW OF UNIT 1'S ROLLING TIRE INDICATION AND PATH OF VEHICLE

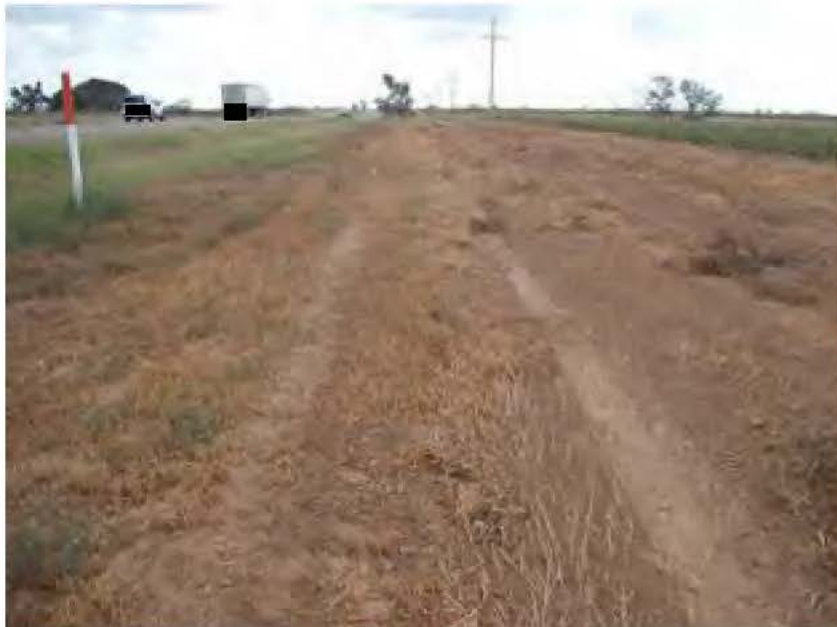
**PHOTO #72**

VIEW OF UNIT 1'S ROLLING TIRE INDICATION AND PATH OF VEHICLE

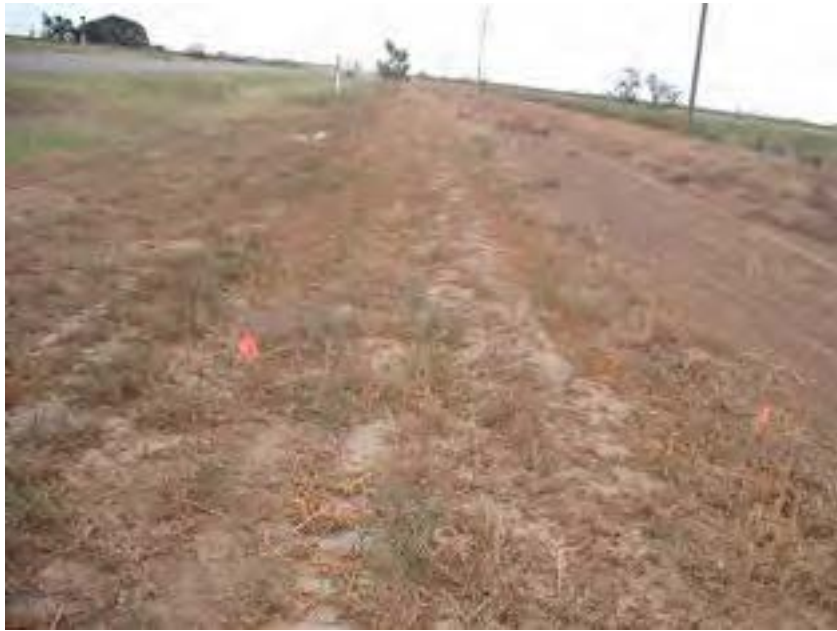
**PHOTO #73**

VIEW OF UNIT 1'S ROLLING TIRE INDICATION AND PATH OF VEHICLE

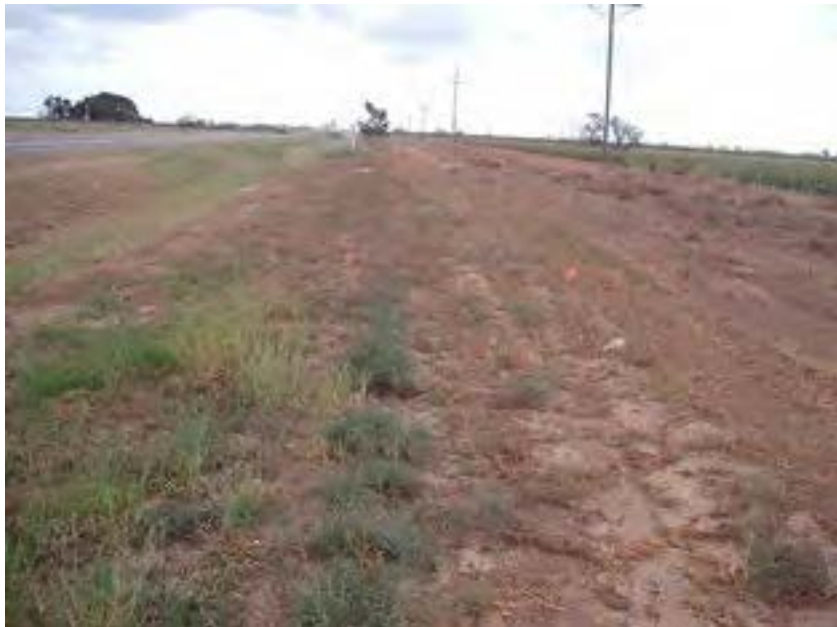
**PHOTO #74**

VIEW OF UNIT 1'S ROLLING TIRE INDICATION AND PATH OF VEHICLE
