**Vehicle Owner's Questionnaire**  
**To Report Vehicle Safety Defects**  
**1-888-DASH-2-DOT**  
**(1-888-327-4236)**  
**INTERNET: www.nhtsa.dot.gov/hotline**

3N1BC13E68L Make  
NISSANModel  
VERSAModel Year  
2008

**From:** [REDACTED]  
**To:** [Chan, Steve \(NHTSA\)](#)  
**Subject:** Re: Your report to NHTSA (ODI #10610795); Ref: 2008 Nissan Versa Airbag Inadvertent deployment  
**Date:** Wednesday, November 19, 2014 7:37:15 PM

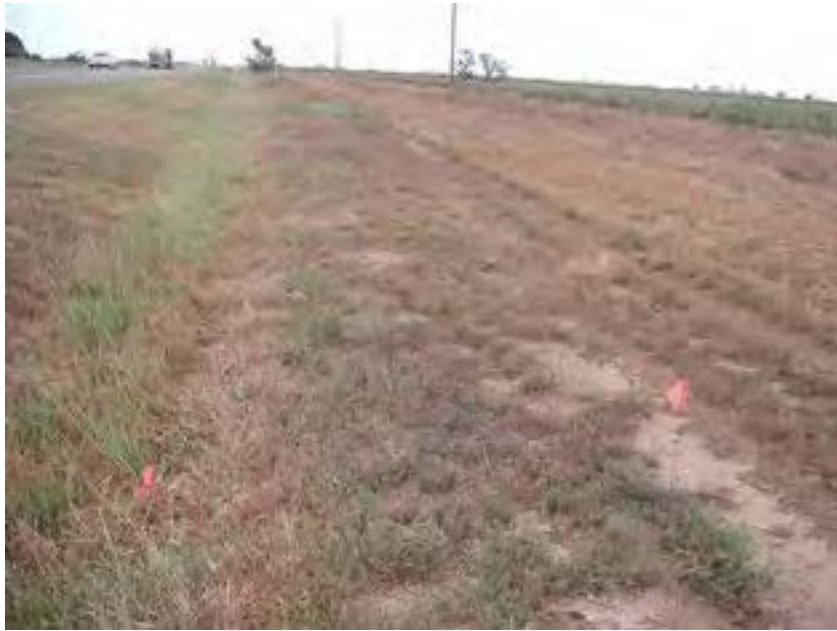
**PHOTO #75**

VIEW OF UNIT 1'S ROLLING TIRE INDICATION AND PATH OF VEHICLE

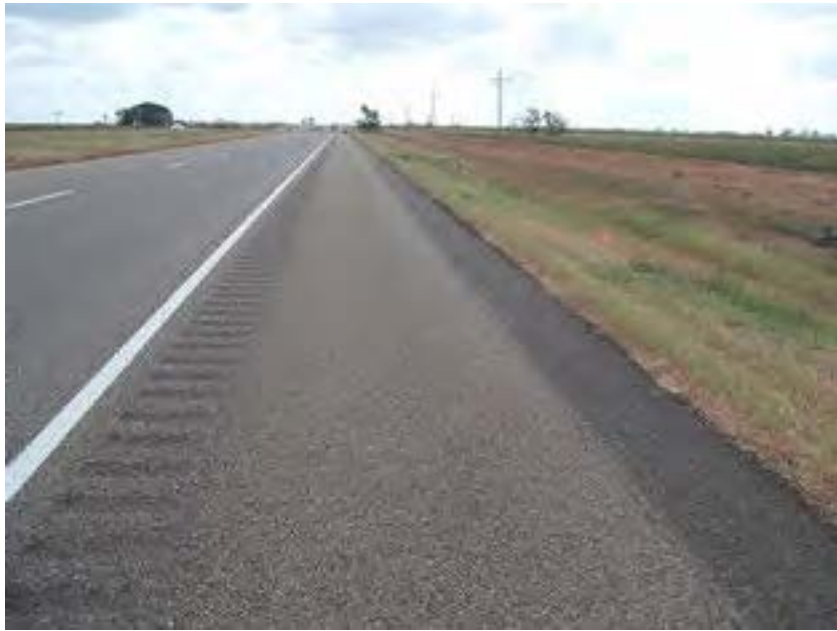
**PHOTO #79**

VIEW OF U.S. HIGHWAY 84, EASTBOUND, DEPICTING NO SKID MARKS AND ONLY ROLLING  
TIRE INDICATIONS MADE BY UNIT 1

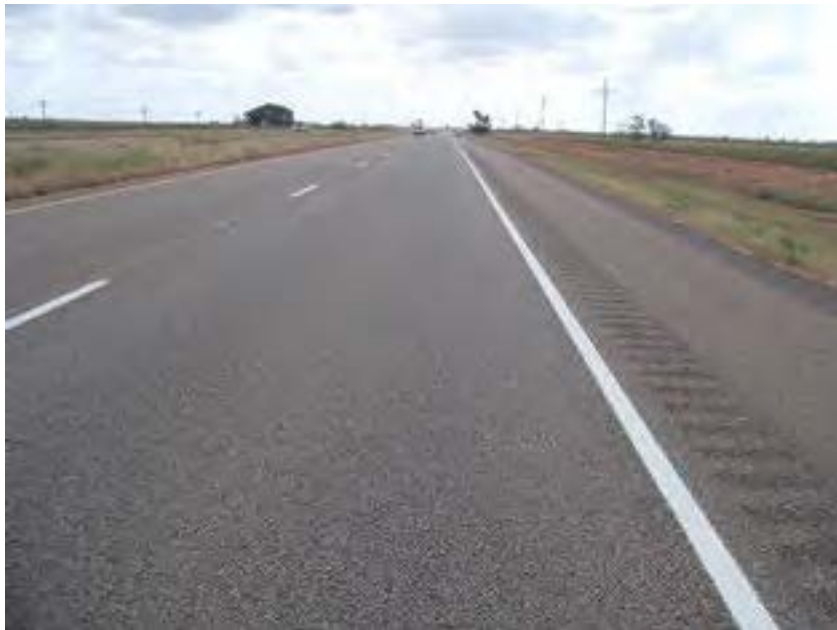
**PHOTO #80**

VIEW OF U.S. HIGHWAY 84, EASTBOUND, DEPICTING NO SKID MARKS AND ONLY ROLLING  
TIRE INDICATIONS MADE BY UNIT 1

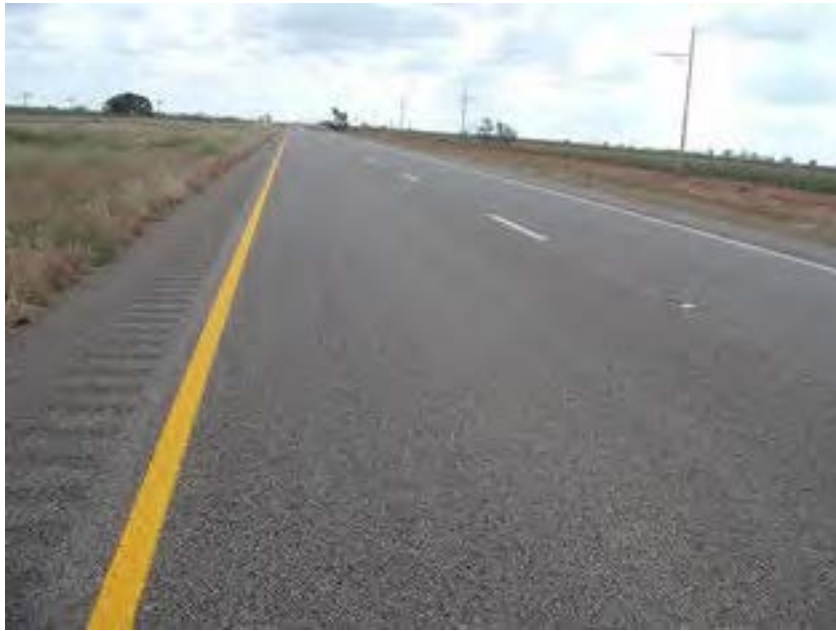
**PHOTO # 81**

VIEW OF U.S. HIGHWAY 84, EASTBOUND, DEPICTING THAT UNIT 1 DID NOT TRAVEL OFF OF THE ROADWAY, INTO THE CENTER MEDIAN, PRIOR TO ITS LEAVING THE ROADWAY IN THE SOUTH DITCH OF U.S. HIGHWAY 84.
