**EA02-025**

**LETTER TO ODI**

**APPENDIX M**

FIRE STUDY

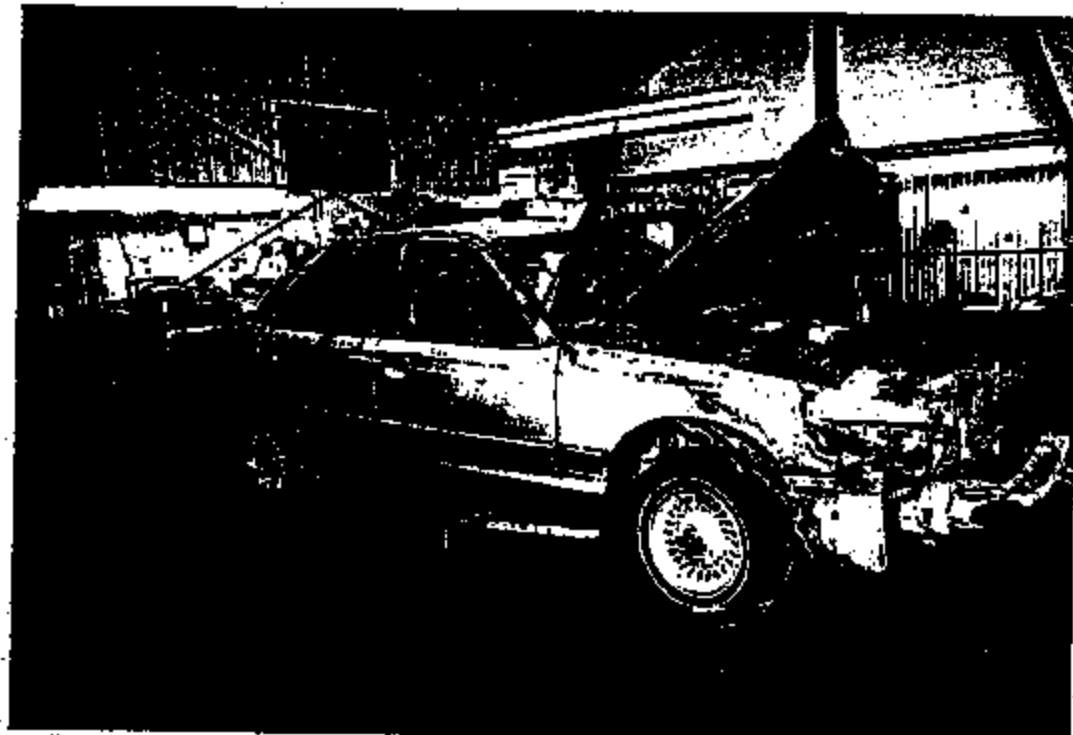
Figure 2 Right view of vehicle

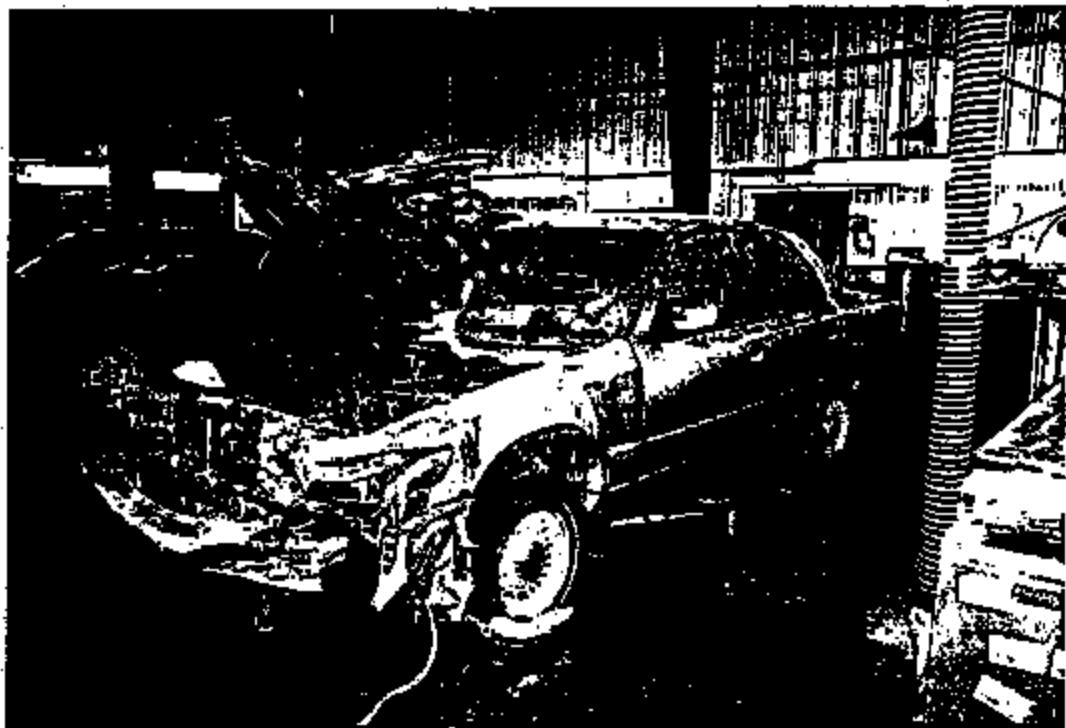
Figure 4 Left view of vehicle

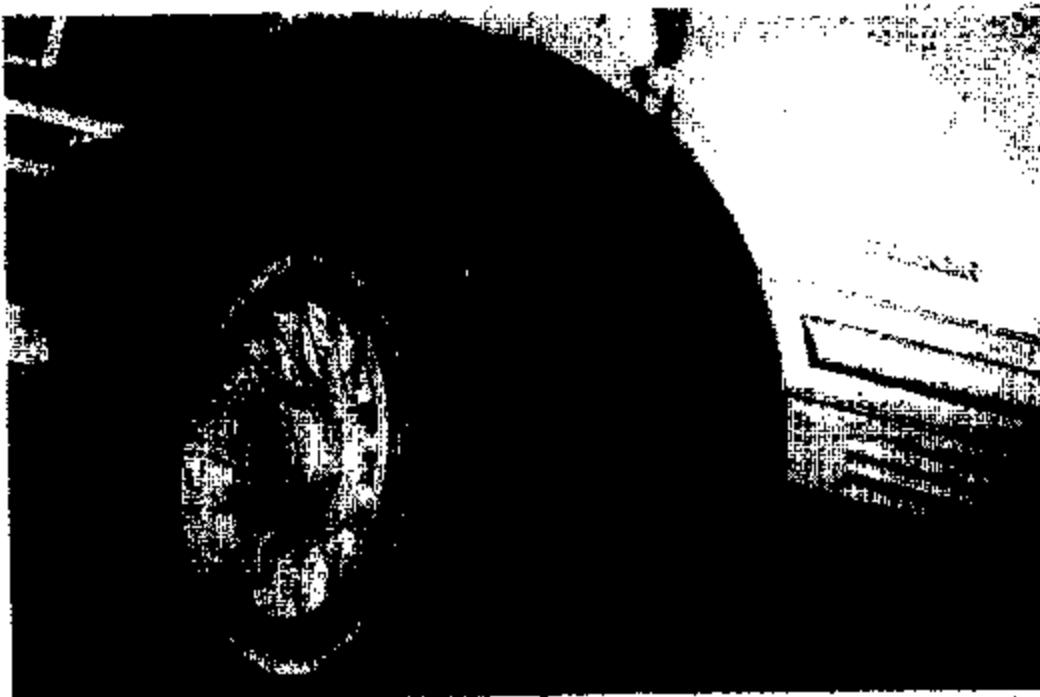
36. The left-front wheel well.

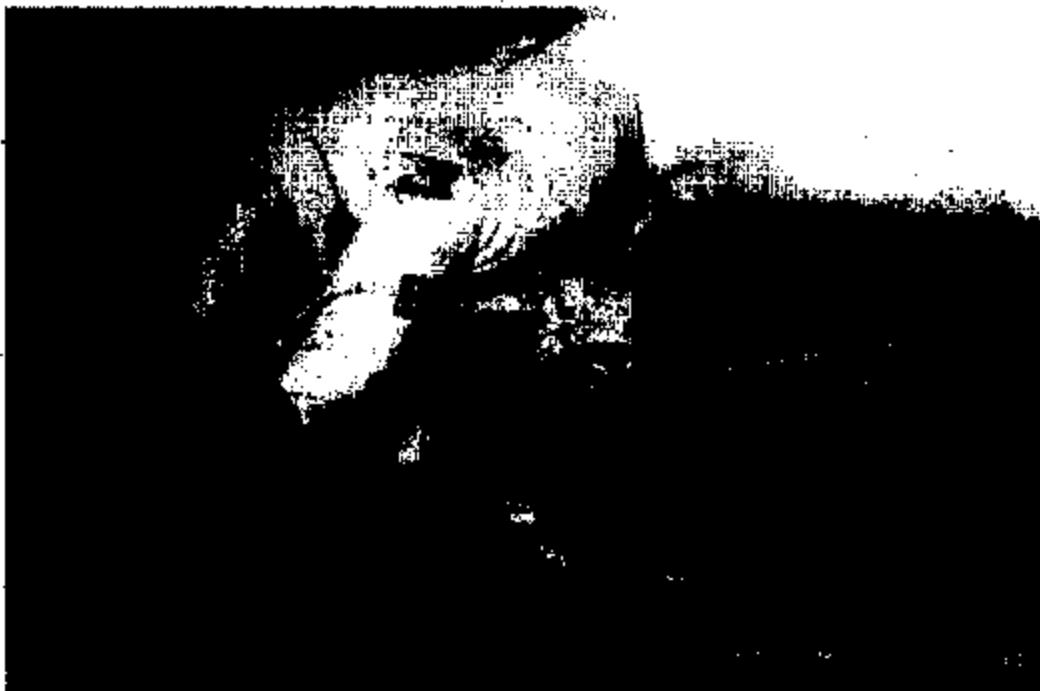
**64. Remains of Connector Shell for Speed Control Deactivation Switch. E002-025 22466**

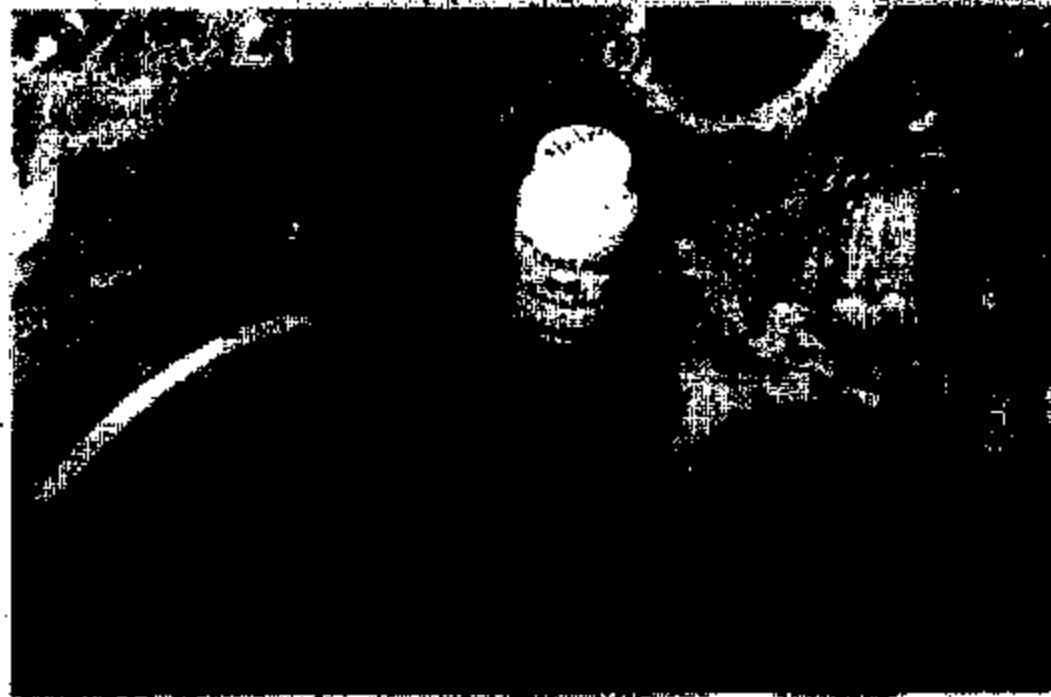
69. Transmission fluid sample.
