**EA02-025**

**APPENDIX N**

NHTSA

**1992-93 Town Car/Crown Vic/Grand Marquis Under hood Fire Oesthousky**

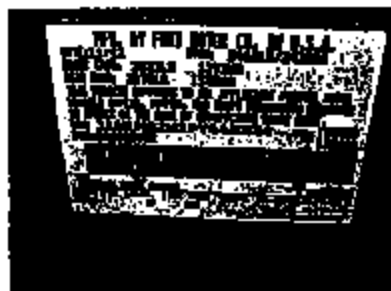
Switch A

1LNLM92WXNY749071 1992 Lincoln Town Car - Dallas, TX, 99-Jan-13

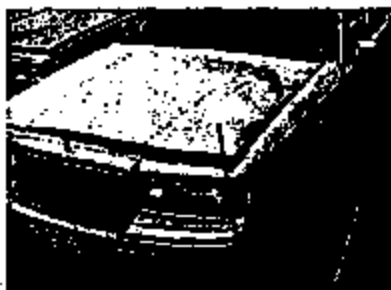
Switch B

1LNLM92W1PY665224 1993 Lincoln Town Car - Houston, TX 99-Jan-14 PE98-055

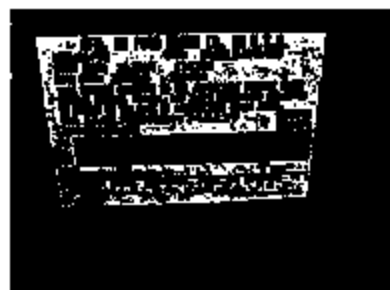
3713 2474

1LNLM83WSNY745119 1992 Lincoln Town Car - Houston, TX 99-Jan-14 PE98-055

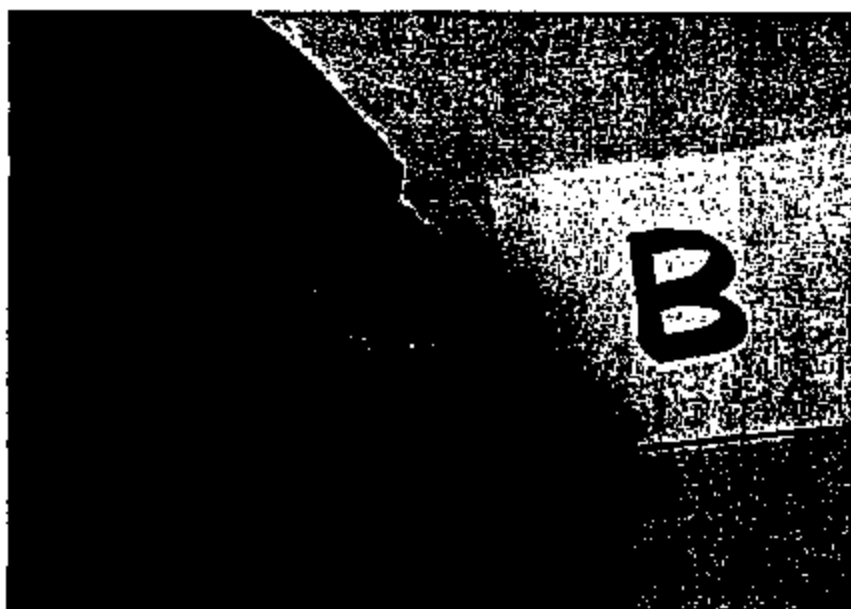
3713 2477

Switch B

F2VC-9F924-AB 2114
