**EA02-025**

**FORD 10/27/03**

**APPENDIX N**

# 1992-93 LINCOLN TOWN CAR UNDERHOOD FIRES

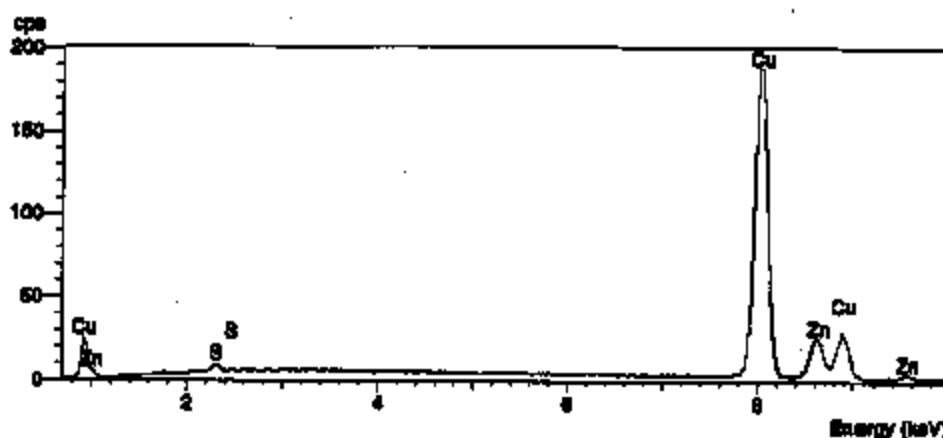
Figure 1: EDS X-ray spectrum of material scraped from the side of the stationary contact body.

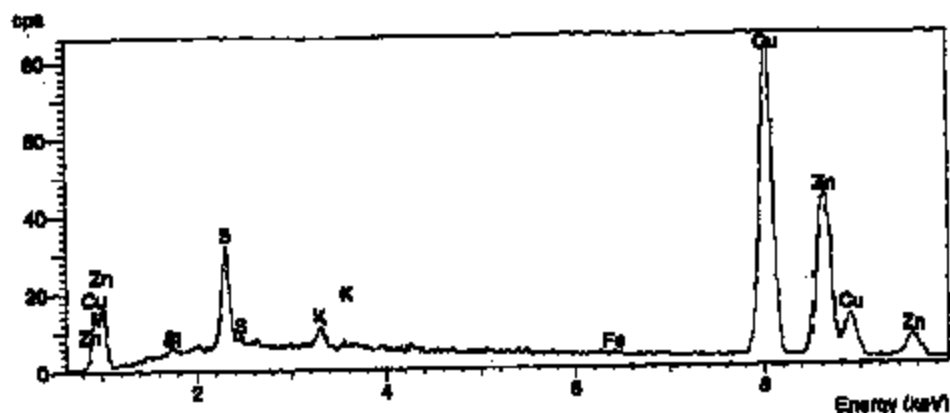
EDS X-ray spectrum material from the pad (area 3).
