**EA02-025**

**FORD 10/27/03**

PE Opening Reports (PE98-055)  
1992 Lincoln Town Car Engine Fires

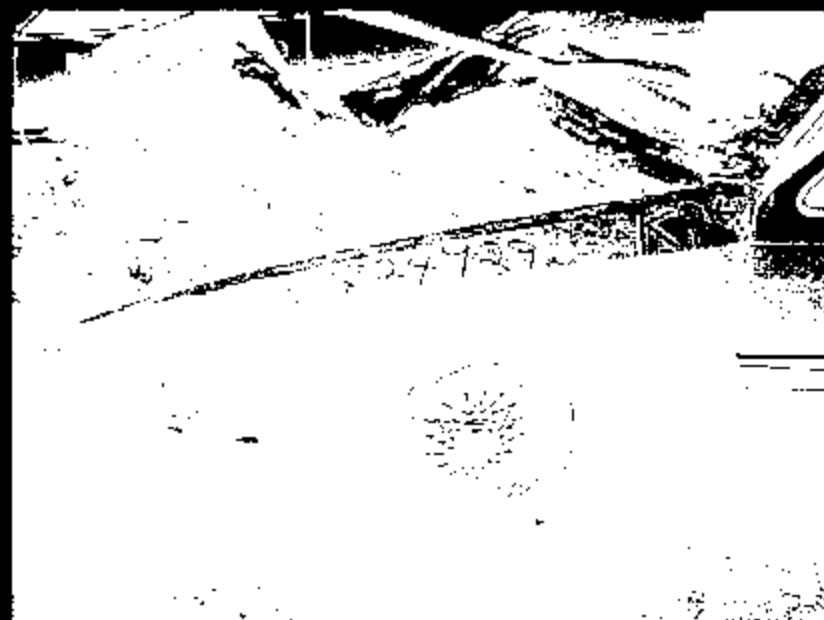
1LNLM92W1PY 1993 Lincoln Town Car - Houston, Tx 99-Jan-14 PE98-055
