EA02-025

APPENDIX N

Brake Pressure Switch Questions

Object: Determine cause of burned switch and connector.

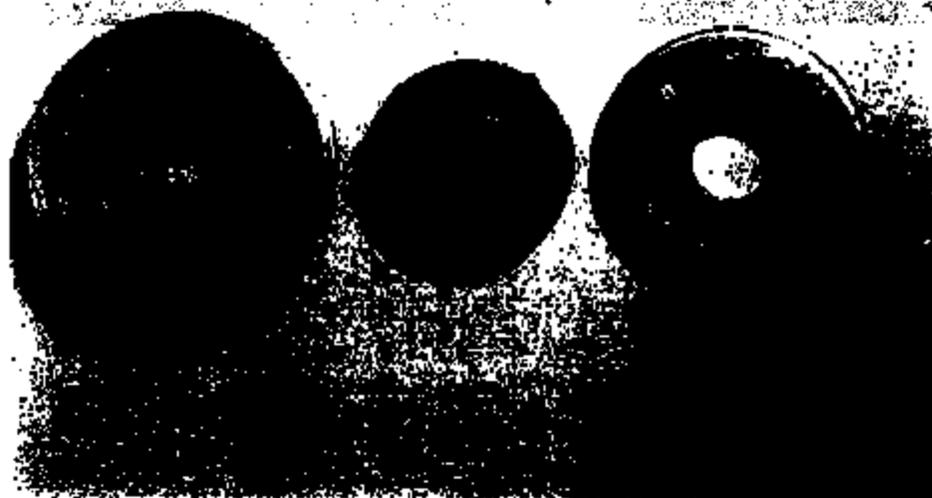
The interior of the cup, the washer, converter, disc, and spacer are covered with a liquid and black residues (Figures 13 and 14). These were sent to the Organic Section of Central Laboratory for sampling and analysis.

Figure 14: Photograph showing internal surfaces of cup, converter/disc, and washer after disassembly at Texas Instruments (N. LaPointe).
