**EA02-025**

**FORD**

## Improved Methods for Testing the Durability of Corrosion Protection in Brake Fluids

This letter is to advise you that the Office of Defects Investigation (ODI) of the National Highway Traffic Safety Administration (NHTSA) is conducting a Preliminary Evaluation concerning engine compartment fires in certain Lincoln Town Car vehicles manufactured by the Ford Motor Company.

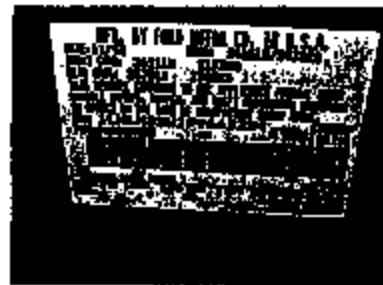
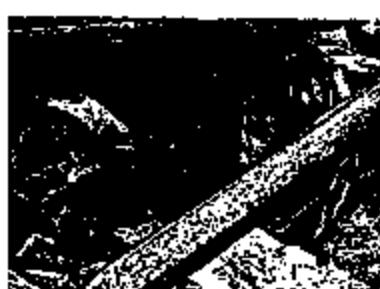
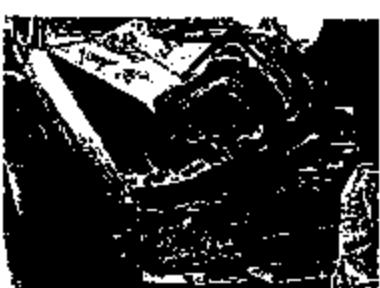
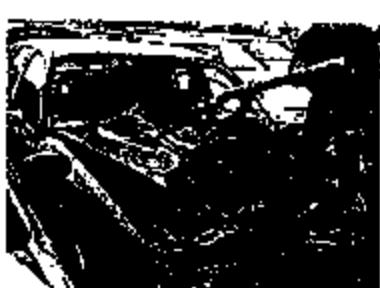
Switch A

The cup is partially covered with a greenish residue. Residue appears to be primarily an oxide of the brass contact material with possibly a sulfur compound. This suggests transfer of oxide or corrosion product from the brass contacts to the cup.

The stationary contact exhibits intergranular cracks which indicate stress corrosion cracking (SCC). SCC is caused by combination of a specific corrosive environment and a sustained tensile stress (can be localized). Ammonia, ammonia compounds, sulfur compounds, and moisture are known to cause SCC in brass. The contact material has been reported to be 360 brass, which is highly susceptible to SCC.

All three diaphragms exhibit what appears to be mechanical damage. The damage does not match up with any mating parts of the switch. This suggests that damage may have occurred prior to assembly. The diaphragm has become brittle and cracked in the vicinity of the damage. Brake fluid has become entrained between the layers (Teflon and capton) of the diaphragms.

The post of the movable contact melted back into the bulkhead between the switch and terminal cavities of the base. There is also arc damage (localized melting) to one corner of the bridge of the stationary contact. This damage appears fresh (surfaces bright and shiny) which suggests that it may have occurred in the later stages of the thermal event.

The terminals exhibit deposits which appear to be primarily sulfur compounds of the terminal material (tin plated brass). Although these deposits appear visually similar to the deposit found on the cup, they appear to be of different composition.

The white residue found in the connector cavity contains elements found in dry chemical fire extinguishers (Muscovite and phosphorus).
