**EA02-025**

**FORD**

Report 9903244

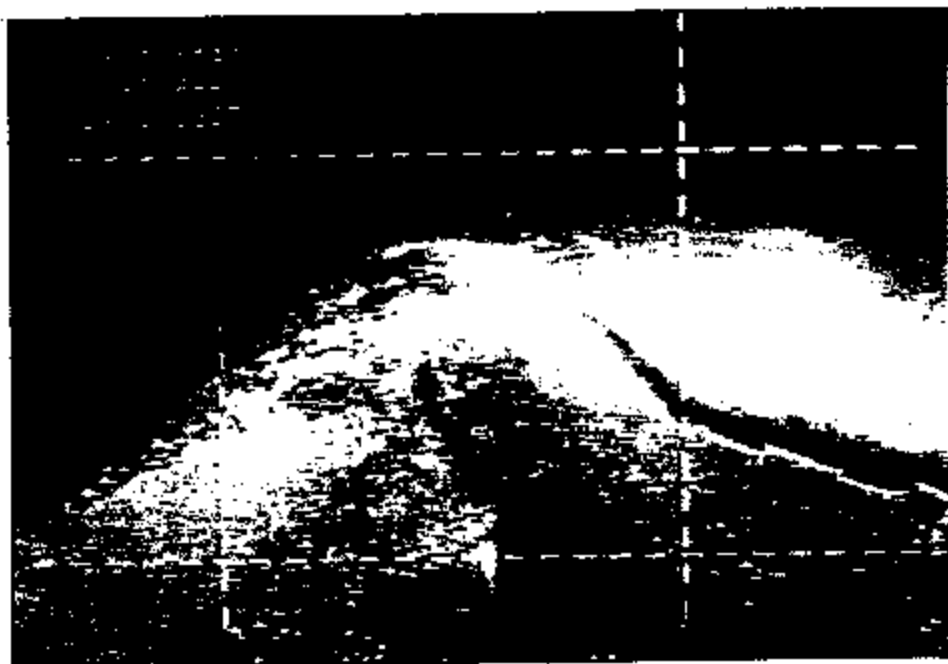
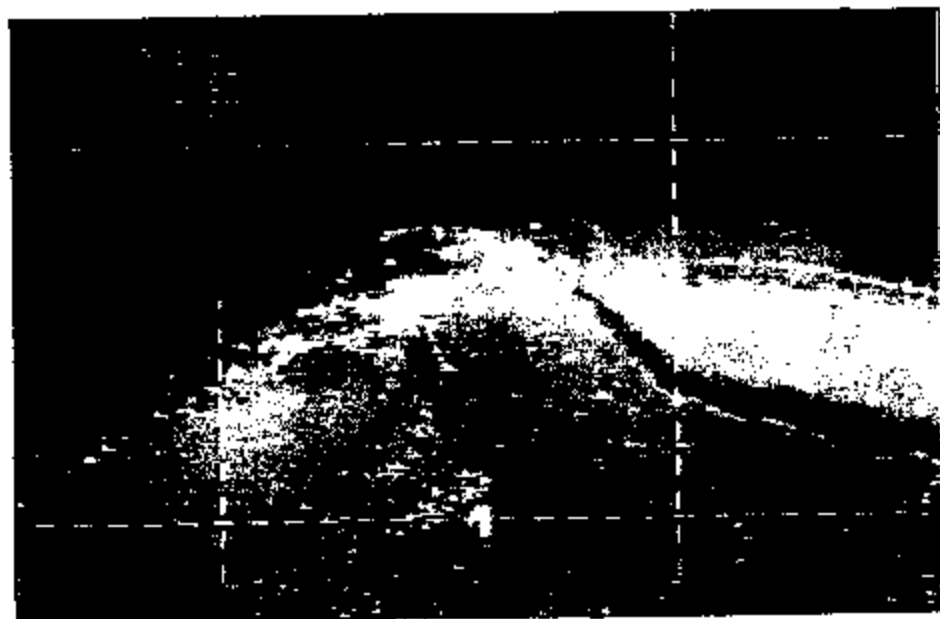
*Layers 1-2 3*

*Switch Sample 01*
