**PE04-078**  
**FORD**  
**1/28/2005**  
**BOOK 3 OF 12**  
**ATTACHMENT F**  
**PART 1 OF 6**

**B. PHOTOGRAPHS**

# Interscience, Inc.

Re: Our Project No: L0500-02  
Insured: [REDACTED]  
Claim No: [REDACTED]  
Date of Loss: April 27, 2004  
Date of Notification: May 4, 2004  
Date of Inspection: May 11, 2004

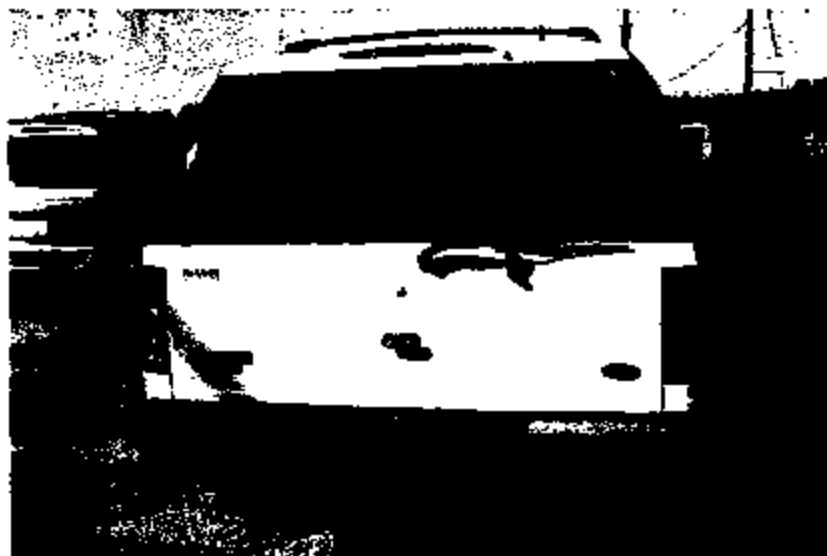
2. Rear view of the Ford Expedition vehicle.

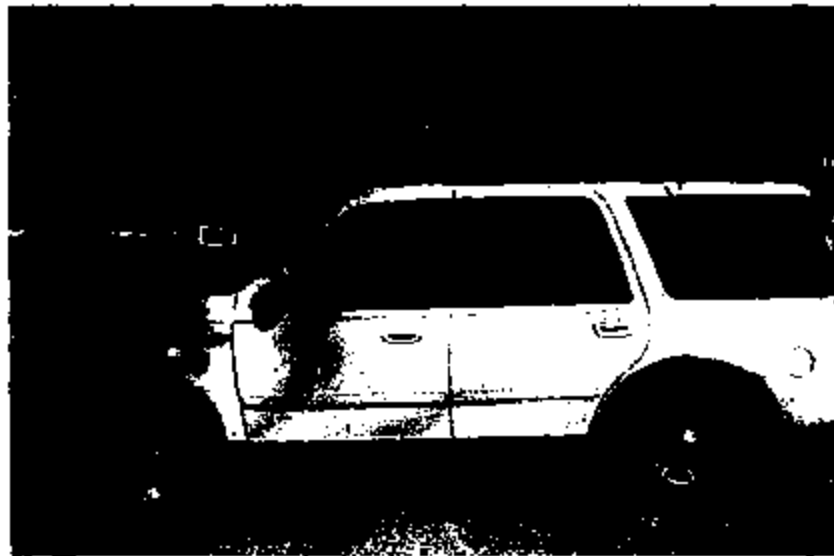
4. Left side view of the vehicle.

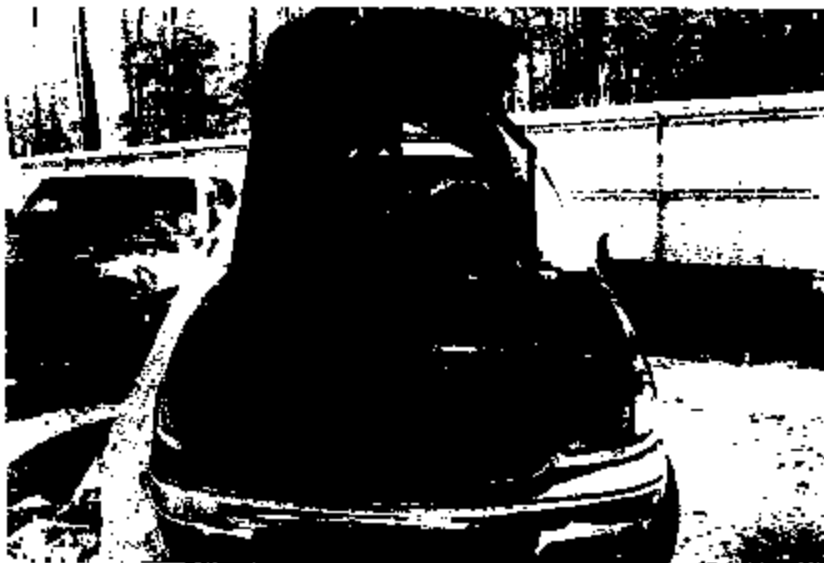
15. View of the underside of the hood.

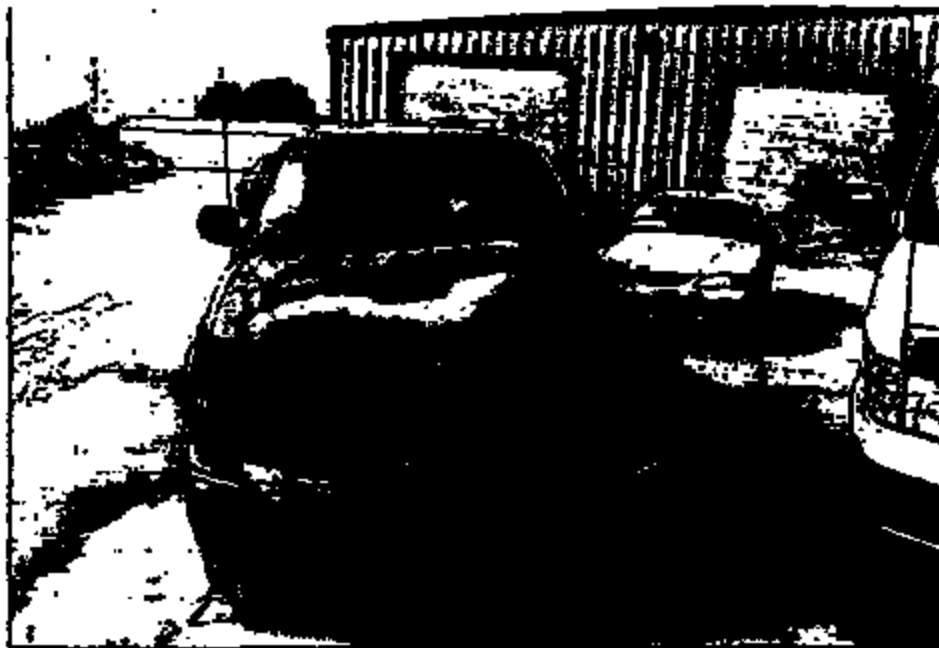
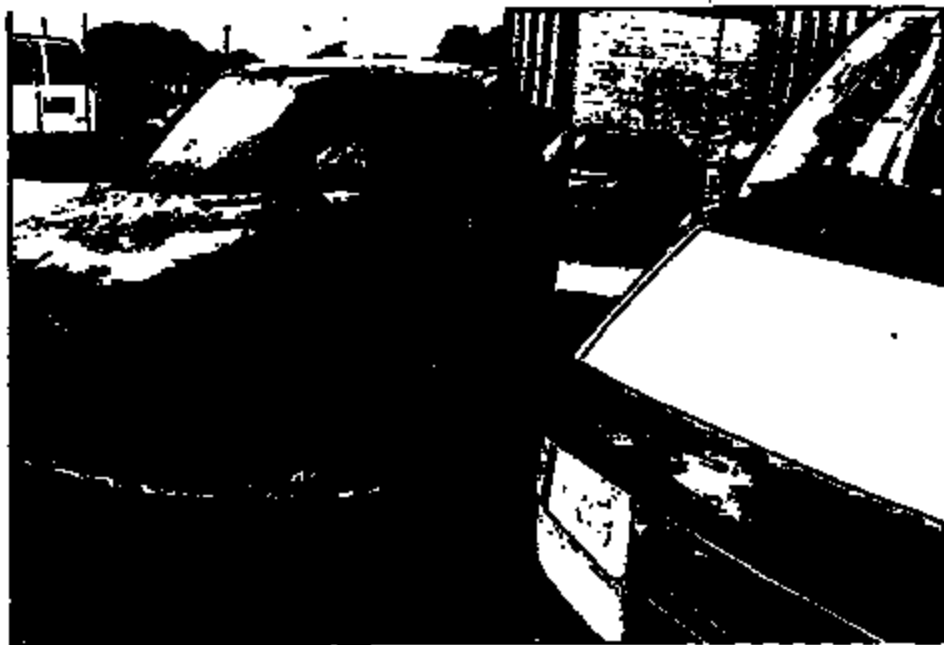
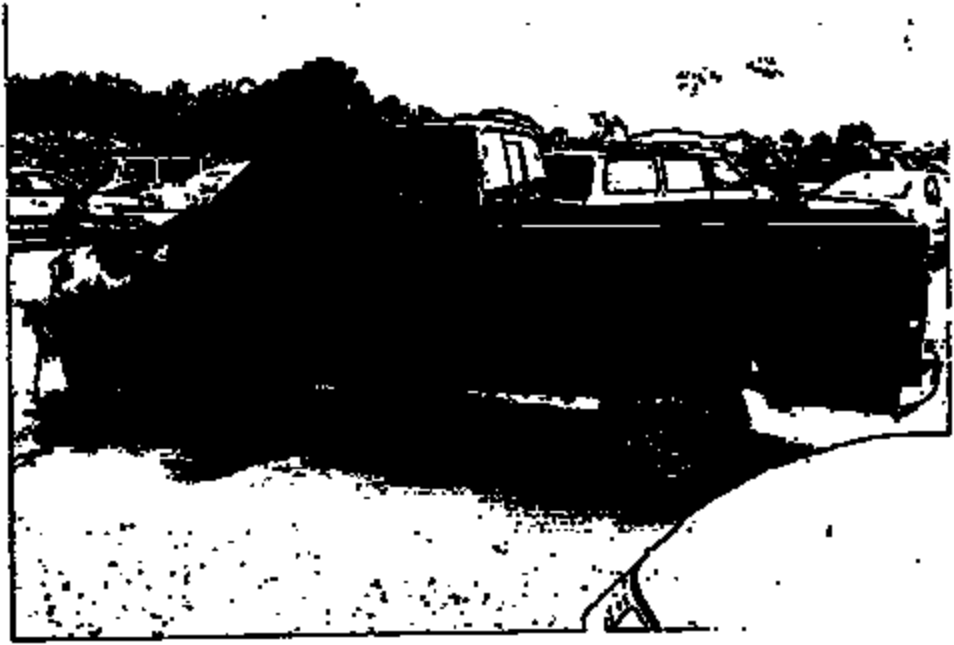
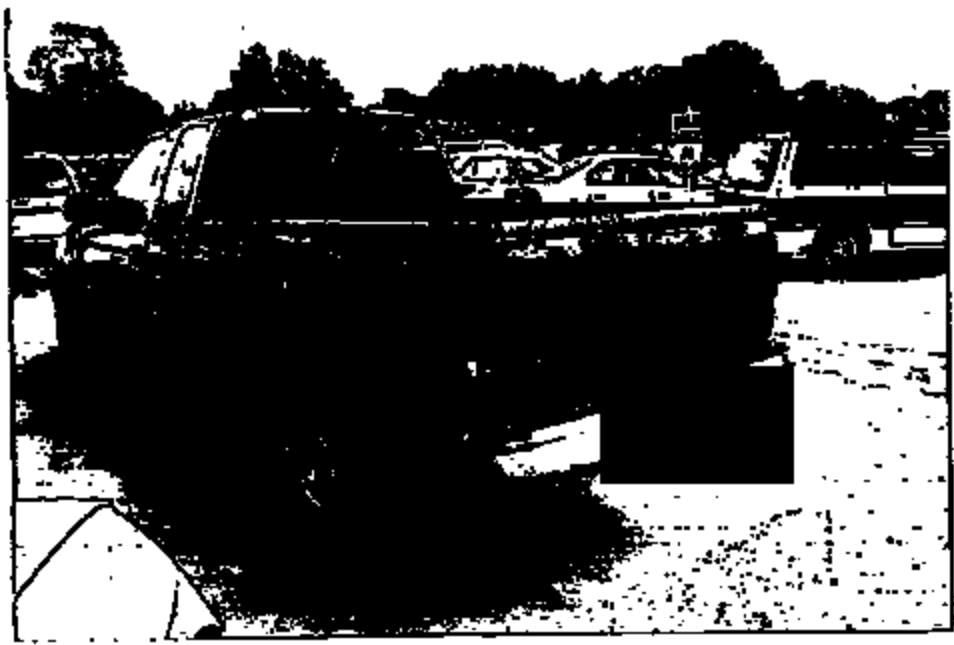
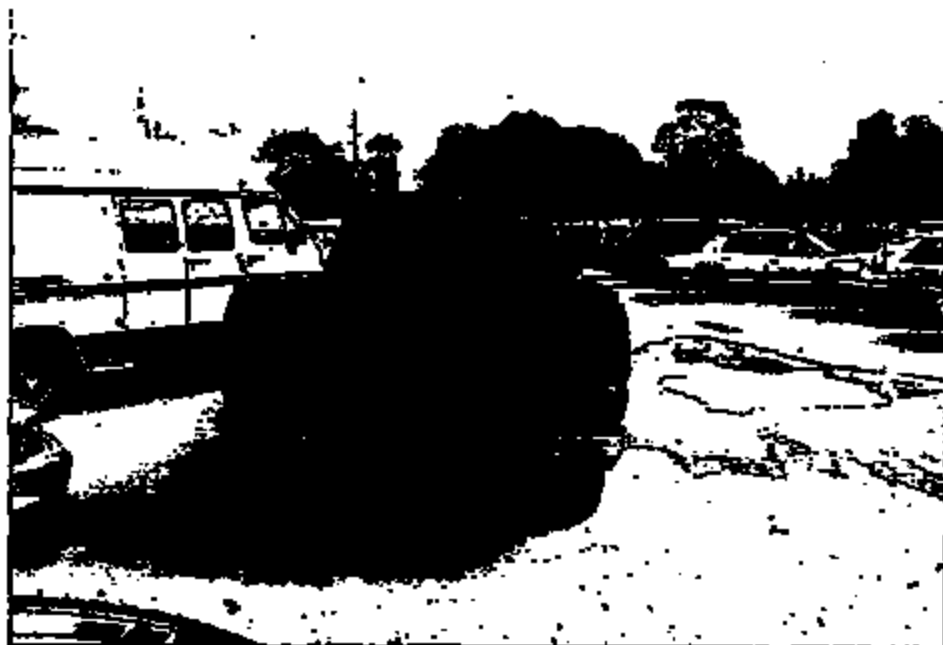
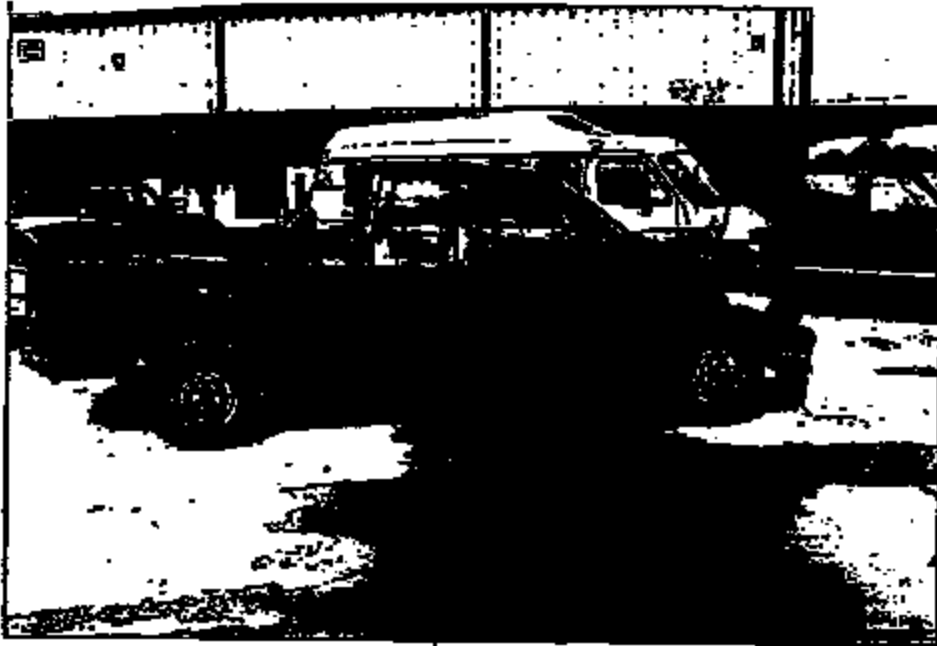
1-8. Exterior views of the subject vehicle.
