PE04-078

FORD

ARBITRATIONS & INSPECTIONS

The purpose of this assignment was to determine the origin and cause of a fire in the below referenced 2001 Ford Expedition, hereafter referred to as the subject vehicle, that reportedly occurred shortly after the vehicle had been parked.

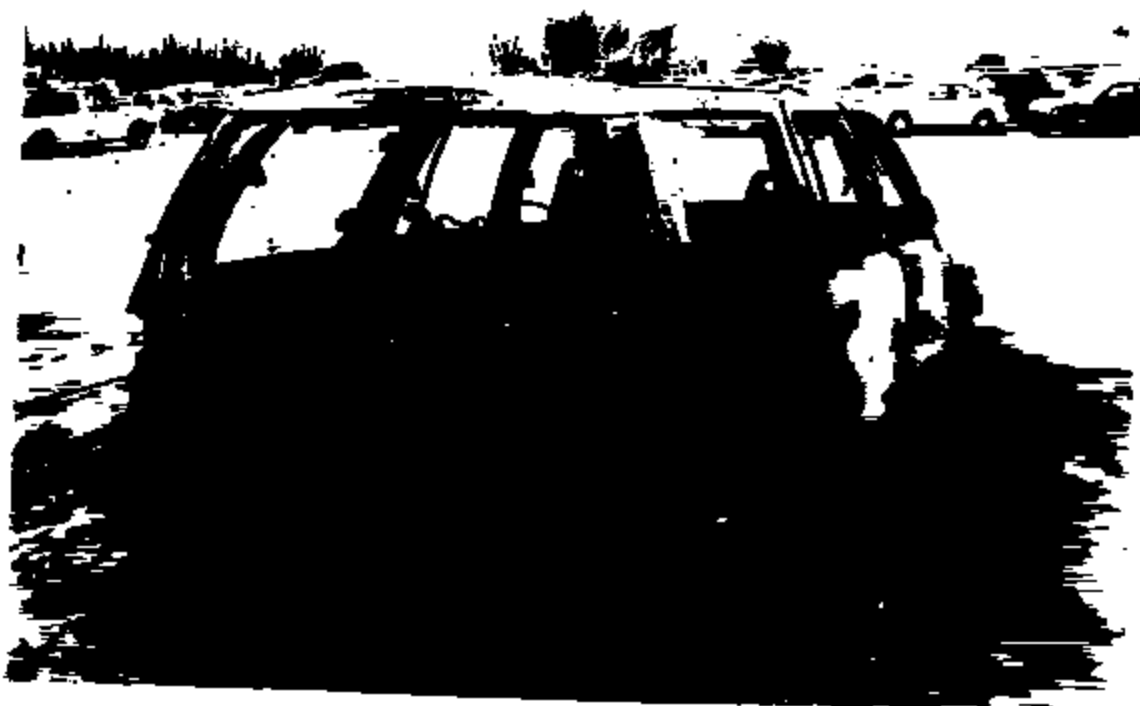
#4 - Right rear 3/4 view

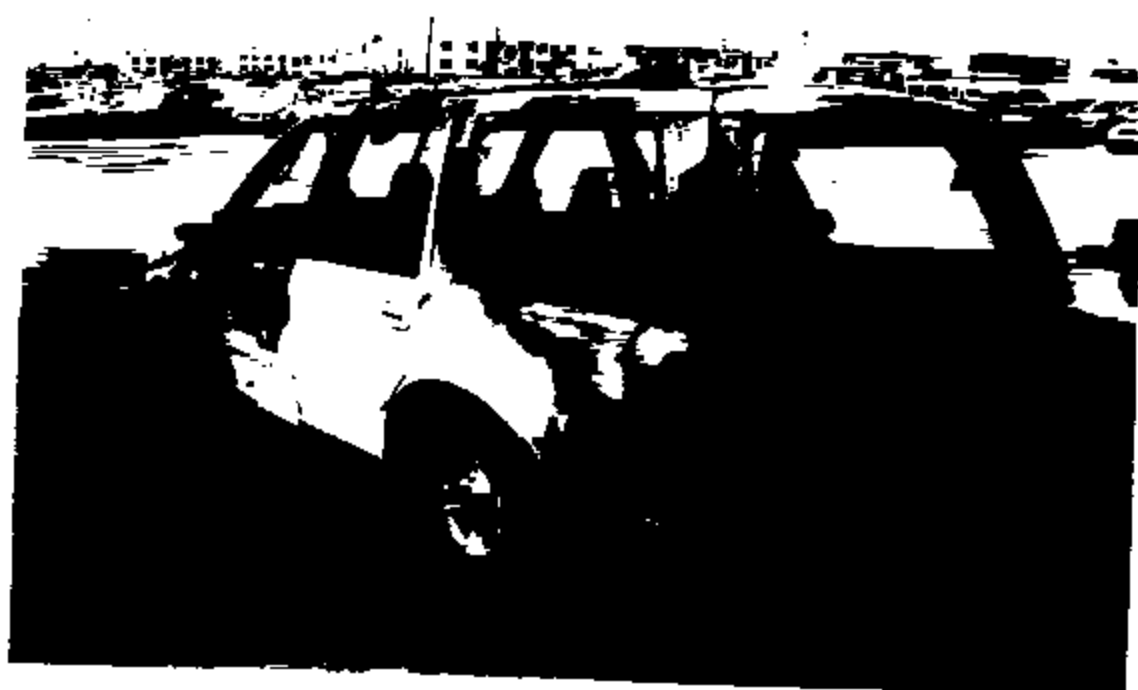
#6 - Left rear 3/4 view

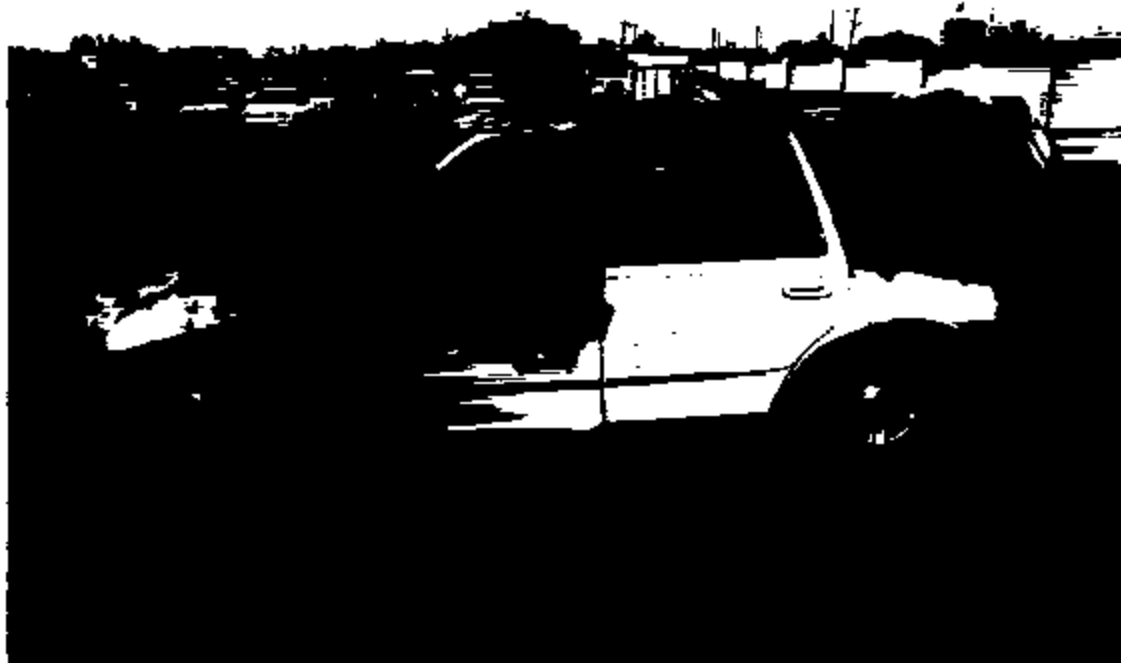
#7 - Left side view
