PE04-078

FORD

The purpose of this assignment was to determine the origin and cause of a fire in the below referenced 2000 Ford F150 pickup truck, hereafter referred to as the subject truck, that had been parked for approximately 20 minutes prior to the fire's occurrence.

The purpose of this assignment was to determine the origin and cause of a fire in the below referenced 2000 Ford F150 pickup truck, hereafter referred to as the subject truck, that reportedly occurred while it was parked.

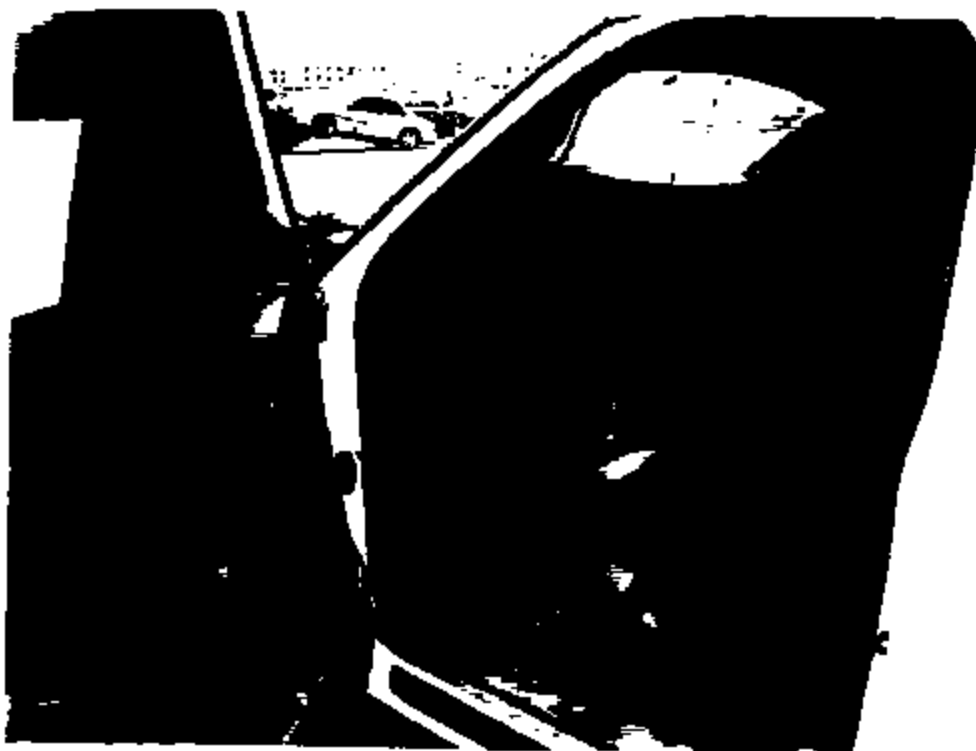
There were only minimal fire damages sustained in the passenger compartment. There was a small amount of charred insulation debris on the driver's floor mat from the fire that migrated through an access hole adjacent to the right side of the power brake booster.

#12 - The passenger compartment as viewed through the driver's door opening
