Liberty Mutual Fire Insurance Company

OUR INSURED: [REDACTED]
OUR CLAIM NUMBER: [REDACTED]
YOUR INSURED: FORD MOTOR COMP
YOUR CLAIM NUMBER: [REDACTED]
DATE OF LOSS: 11/18/2003
PLACE OF LOSS: [REDACTED]
LOSS: SAULT SAINTE MARIE, MI

Based on our investigation of this accident, we believe your Insured to be responsible for the damage to our Insured's vehicle. I have enclosed documentation to support the following subrogation claim:

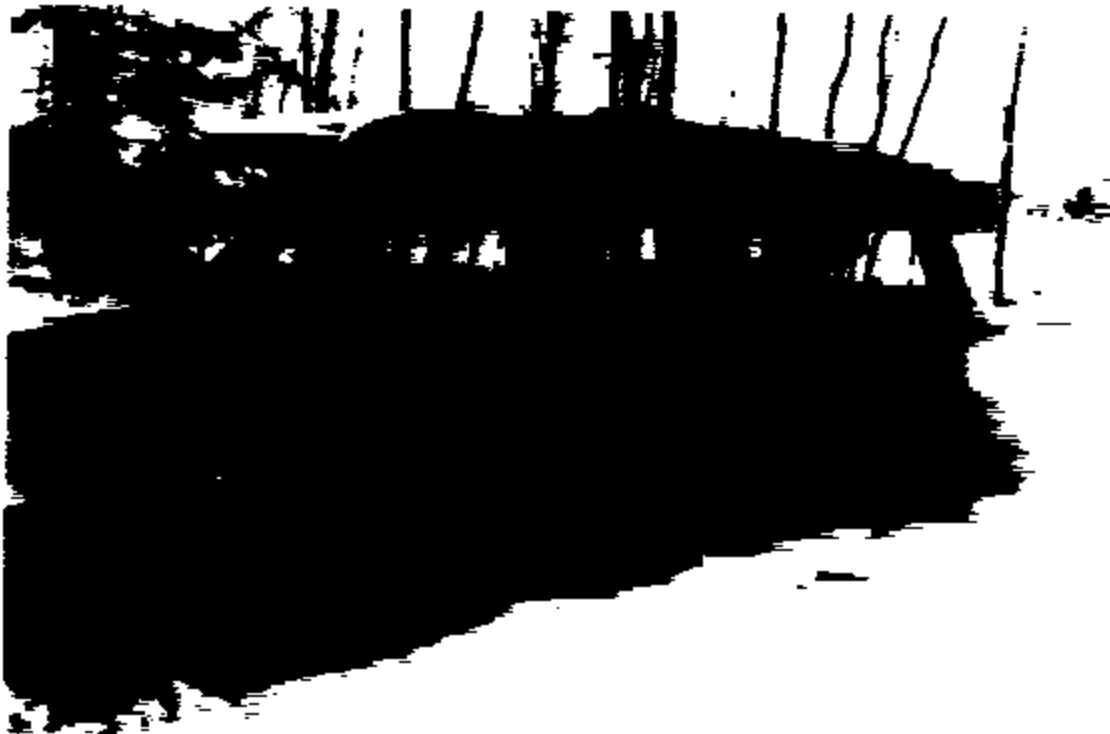
6 A view of the driver's side seen from the front

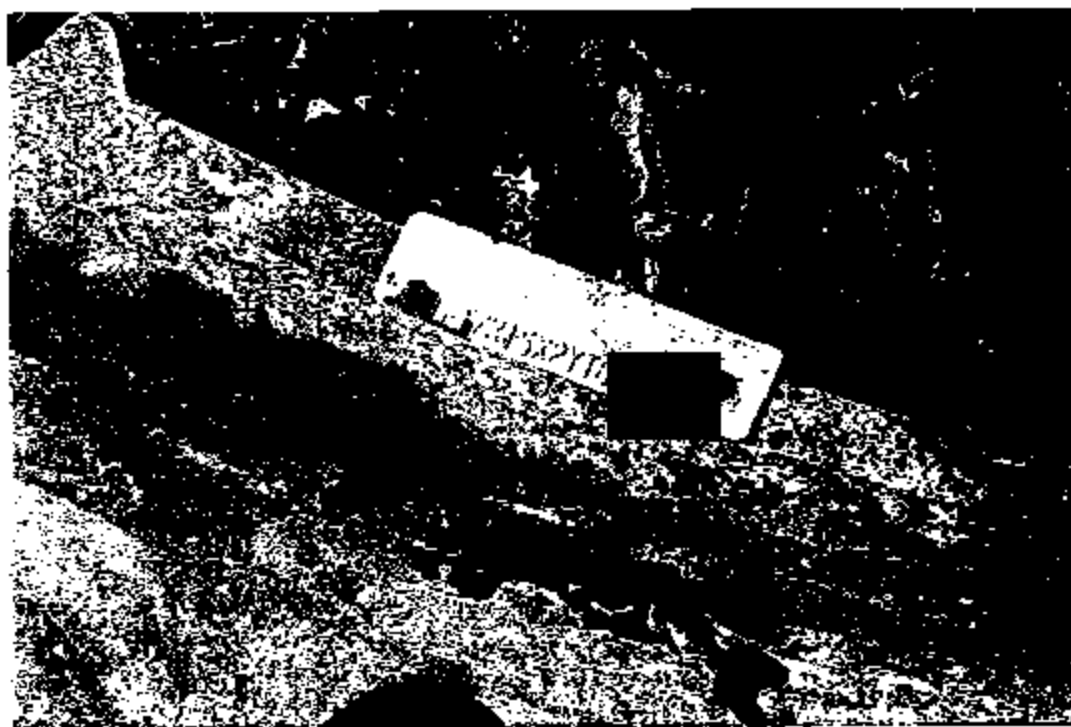
FIGURE #6

This is a view of the VIN tag used to positively identify the subject vehicle.

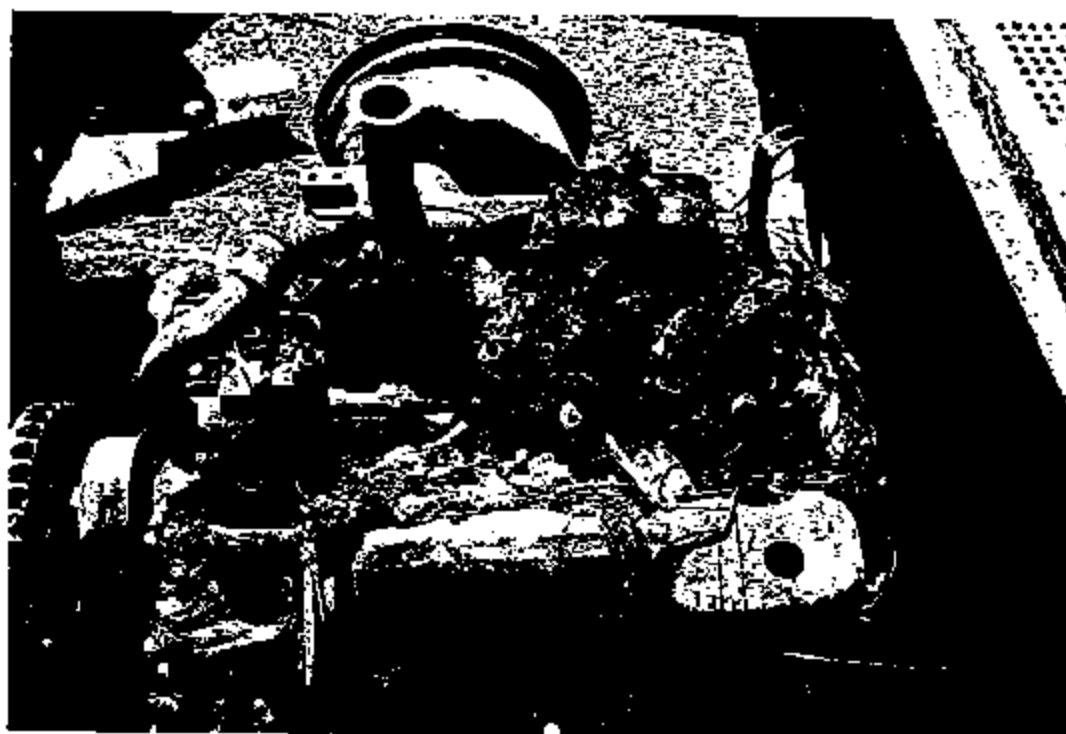
FIGURE #27

This is a view looking across the top of the engine from left to right. Part of the upper intake had been destroyed, but part of it remained, melted but in place.

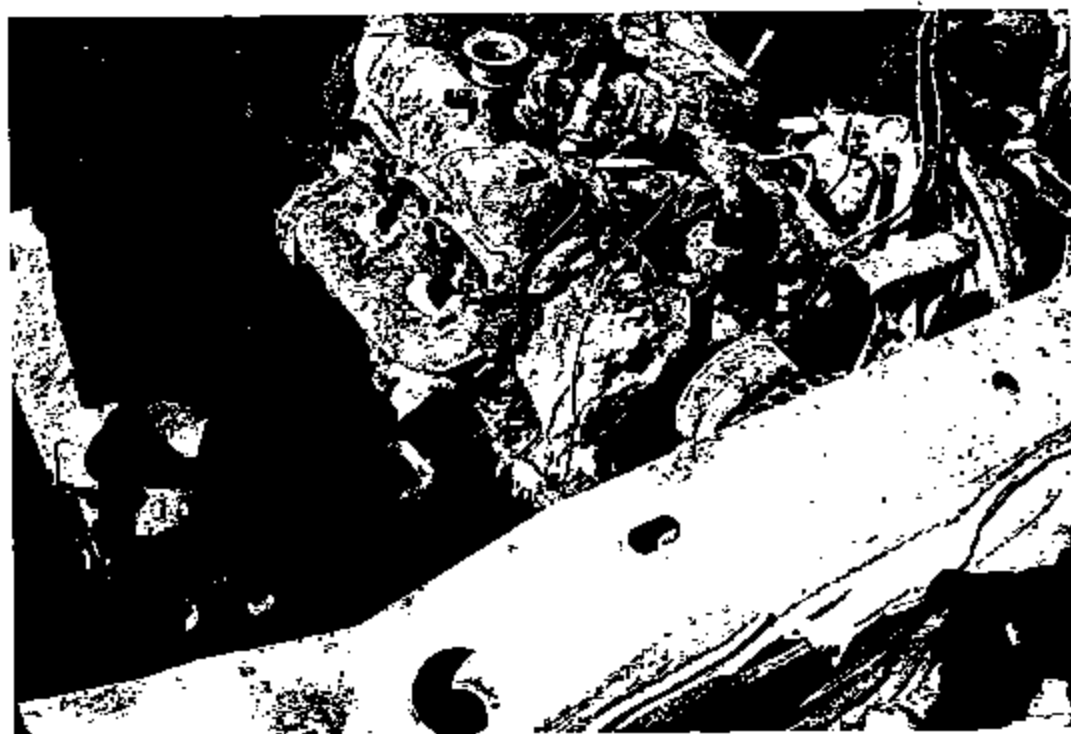
FIGURE #31

This is a view looking from the right front quadrant of the engine compartment back toward the left rear quadrant. With the exception of the battery, the coil pack and a portion of the upper intake, all combustible components had been destroyed.
