Tempe Police Department

Incident Report

This assignment was received on June 6, 2003 from Daye Dixson of State Farm Insurance Company. I was instructed to conduct an origin and cause investigation as a result of extensive fire damage that occurred to the insured's 1998 Ford Expedition.

Reportedly, on May 23, 2002, a fire occurred involving a 1997 Ford F-150 vehicle. On May 24, 2002, Forensic Analysts, Inc. was retained by Mr. Hugo Benavides of Allstate Insurance Company to inspect the vehicle and determine the origin and cause of the fire.

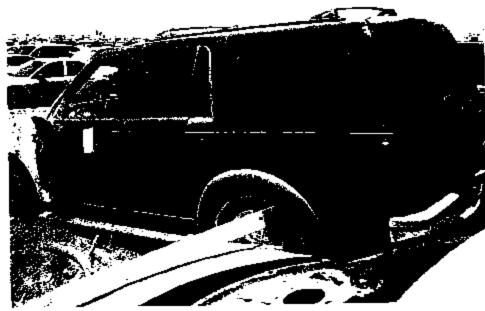
Photo 1. Left side of vehicle

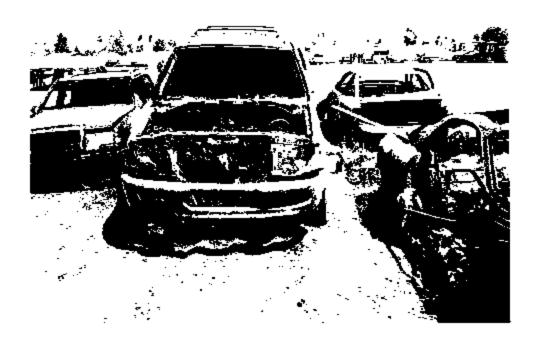
Photo 2. Overall view of the front hood and grill area

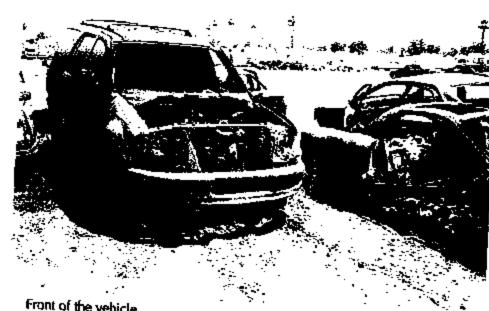
Photo 3. Front of the vehicle

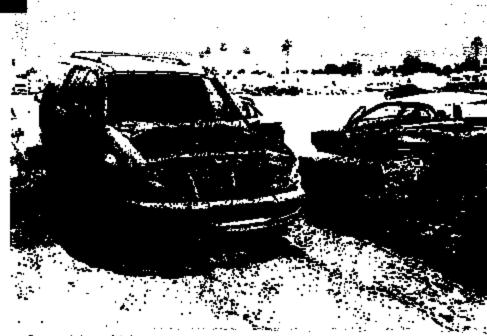
Photo 3. Front of the vehicle

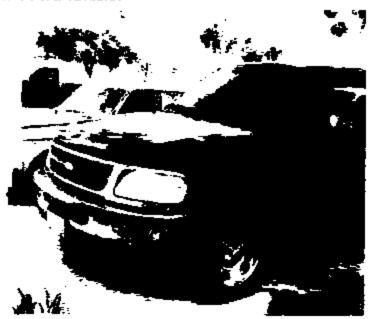
1. View of the front of the Ford vehicle.

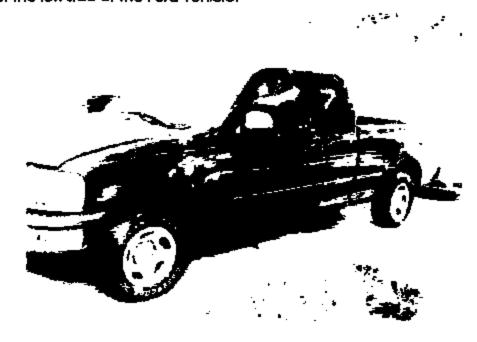
2. View of the left side of the Ford vehicle.

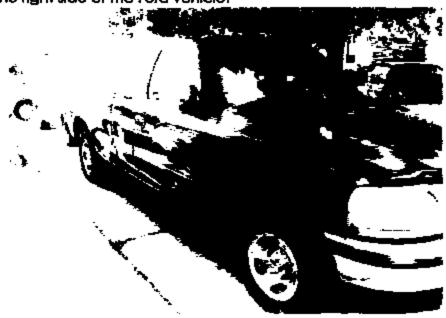
3. View of the right side of the Ford vehicle.

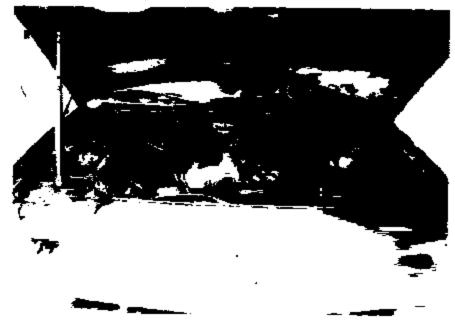
16. Overview of the engine compartment.

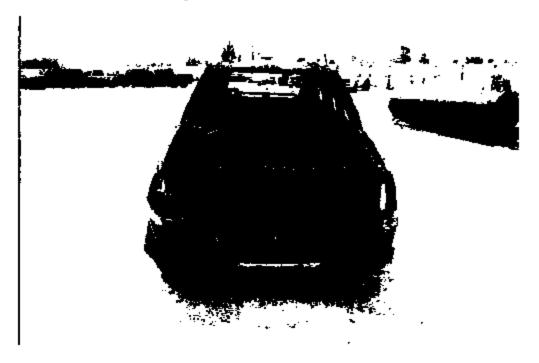
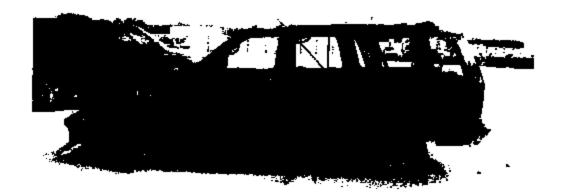
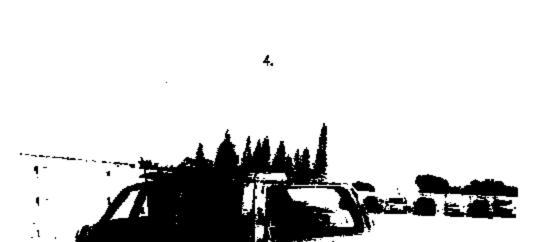
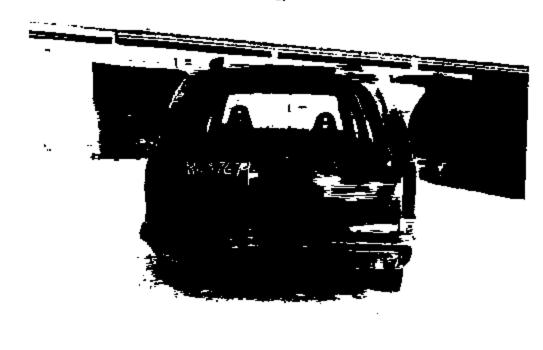
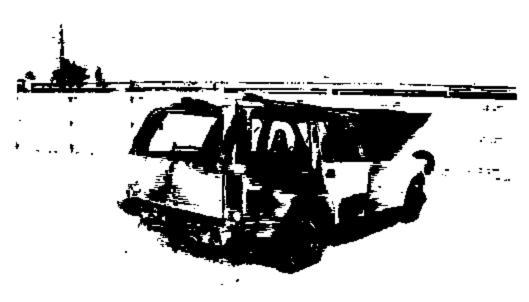
1-8. Exterior views of the subject vehicle.

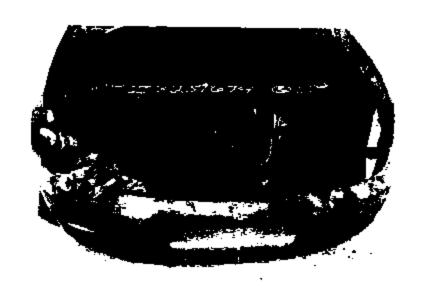
27-53. Views of the engine compartment.
