Unified Investigations & Sciences, Inc.

UIS FILE #: TX01-05928

The assignment was received on May 14, 2004 from Mr. John Gonzalez of Allstate Insurance Company. The instructions were to evaluate the evidence collected by Mr. Mike Beres of Unified Investigations and Sciences, Inc. from subject vehicle to determine the cause of the fire.

1. The cause of the fire was the catastrophic failure of the brake pressure switch.
2. The first fuel was the thermoset plastic material that made up the body of the electrical portion of the switch.

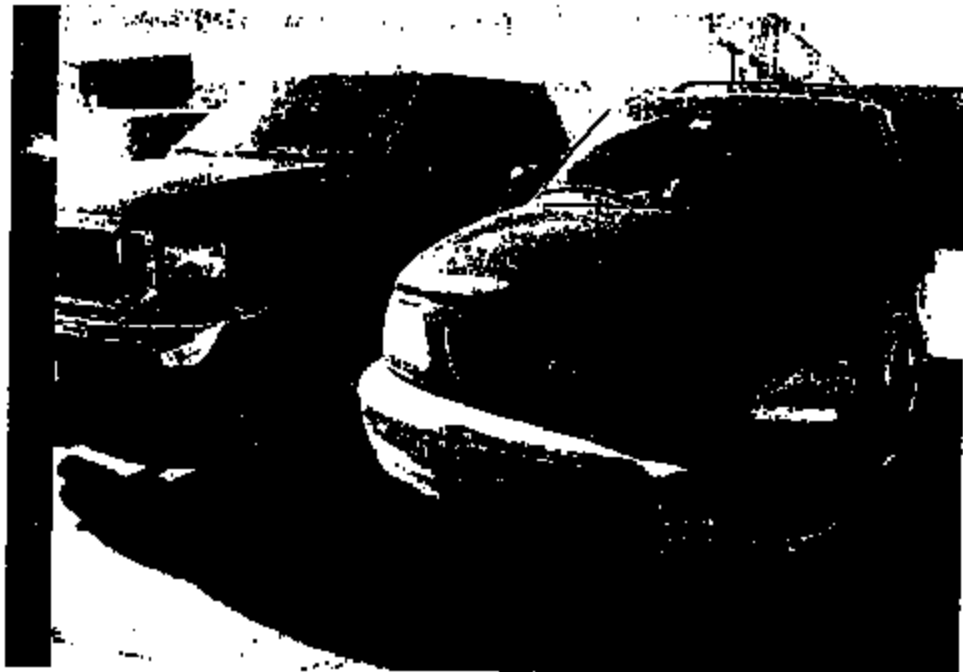
1. View of the front of the Ford vehicle.

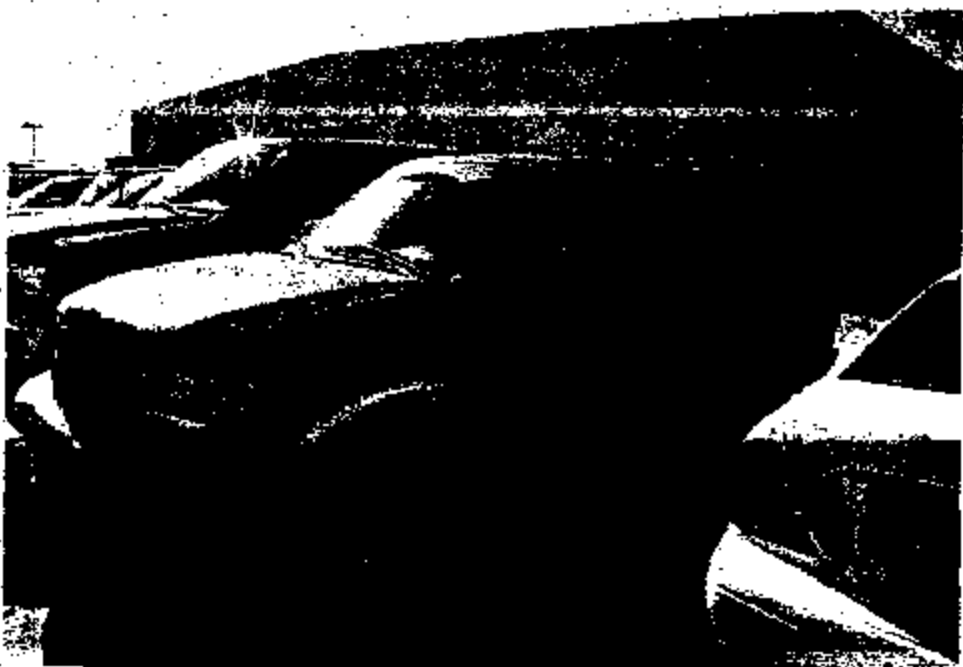
2. View of the left side of the Ford vehicle.

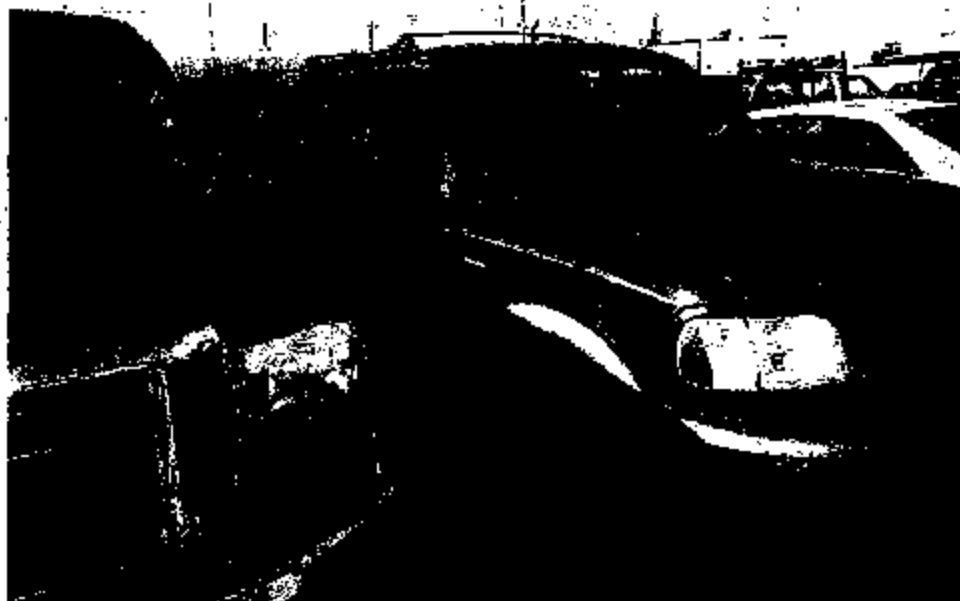
3. View of the right side of the Ford vehicle.

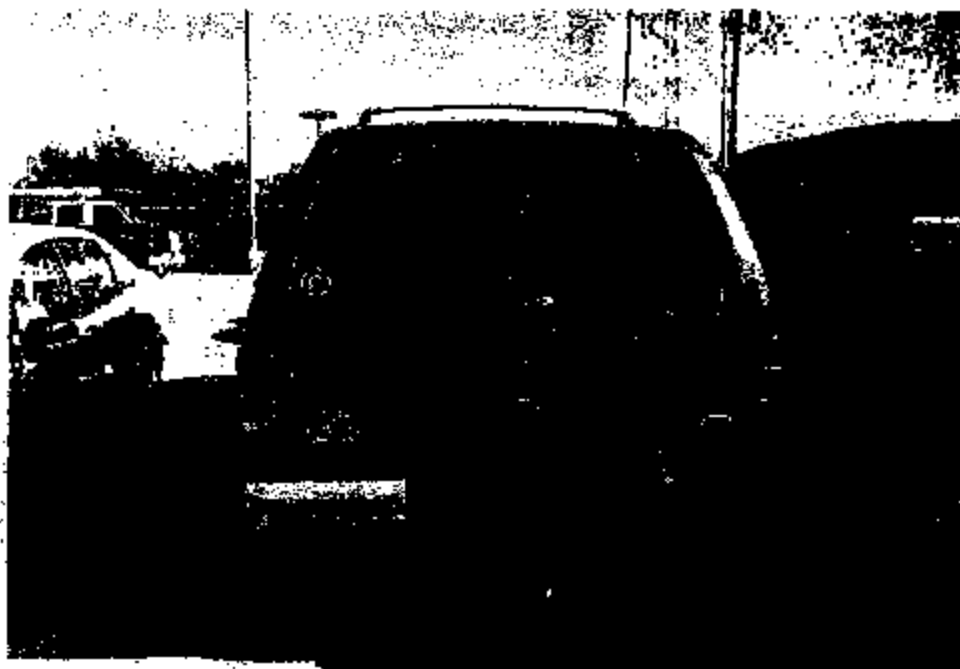
4. View of the rear of the Ford vehicle.

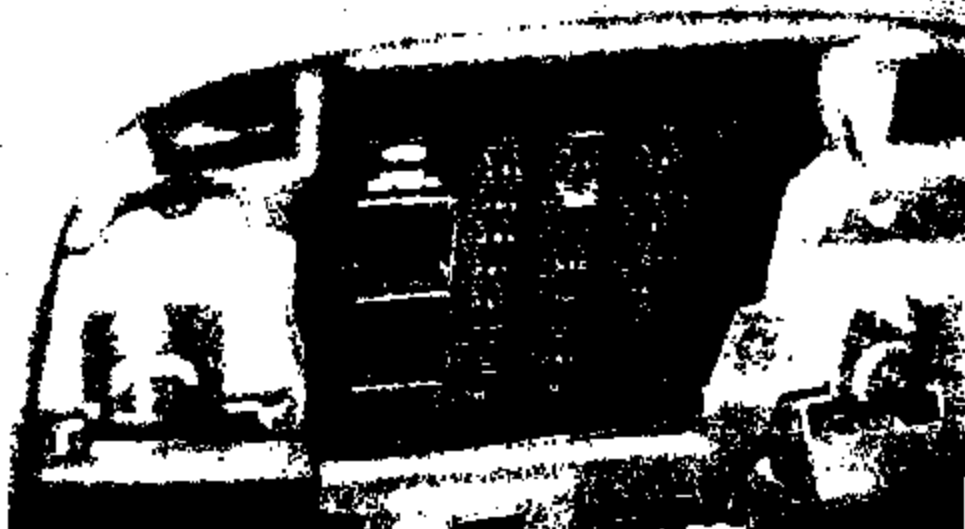
9. Overview of the uncompromised area surrounding the fuse box within the interior of the vehicle.

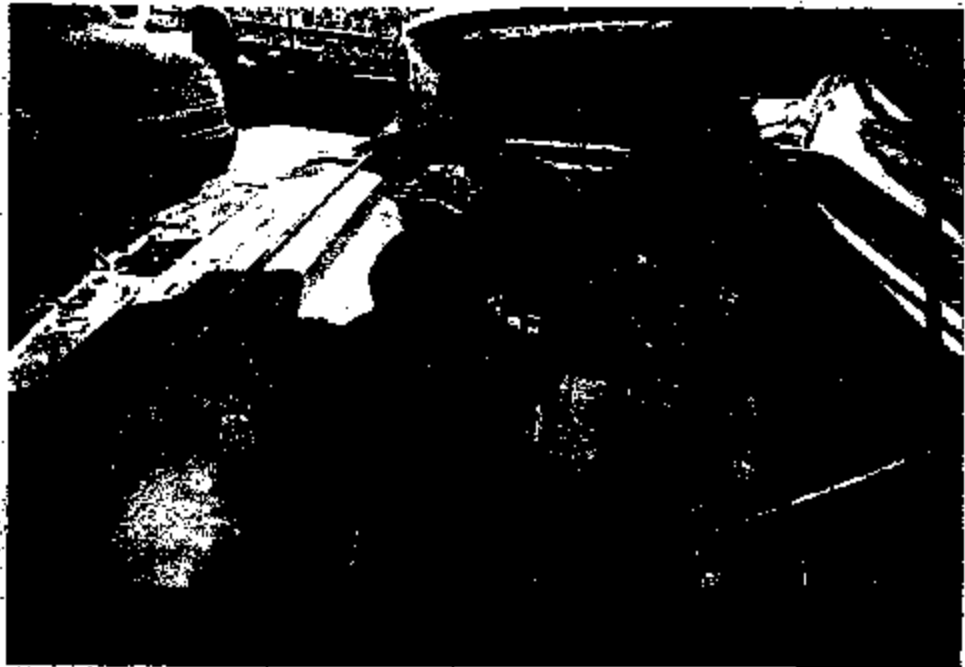
11. View of the engine compartment as viewed from the left.

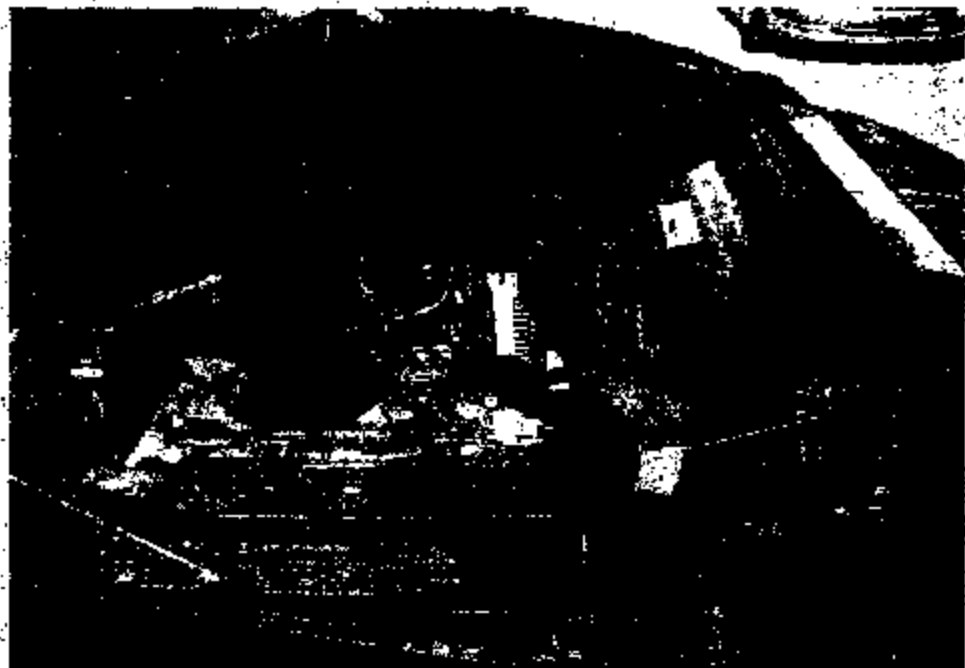
13. View of the unbowed front portion right half of the engine compartment as viewed from the front.

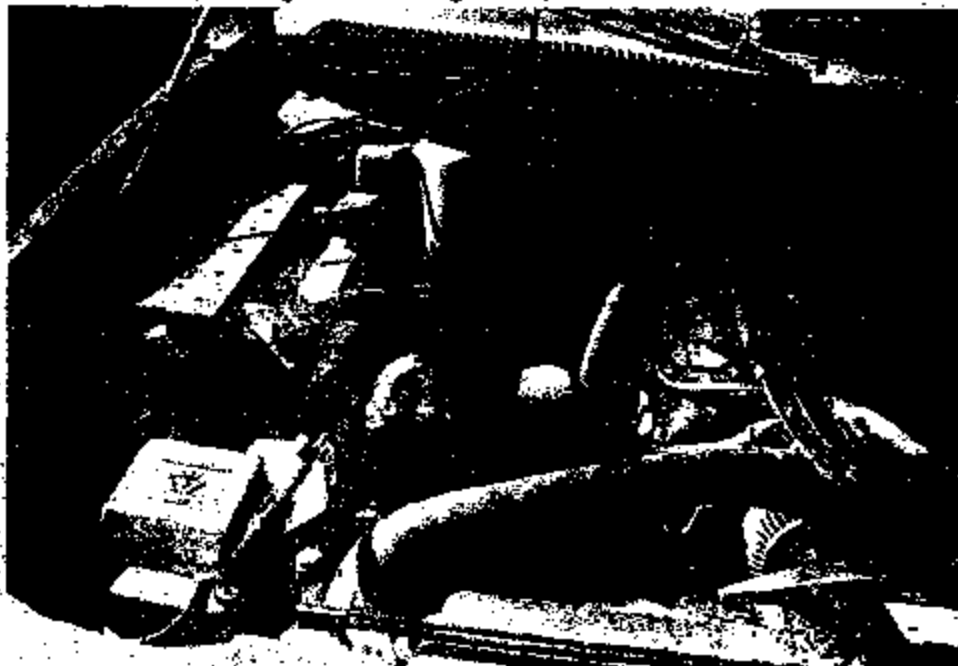
14. View of the left half of the engine compartment as viewed from the front.
