REPORT OF FINDINGS

1997 FORD F150 TRUCK

ProNet File No. 5904

EA05-005-LC-2003

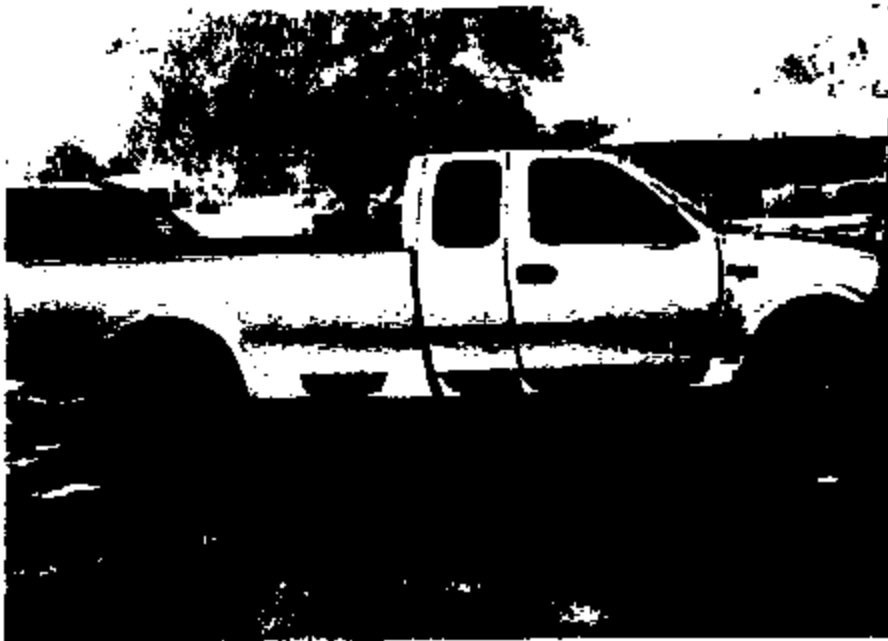
3. Right side view of the Ford truck.

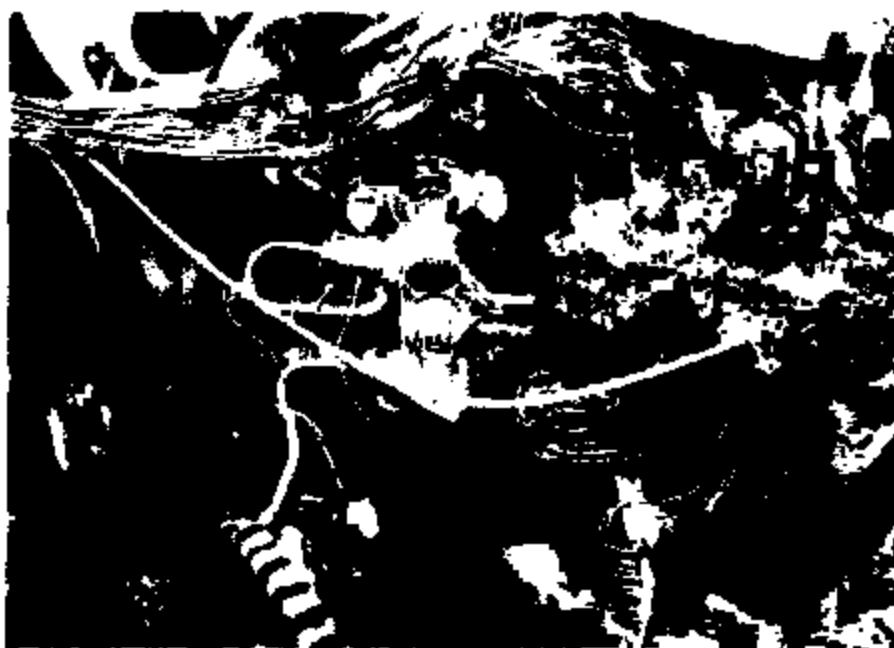
24. View of the brake pressure switch as viewed from the front towards the rear.

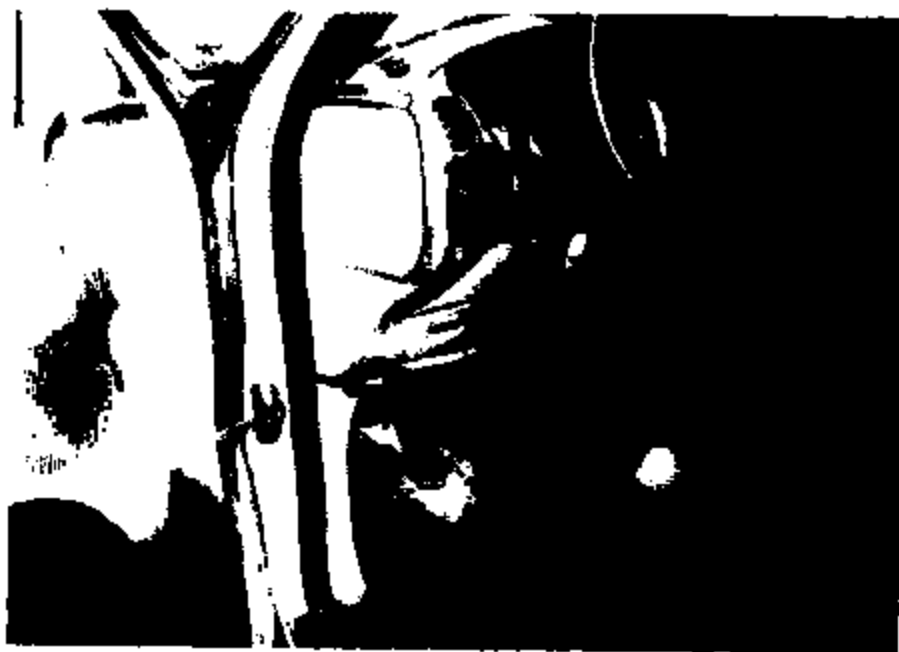
34. Overview of the interior fuse panel, prior to the removal of the fuse panel cover.

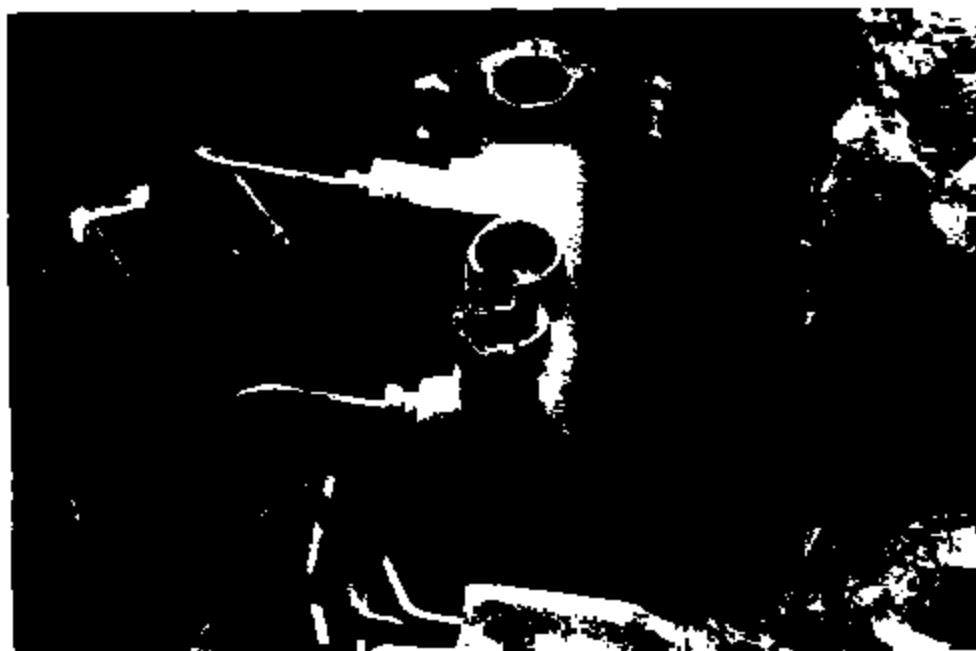
42. Closer view of the brake master cylinder.

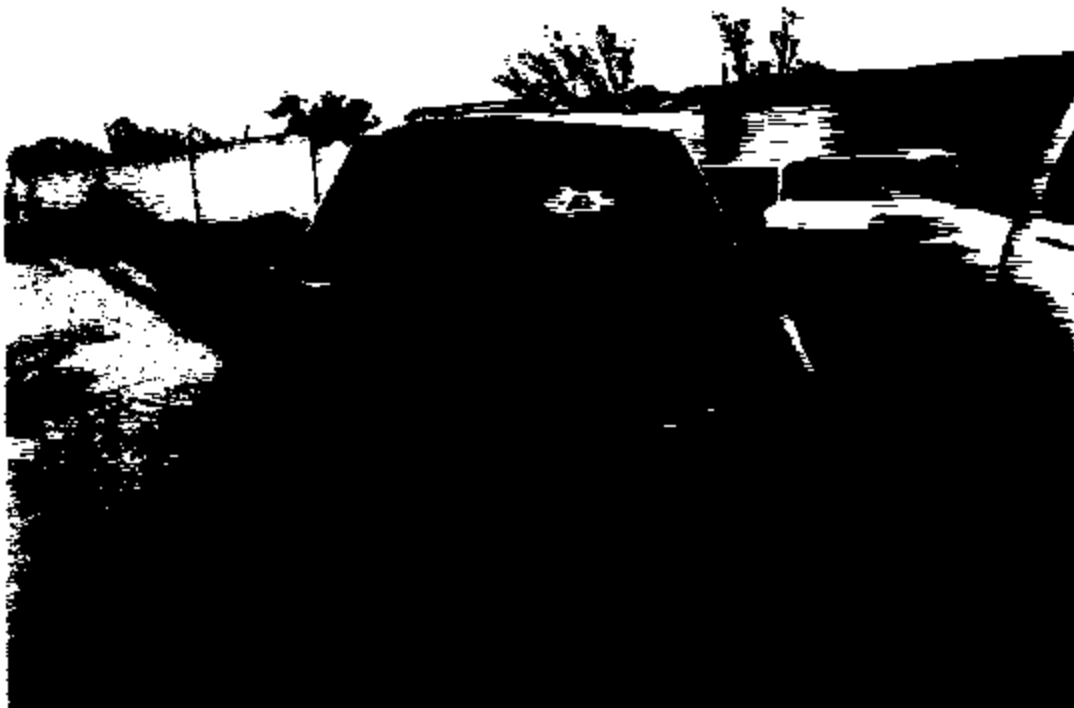
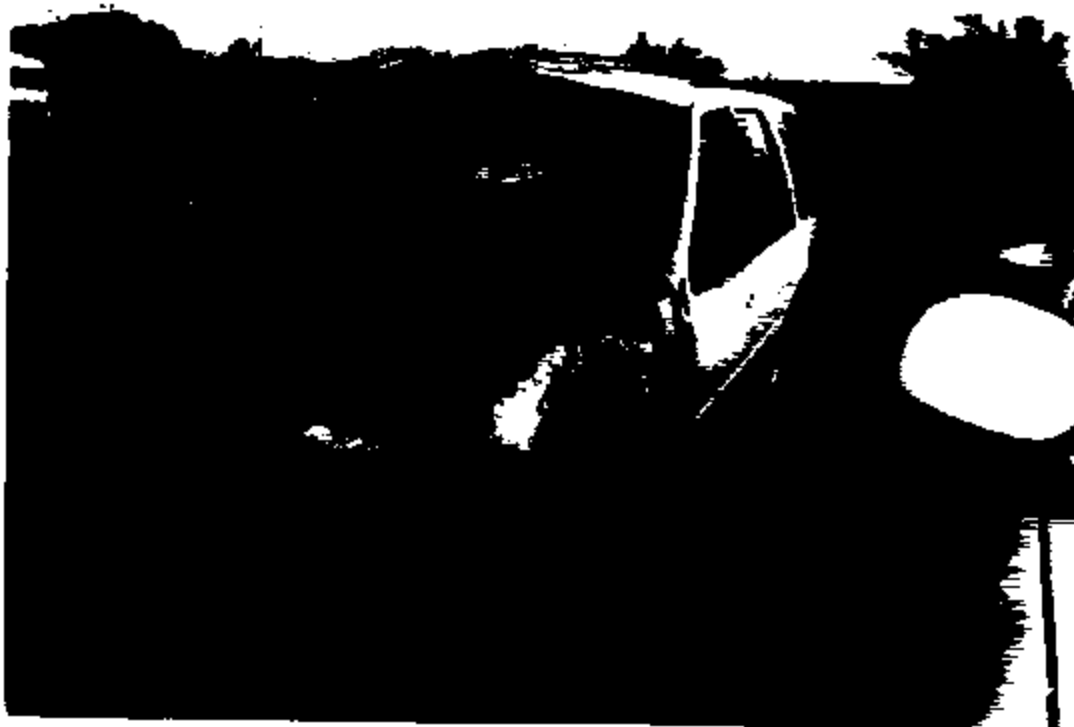
1-9. Exterior views of the subject vehicle.

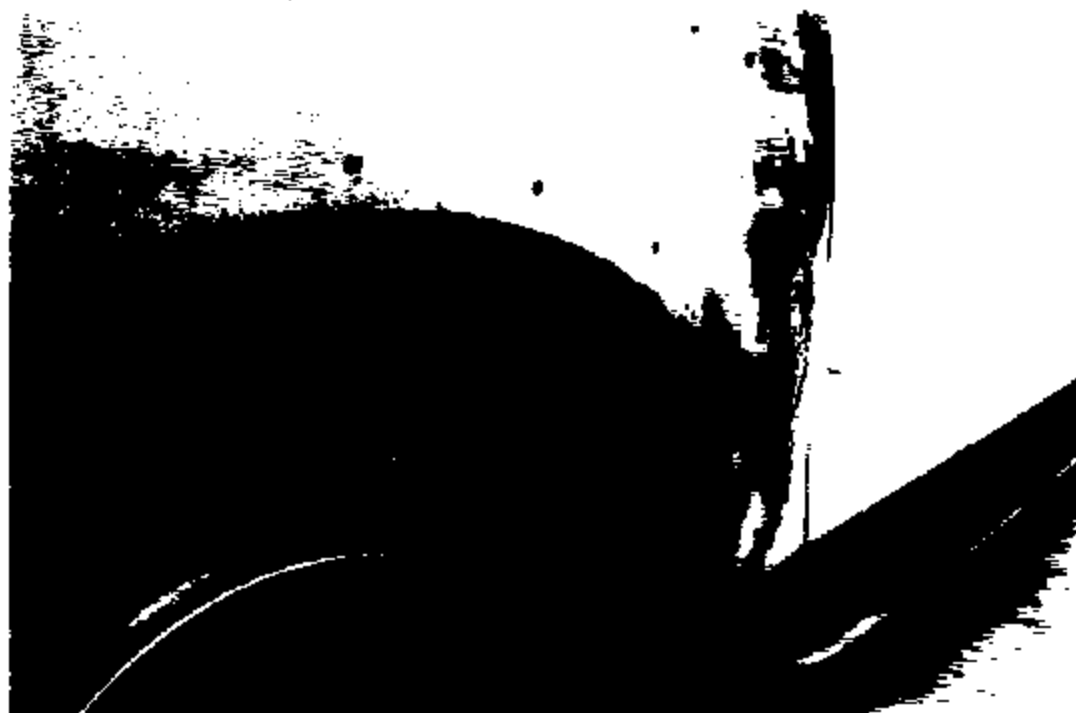
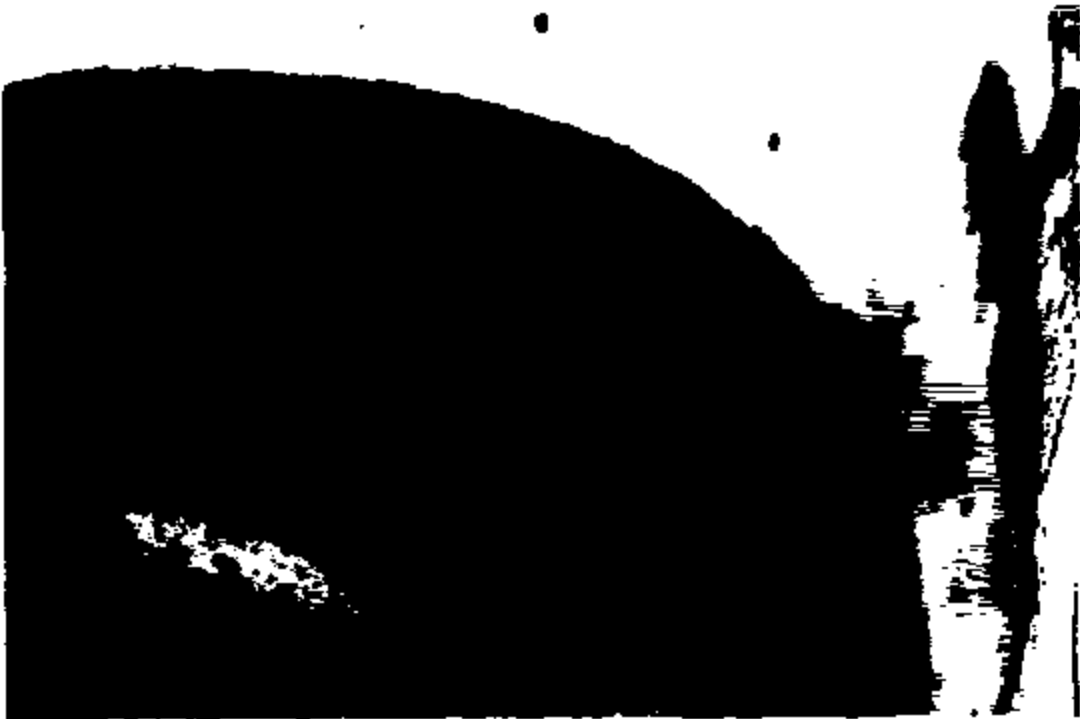
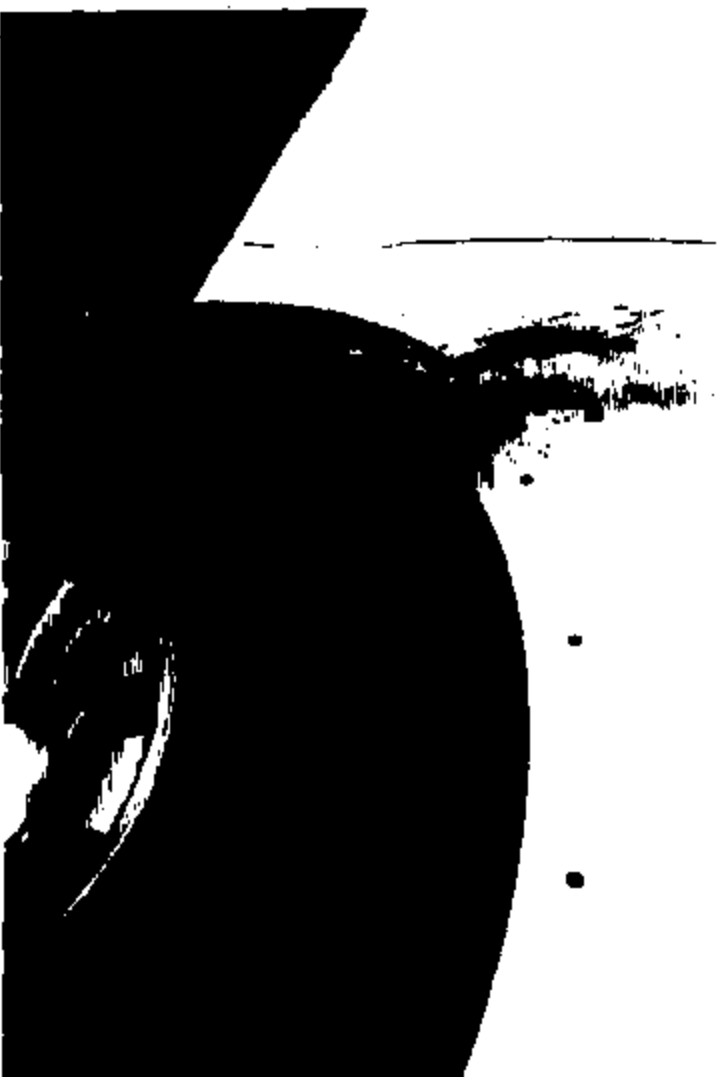
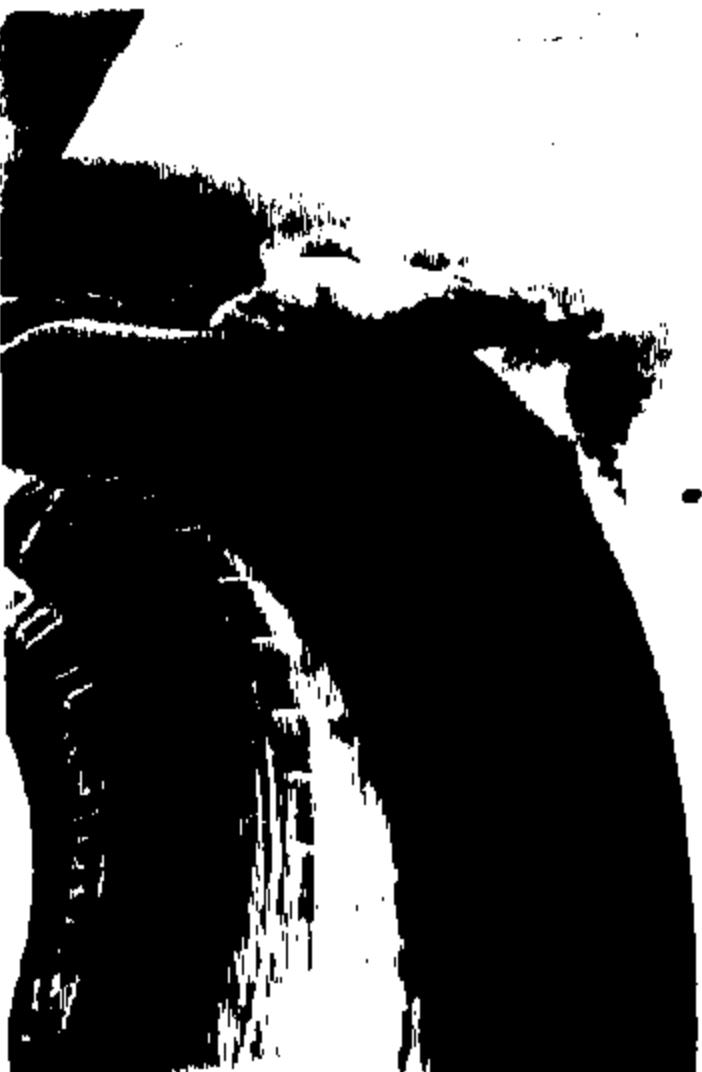
13-18. Views of the subject vehicle wheel wells.

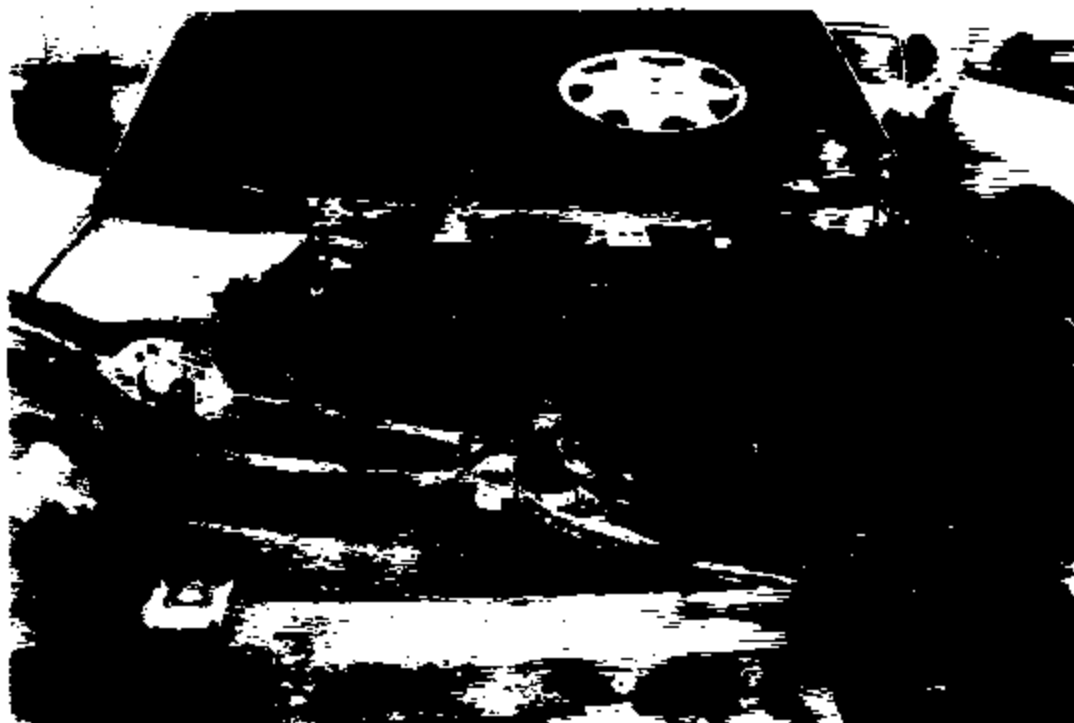
It is the conclusion of Interscience, Inc. that the area of fire origin was located on the driver's side within the engine compartment of the vehicle. The point of origin was most probably within a cruise control deactivation switch located in the engine compartment; however, this could not be conclusively determined due to the extent of the damage. This type of failure has been observed by Interscience, Inc. personnel in the past. Research also revealed that there had been a number of complaints filed with the National Highway Traffic Safety Administration about similar failures in the past.

The cause of this fire was most likely overheating and short circuiting of the cruise control deactivation switch. No other fire causing malfunction was identified during the examination of the vehicle.

41-72. Views of the engine compartment of the subject vehicle.

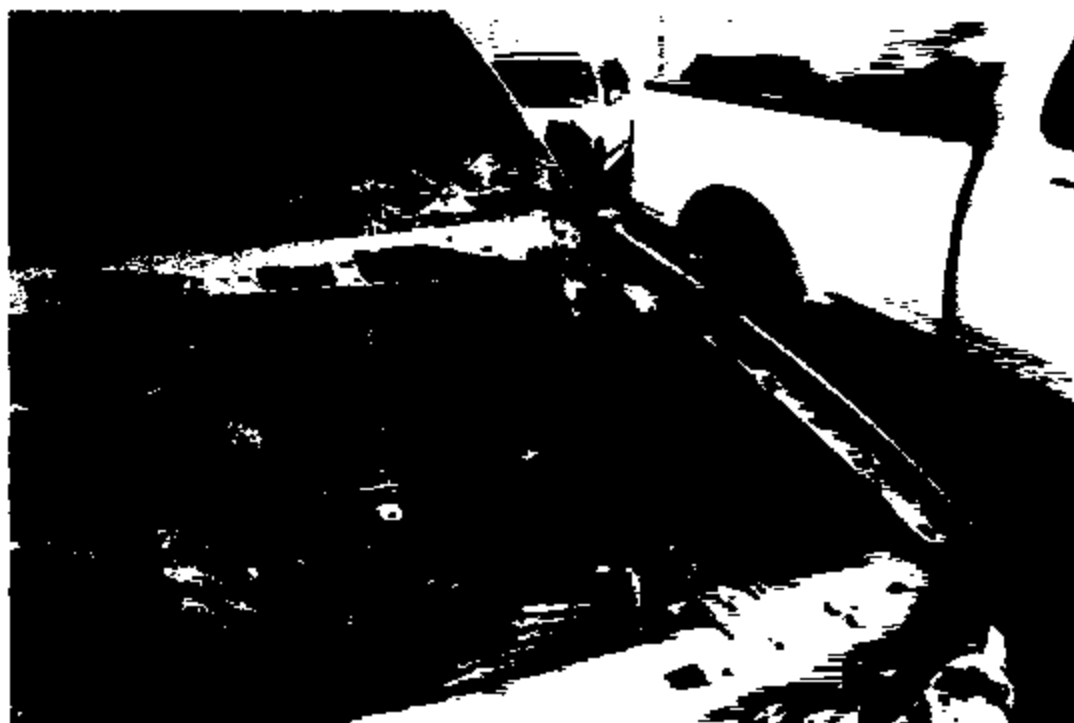
85-91. Views of the remains of the brake master cylinder.
