1996 Ford F150 Pick-up truck adu.

The identified 1996 Ford F150 Pickup is insured by State Farm Mutual Automobile Insurance Company. This vehicle experienced an engine compartment fire.

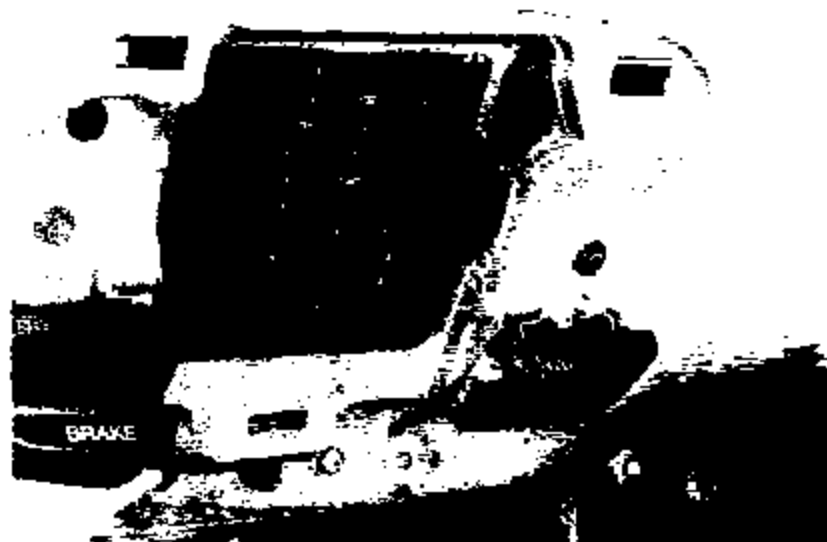
7. Inspection of the passenger compartment fuse/relay center revealed No. 14, a 15-amp fuse, had failed.

18. View showing the passenger compartment fuse/relay center.

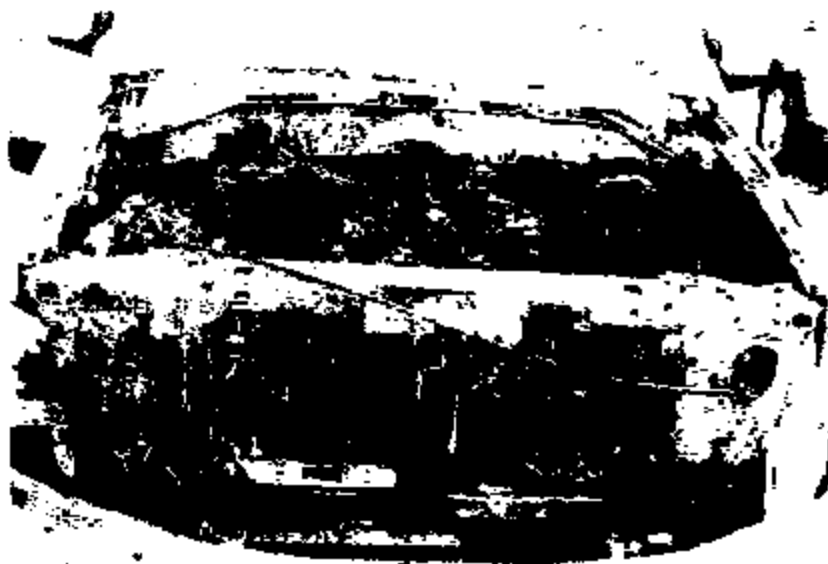
Our inspection of the engine compartment revealed moderate to intense lower to upper level progressive type burn patterns consistent with a fire originating in the left rear

21. Overview of the engine compartment.

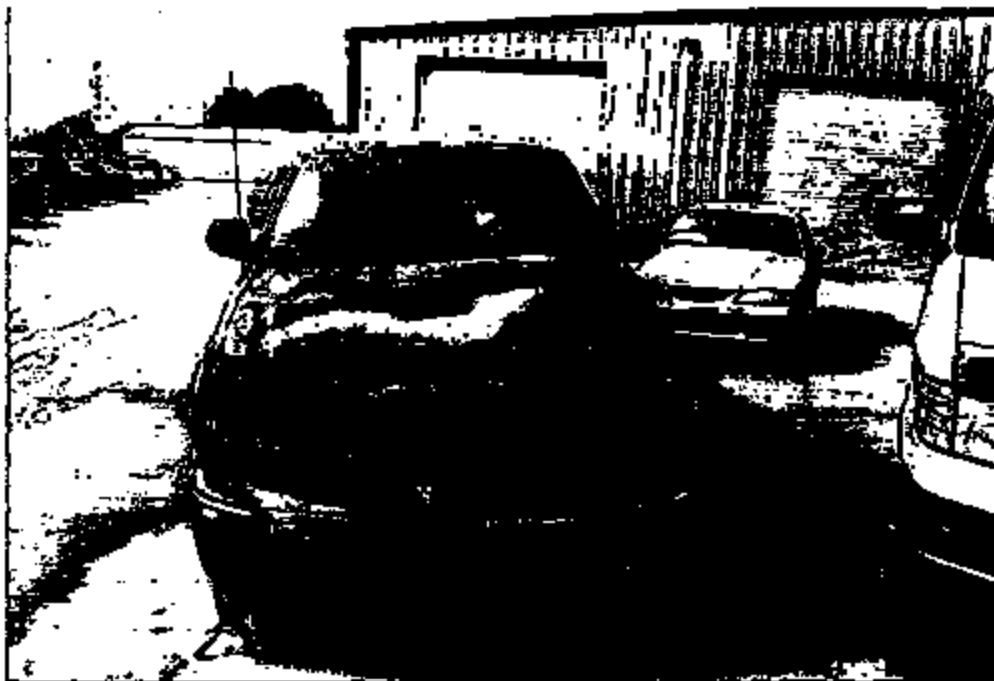
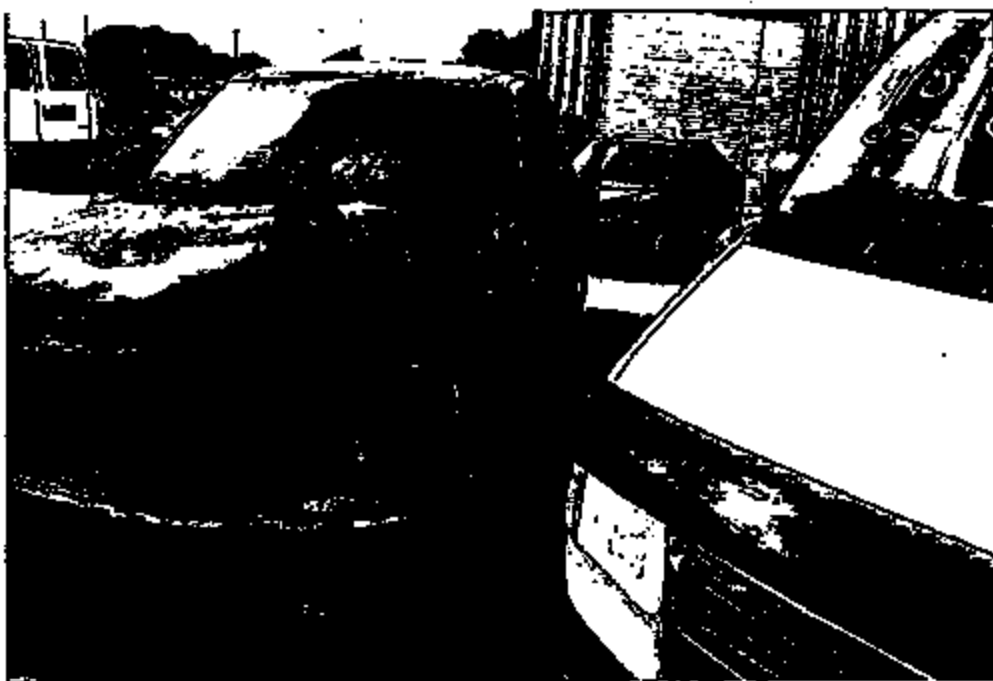
1-8. Exterior views of the subject vehicle.

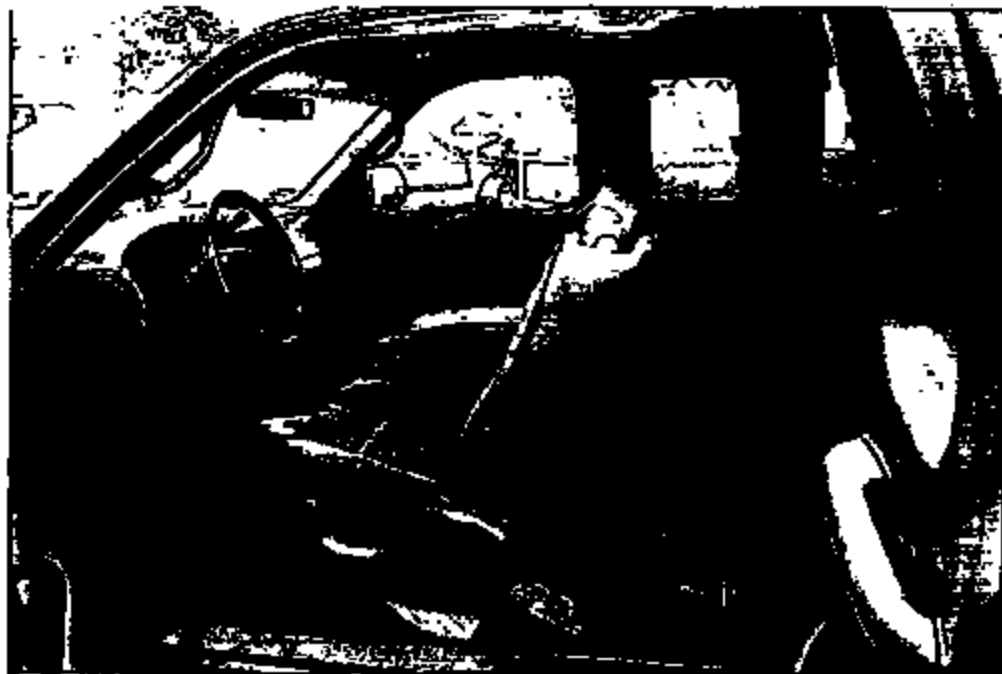
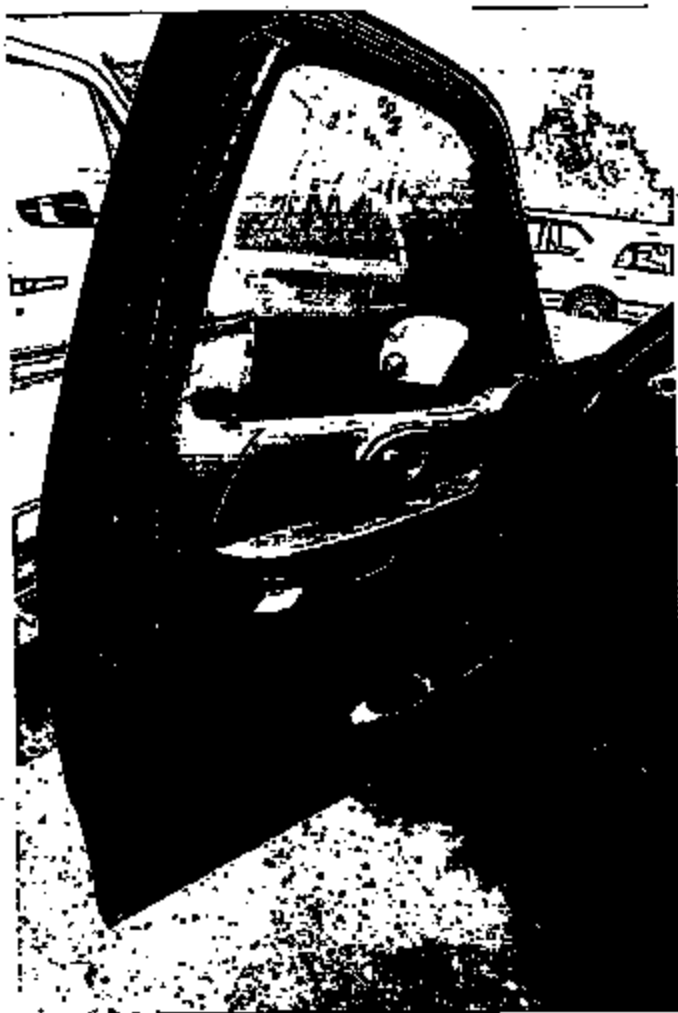
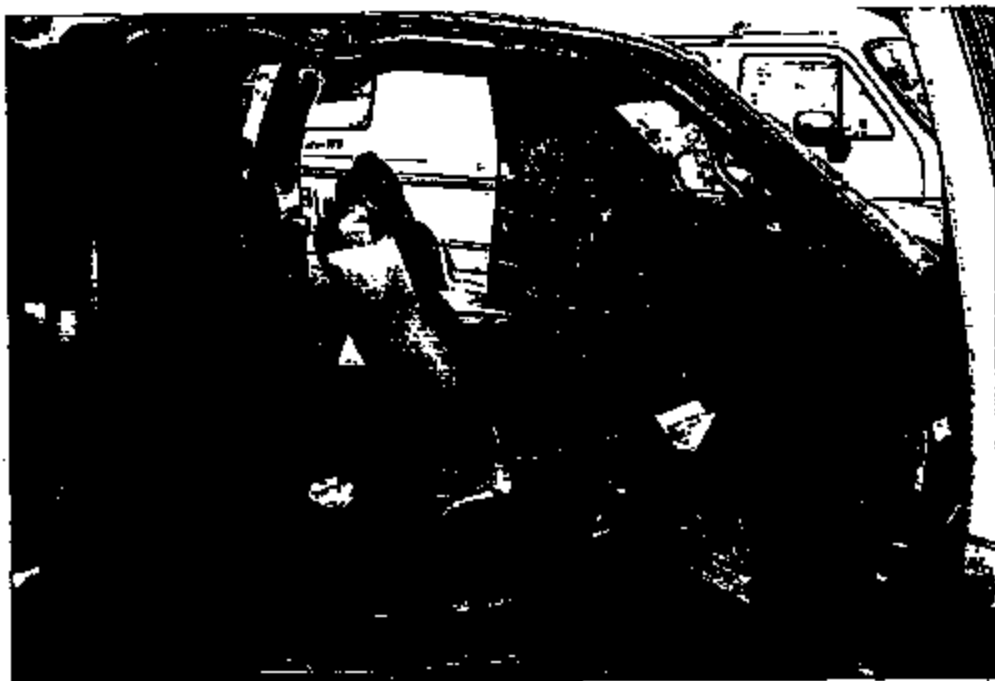
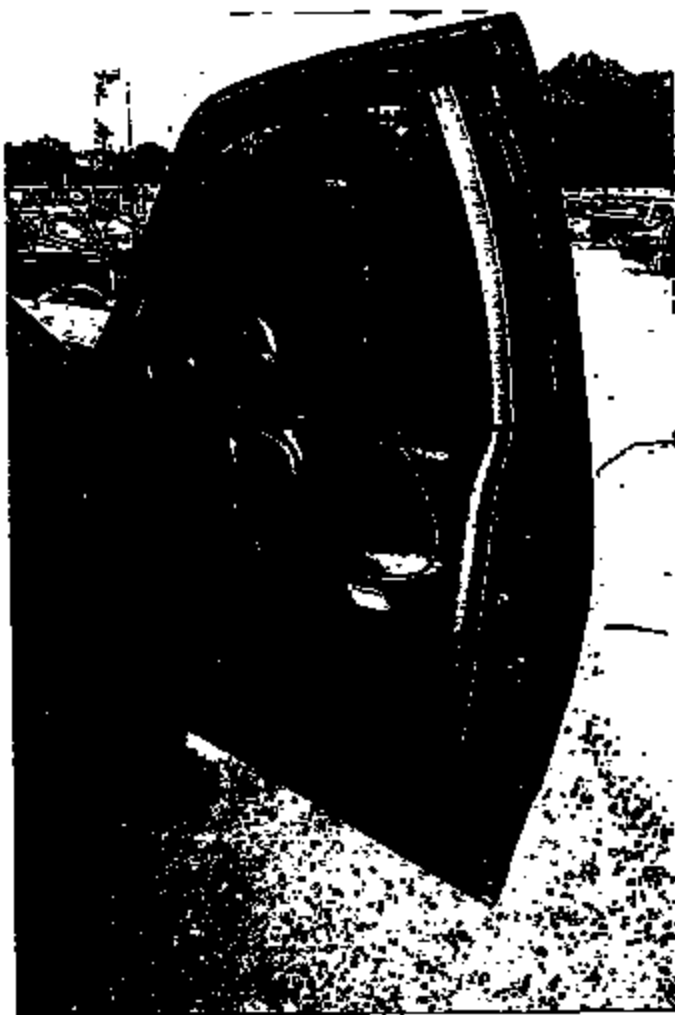
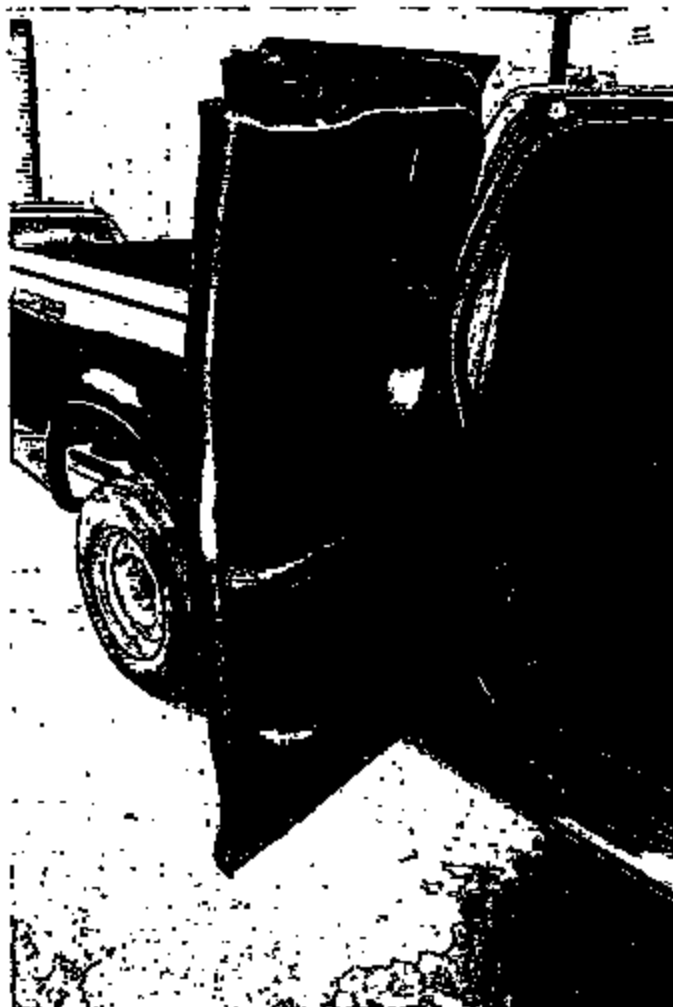
A visual examination of the interior and exterior of the subject vehicle revealed that the windshield of the vehicle on the driver's side had sustained fire damage as a result of radiant heat from the engine compartment. Essentially no fire or smoke damage was observed on the interior of the vehicle. However, there was some fire damage to the interior side of the fire wall below the dash board on the driver's side. This was most likely caused by radiant heat from the engine compartment.

The interior fuse panel was examined and five fuses were observed to have been blown. The fuse diagram was not available for identifying the circuits served by the fuses.

9-15. Interior views of the subject vehicle.

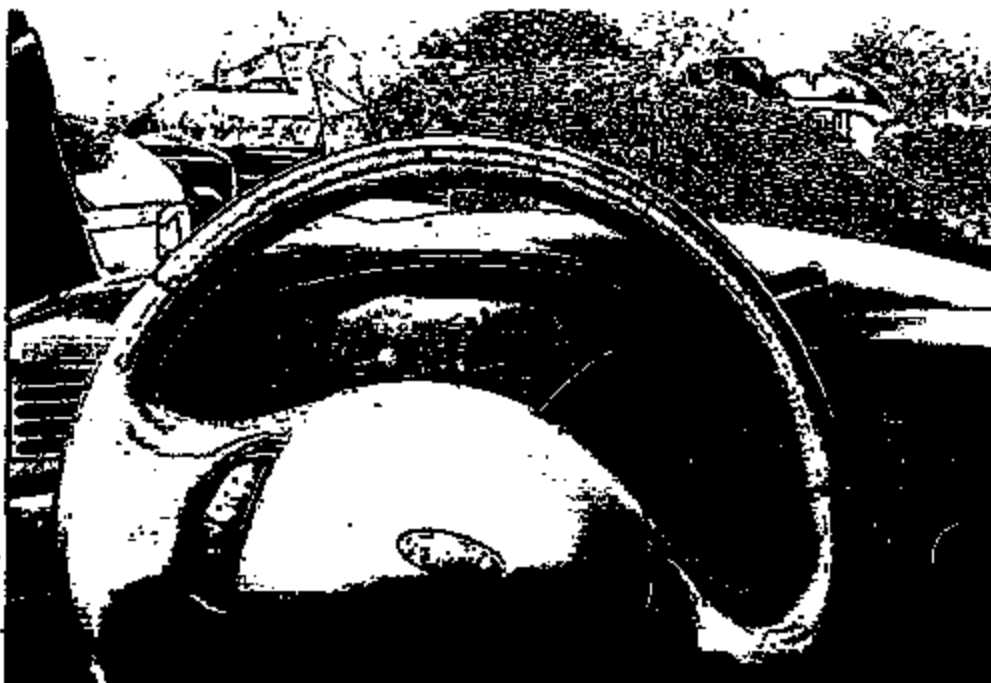
16. A view of the vehicle instrument panel.

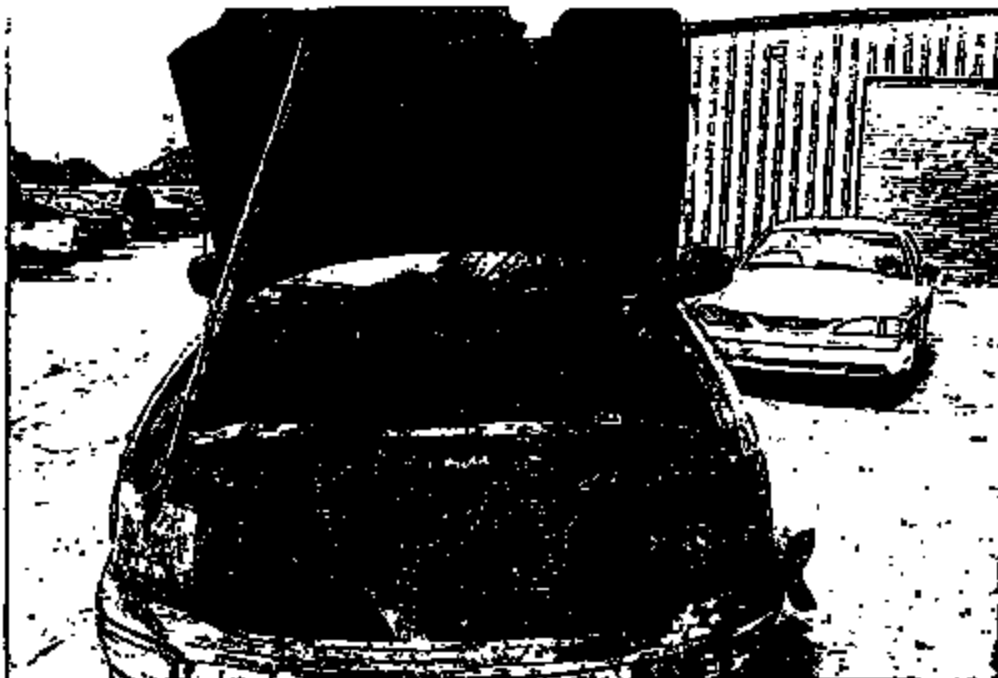
The engine compartment was systematically and thoroughly inspected and photo documented. The area of fire origin was determined to be located within the engine compartment on the driver's side of the vehicle which had sustained significant flame and heat damage. The fire damage was intense and localized on the driver side of the engine compartment. The fire consumed most readily combustible materials in this localized area.

24. Overall view of the engine compartment.

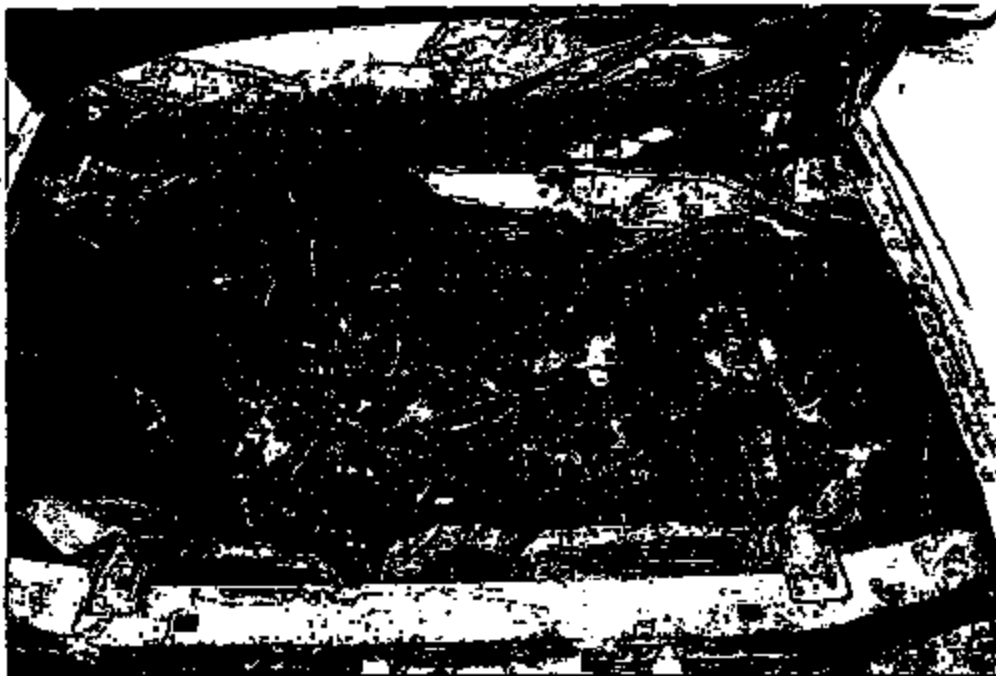
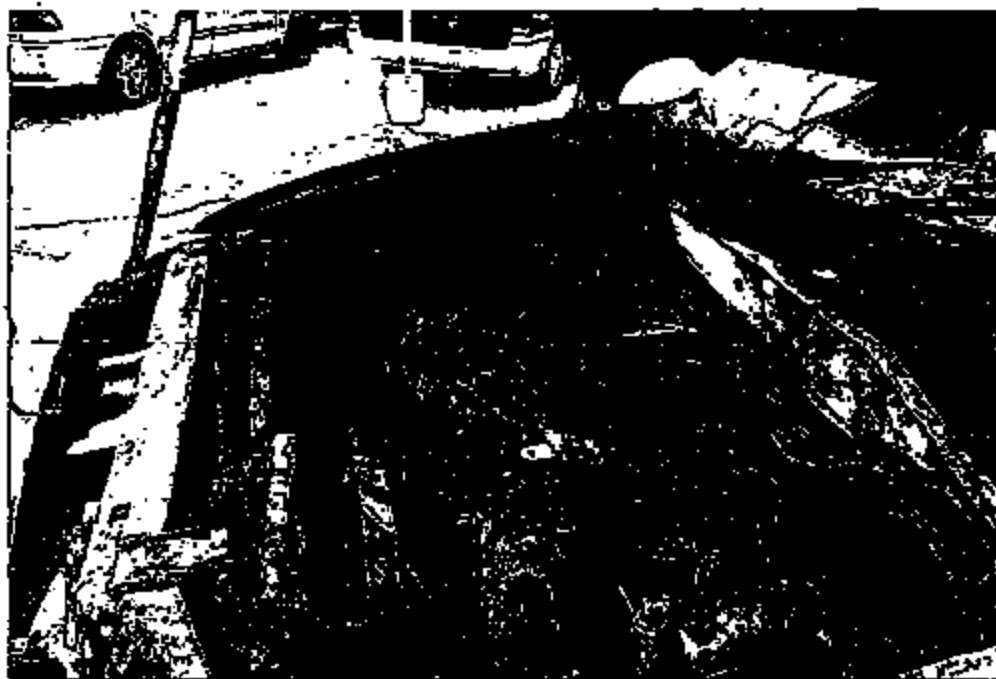
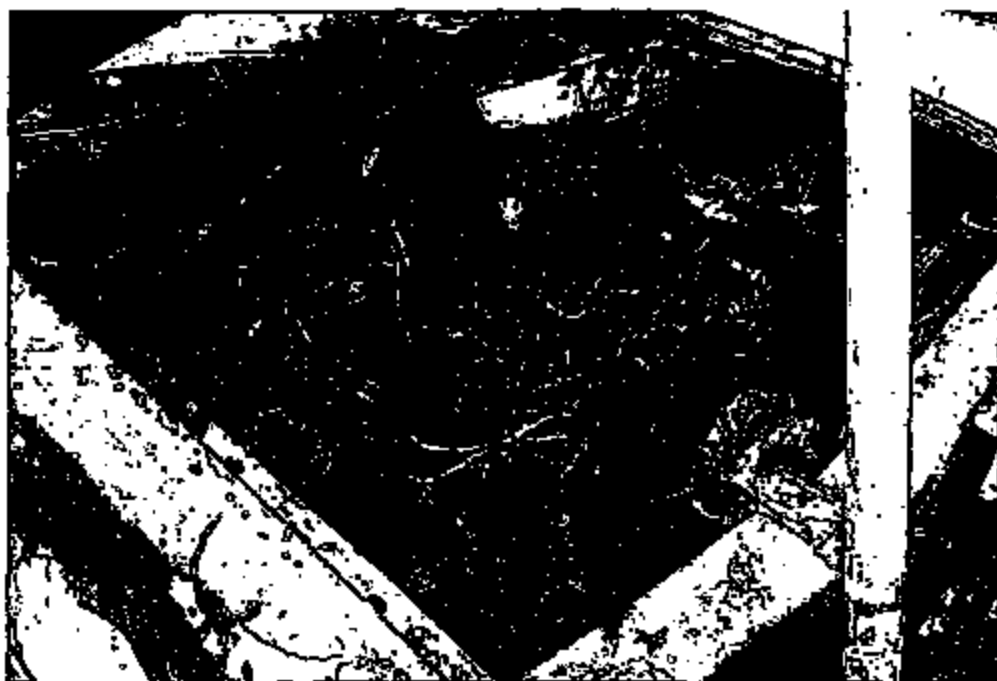
26-28. Views of the engine compartment.

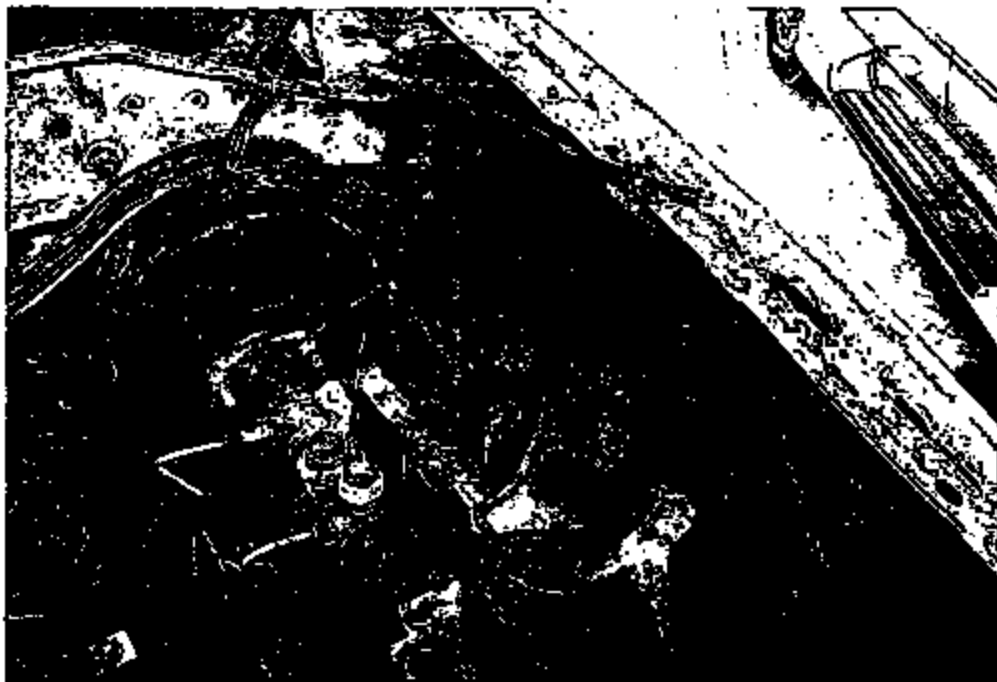
32-33. Views of the engine compartment fuse panel.

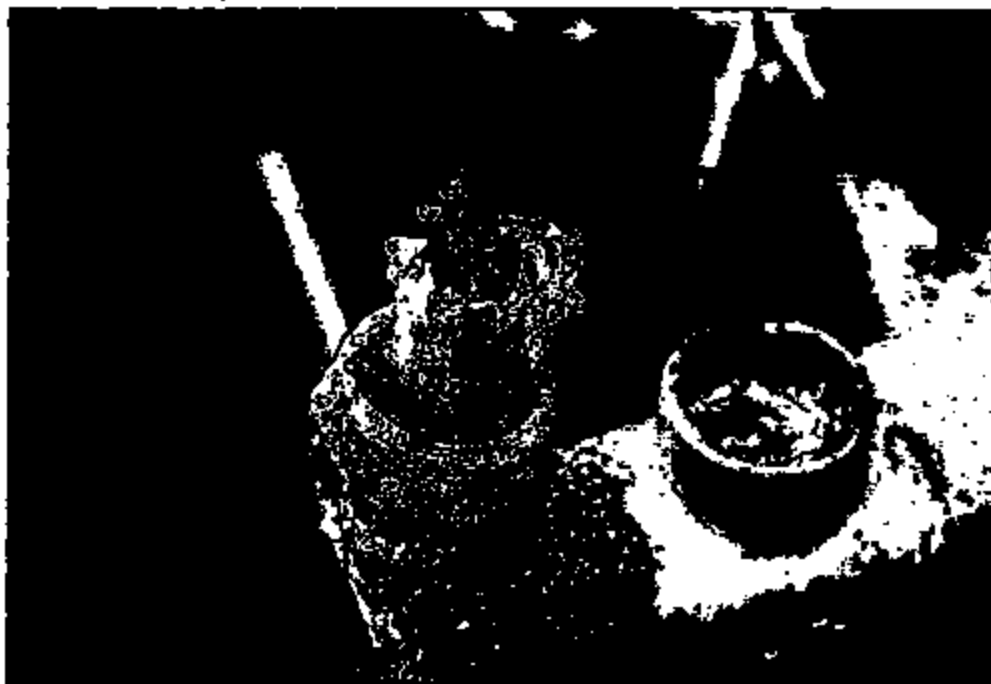
the switch. The X-Ray revealed that the interior of the switch had electrical arcing. This arcing was a failure within the switch. This switch was located on the brake master cylinder on the driver's side of the engine compartment.

The cause of this fire was most likely overheating and short circuiting of the cruise control deactivation switch. No other fire-causing malfunction was identified during the examination of the vehicle.

44-51. Views of the electrical connectors located at the top of the deactivation switch on the master cylinder.

We recommend that the 2001 Ford F150 Lariat vehicle be retained, secured and protected regarding any further testing or inspection by other interested parties. We also reserve the right to be present and observe any and all inspections or testing of the Ford vehicle by any other concerned parties.
