**FARMERS**

Baltimore Subrogation Center of Excellence

Re: Our Claim #: [REDACTED]  
Our Insured:  
Date of loss:  
VIN:

We are the insurance carriers for Bruce Luster. On January 6, 2001, [REDACTED] 1998 Ford XL 150 Pick-Up was damaged by a fire. An independent C&O report requested by Farmers Insurance Group concluded the fire was the result of a mechanical failure in the fuel system. (See attached report). We are now making a subrogation claim against Ford as the manufacturer of the truck. Please review the enclosed materials and advise of your decision on liability at your earliest convenience.

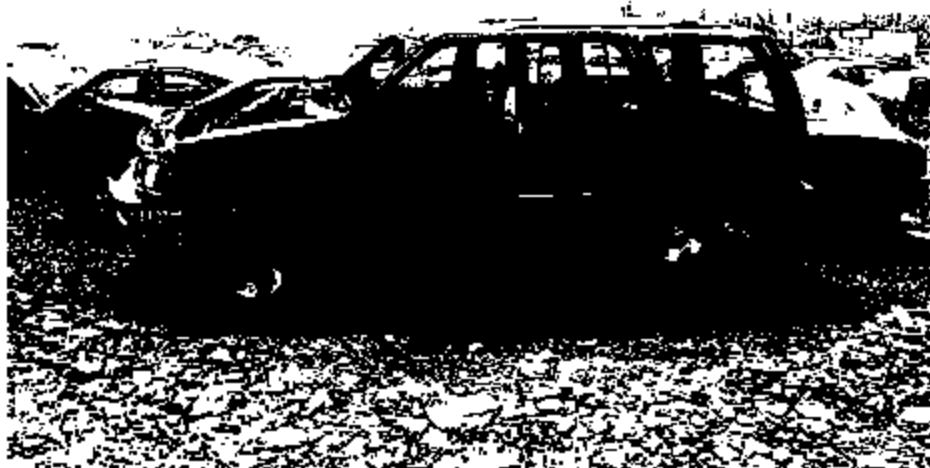
1. Overall view of the left side of the vehicle.

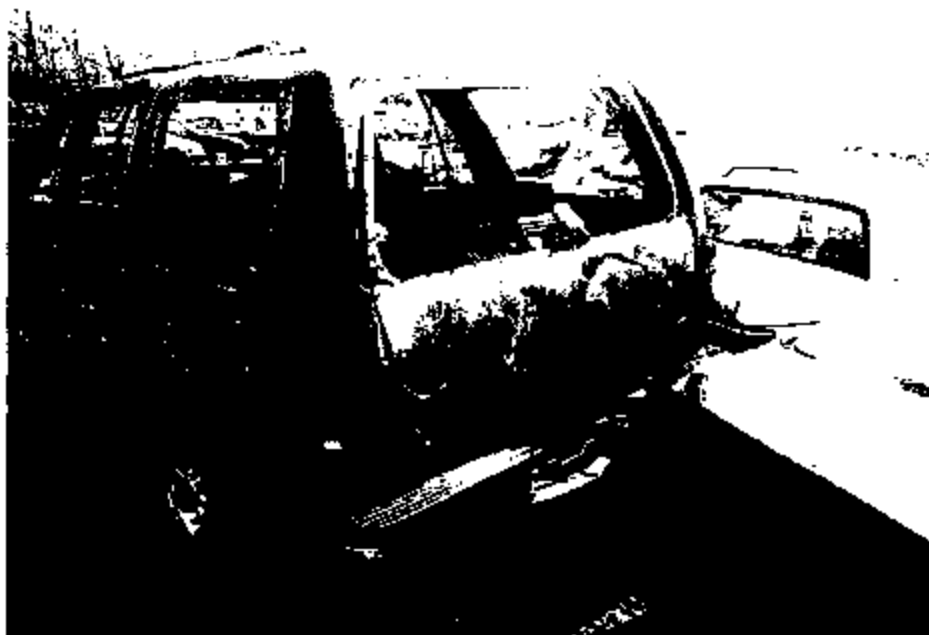
5. Overall view of the fire patterns on the rear of the vehicle.

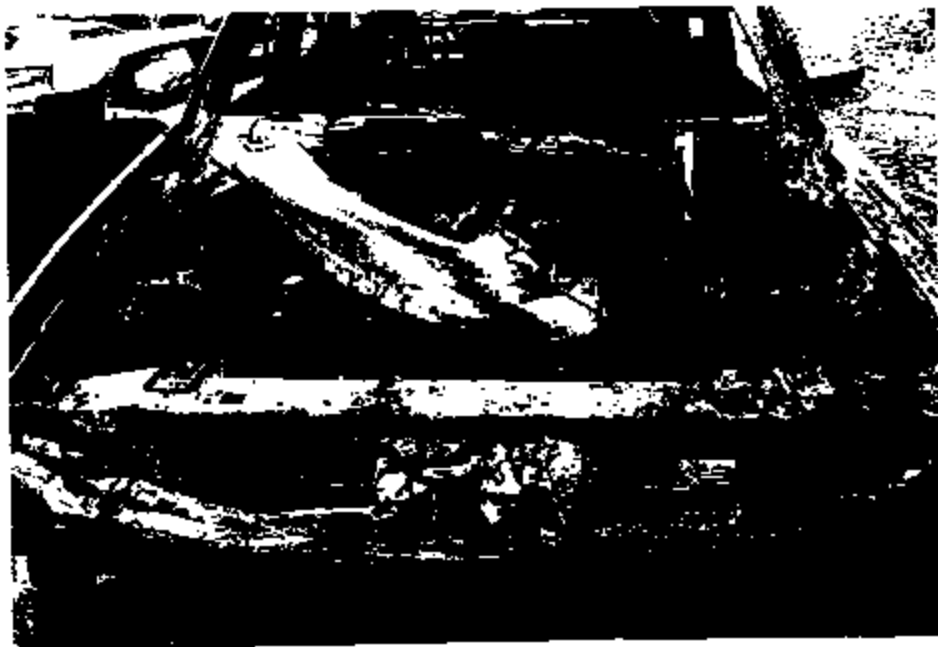
16. Closer view of the engine compartment. Note the piece of aluminum hood that remains.

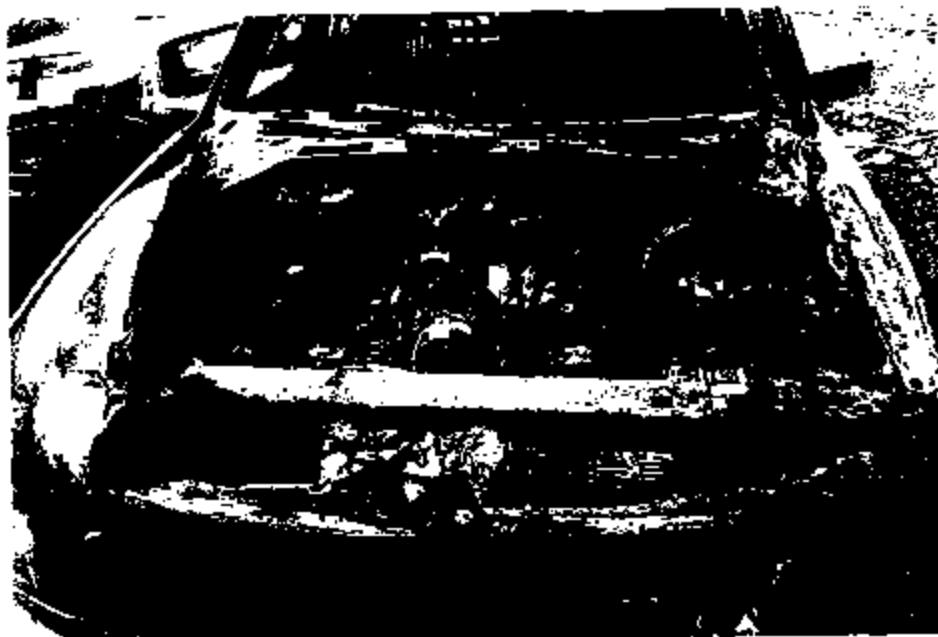
17. View after replacing the piece of aluminum hood to it's original position as indicated by the arrow.

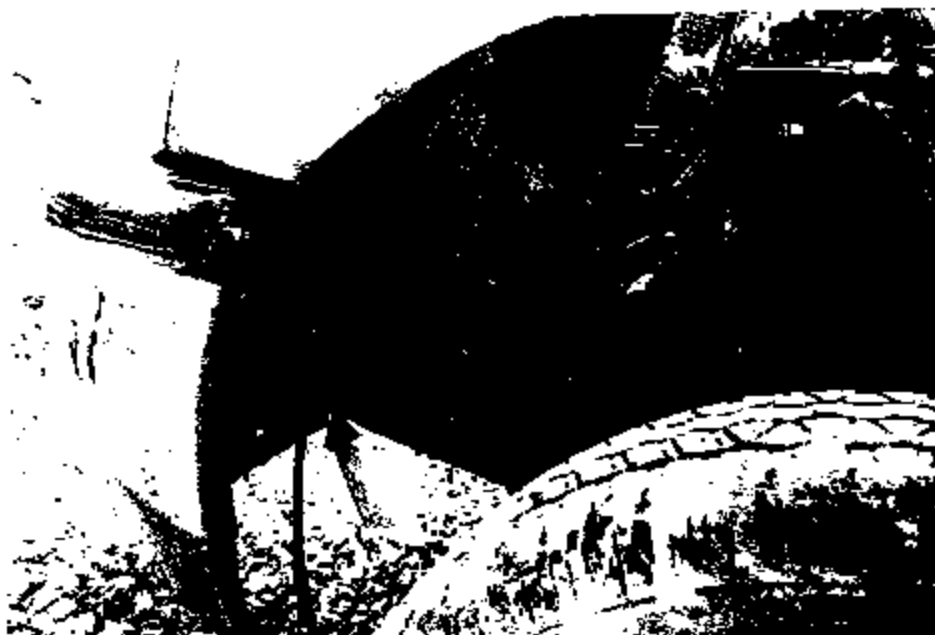
21. Another view looking towards the front in the left wheel well. Note the oil filter is still intact.

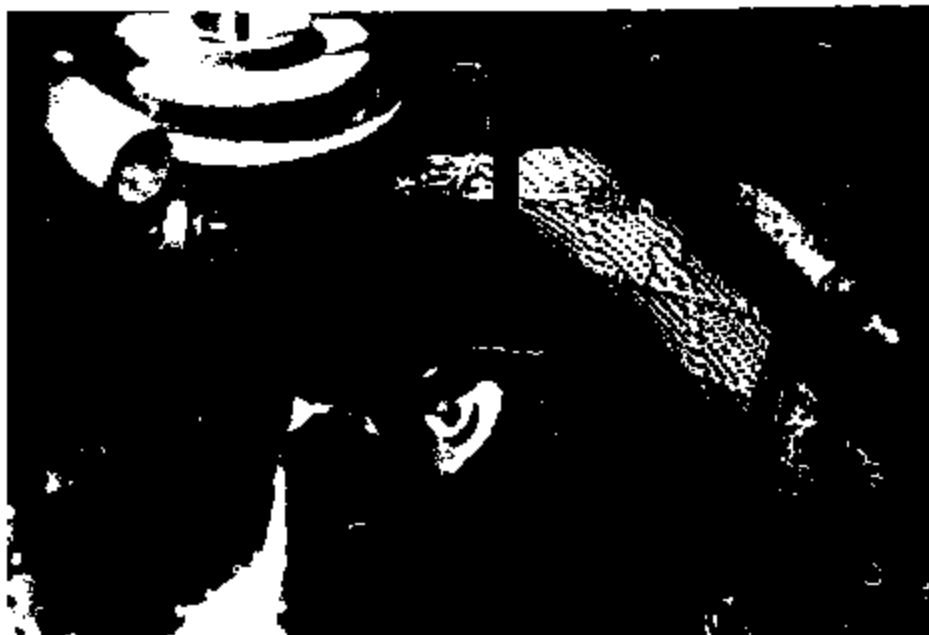
25. Close up view of the fuel lines entering the left rear of the engine compartment indicated by the arrow.

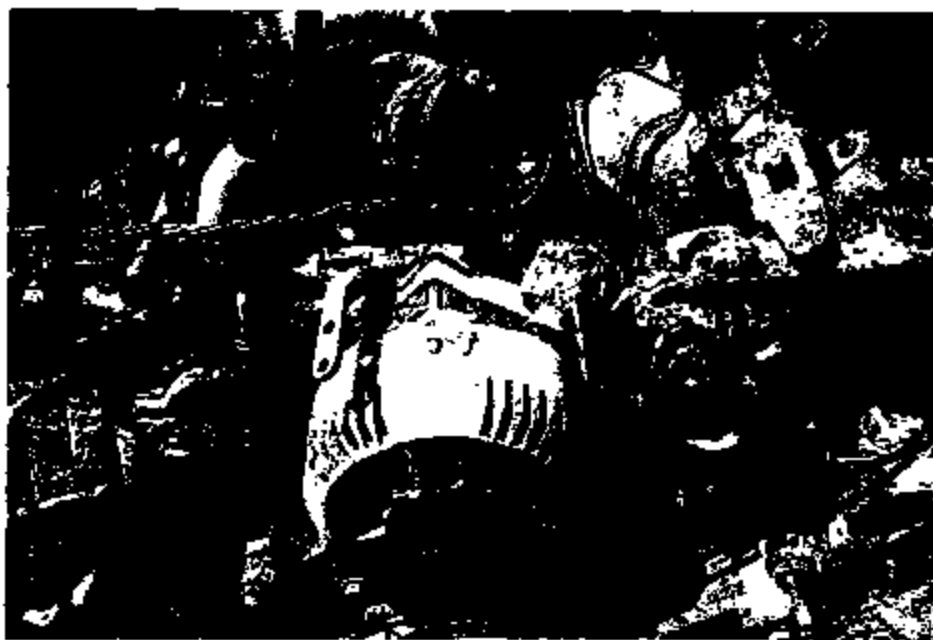
30. Close up view of the battery cable connected to the alternator indicated by the arrow.

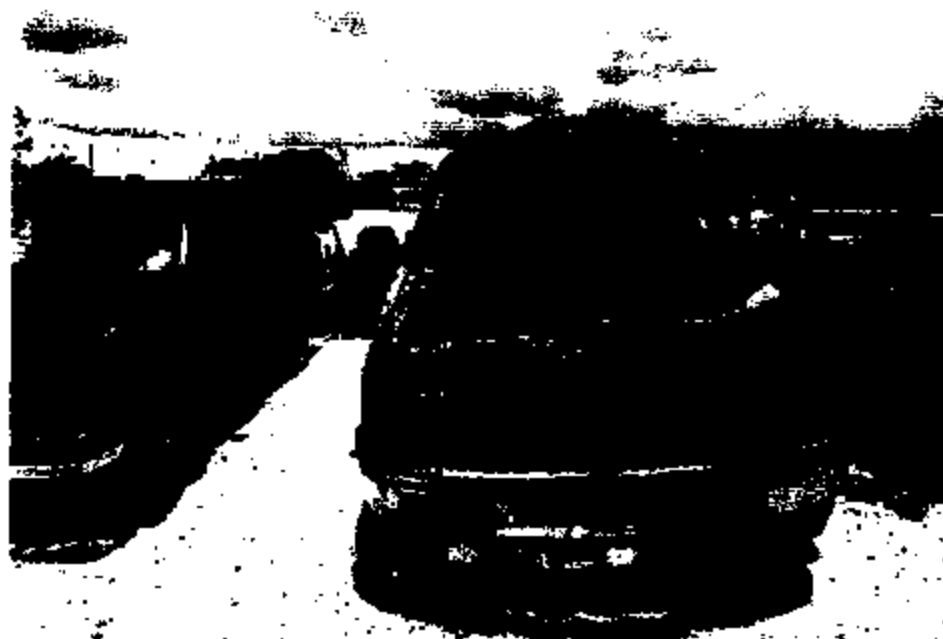
Photo No. 1-5

Comments: Show the exterior of the vehicle looking at all four sides. The heat, and fire patterns indicate the fire originated inside the engine compartment on the passenger side.

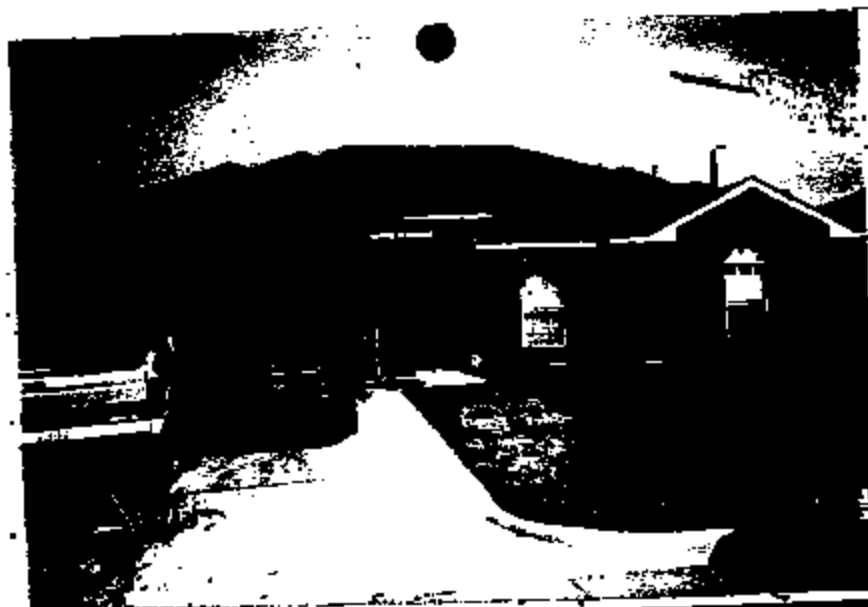
Photo No. 1

*Back*

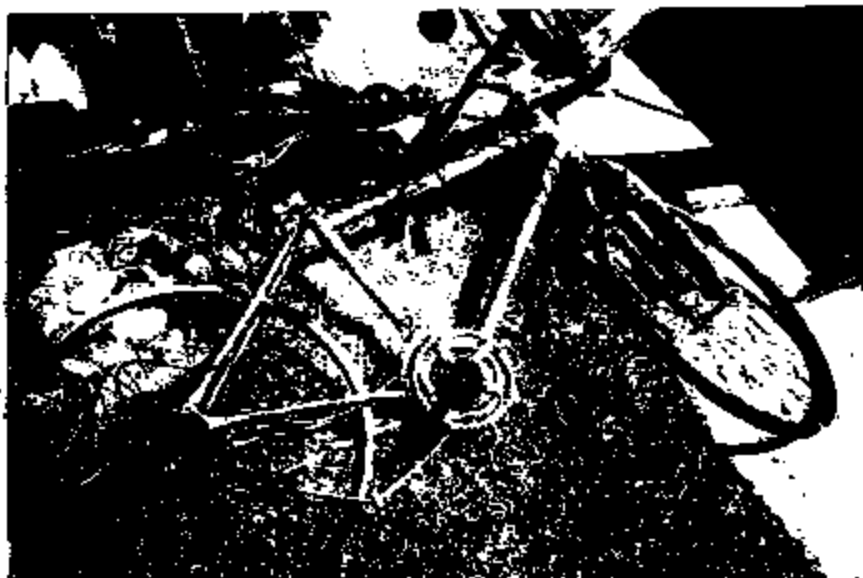
Photo No. 4

*Bike, minor damage*

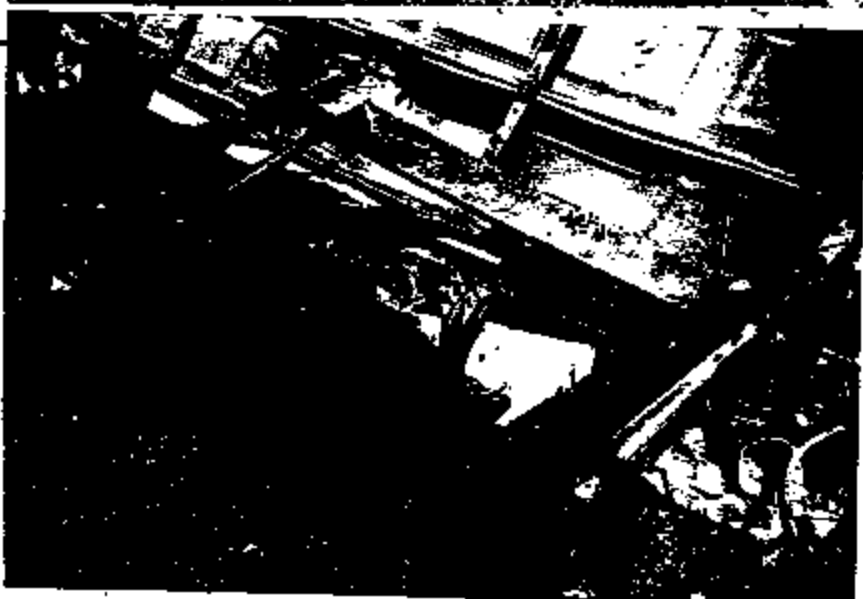
Photo No. 5

*Bed headboard &  
footboard &  
golf clubs found*

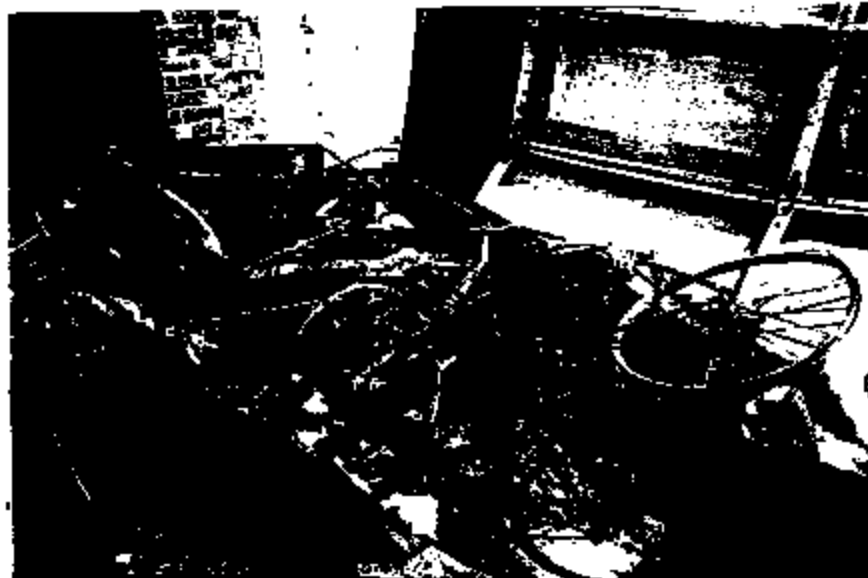
Photo No. 7

*Grange constants  
burned*

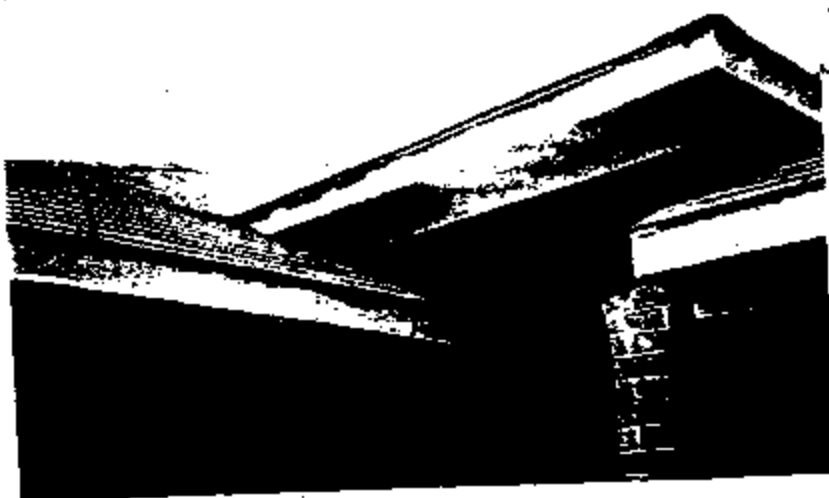
Photo No. 12  
 Location/View  
*Front soffit & fascia  
 smoked & burned*  
 Date 9/11/00  
 By  
 REAS GUNTER

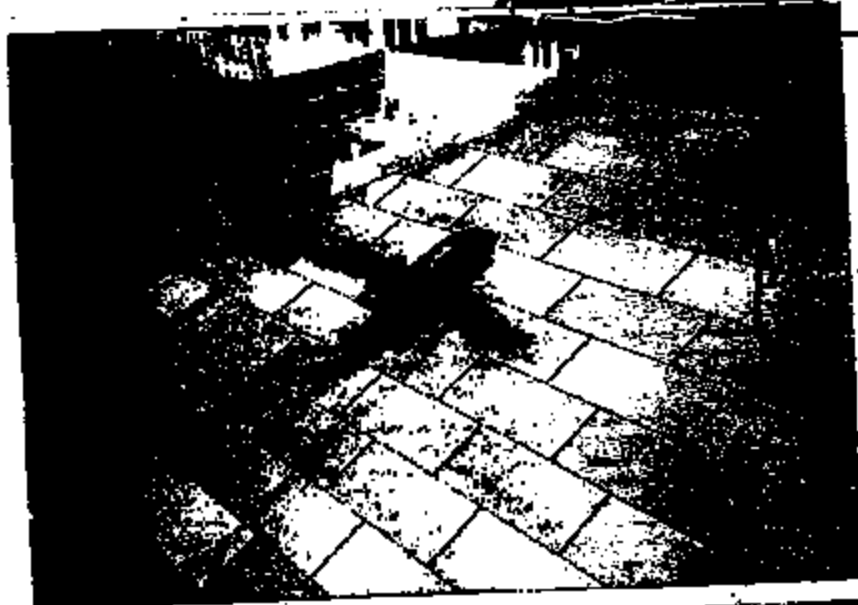
Photo No. 17

Front slope back  
matted

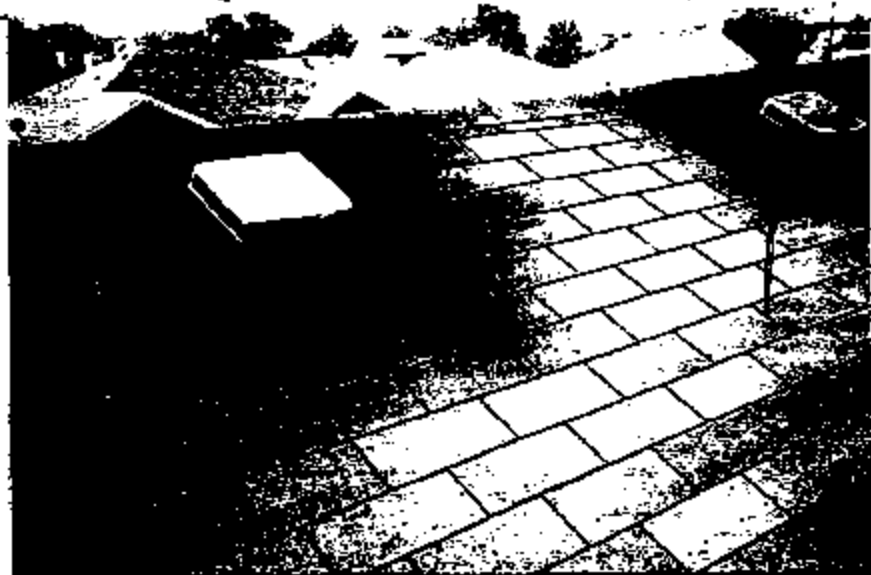
Photo No. 20

Back slope - mostly  
barren & shrubby

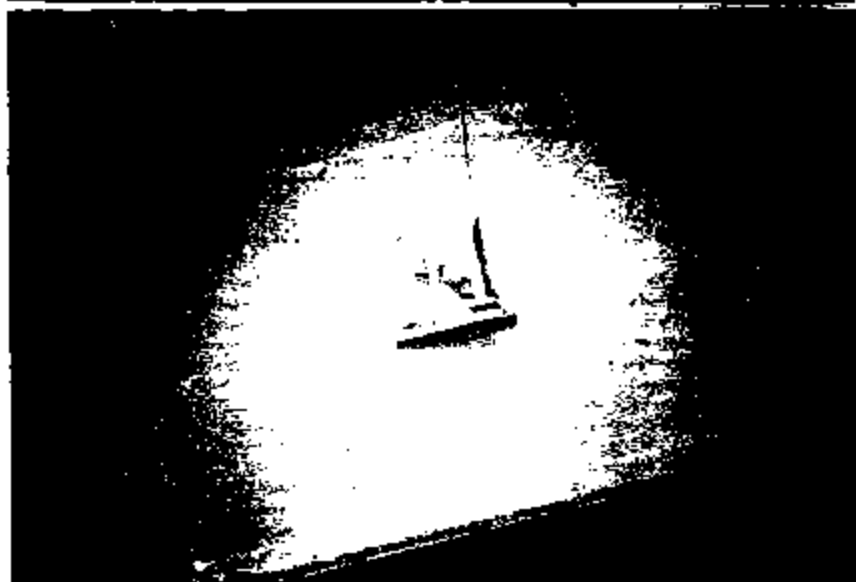
Photo No. 23

Front porch

ceiling removed

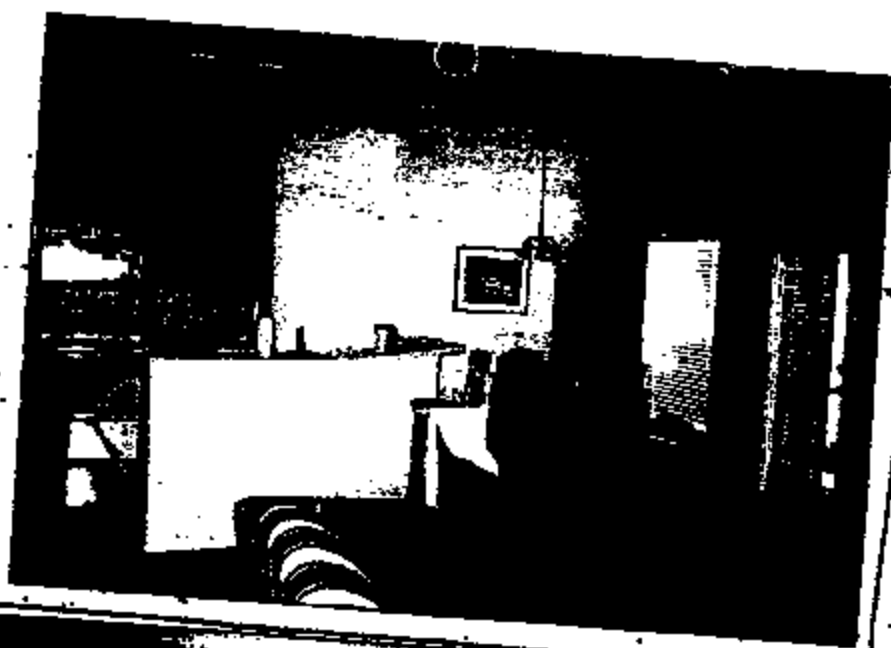
Photo No. 37

Li Brit Kitchen  
 Area Area

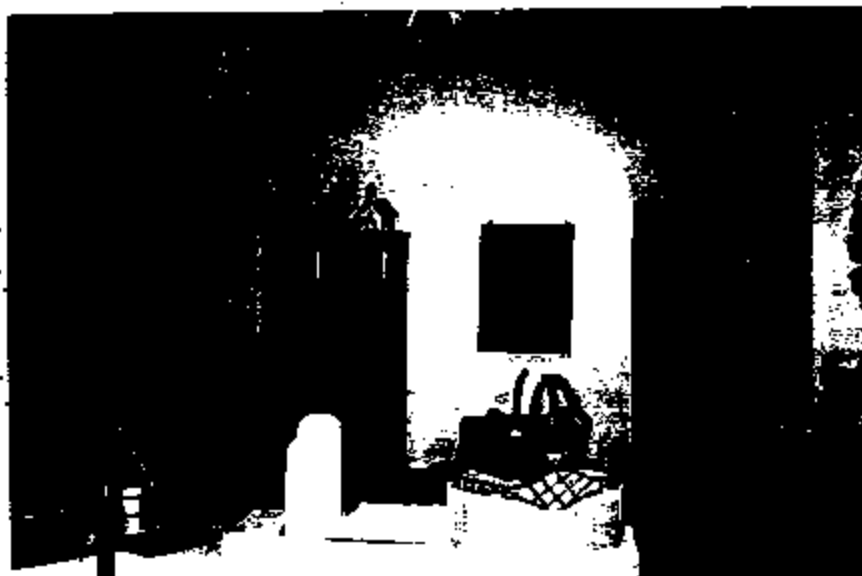
Photo No. 90

Lin. in view from  
Litch

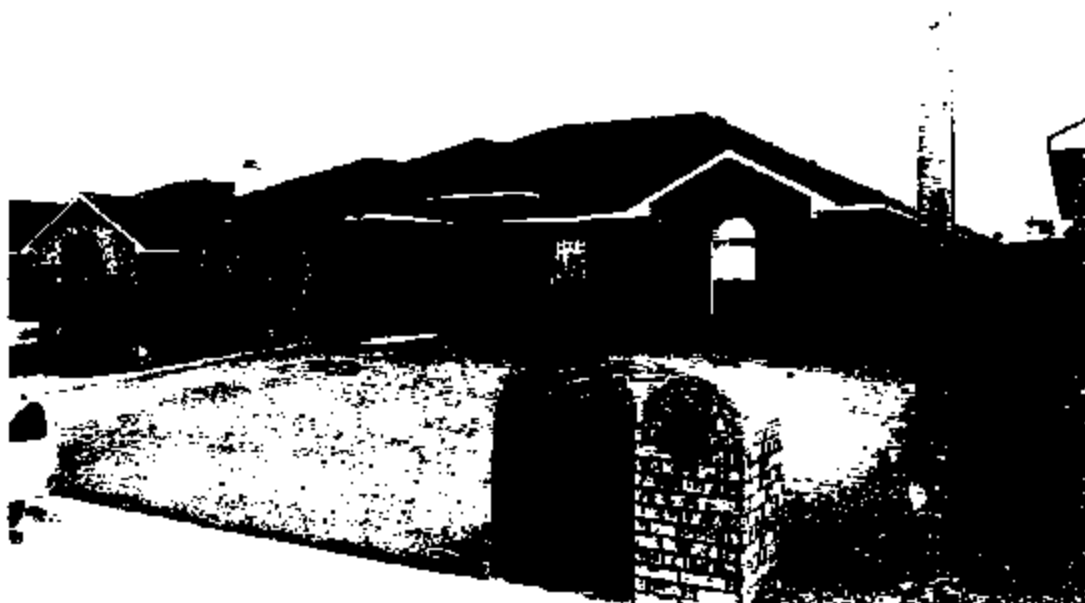
#3

**PHOTO #3:** Shows an exterior view of the southeast portion of the structure.

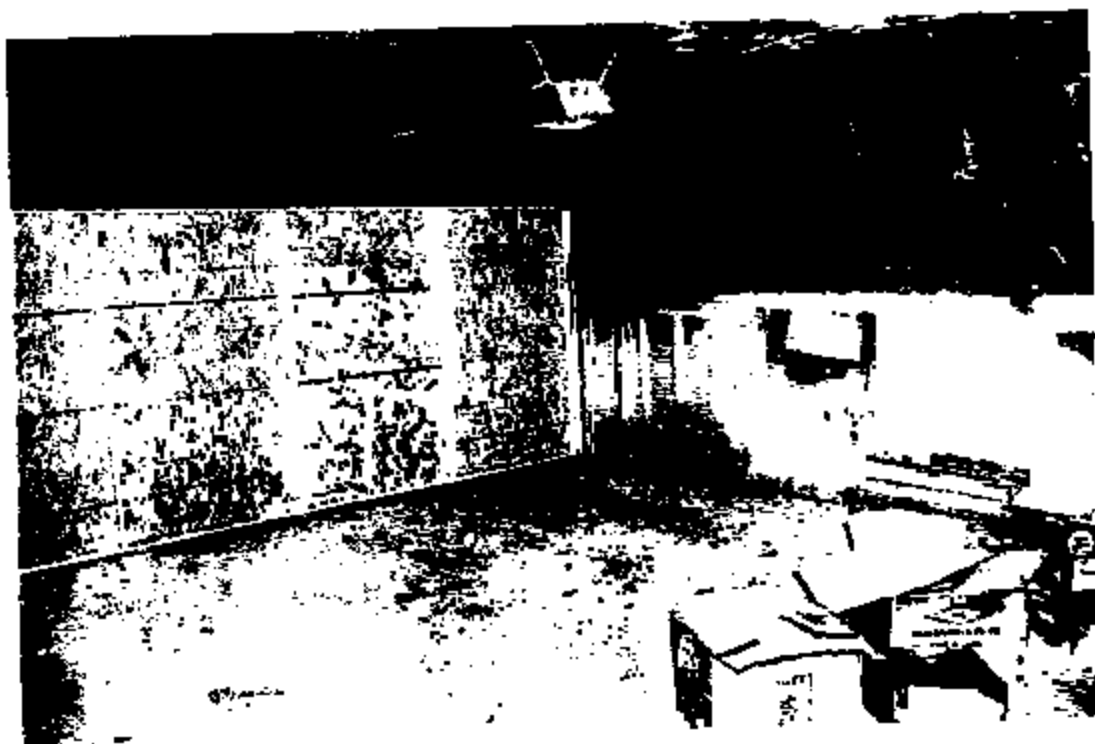
#8

**PHOTO #8:** Shows a view of the southwest portion of the garage taken from the entryway from the foyer.
