FILE # 430-281183
INSURED [REDACTED]
VEHICLE 1998 Ford F150
VIN 2FTZX1SW5WC [REDACTED]
ODOMETER Unknown - burned
DATE OF LOSS October 24, 2002

Examine the Ford F150 and determine the origin and cause of the fire. Determine the mechanical and cosmetic condition of the vehicle at the time of the loss.

IN RE: Allstate Claim No. [REDACTED]
H&A File No. 04-0883VF
Date Received: May 14, 2004
[REDACTED]

ORIGIN AND CAUSE INVESTIGATION:

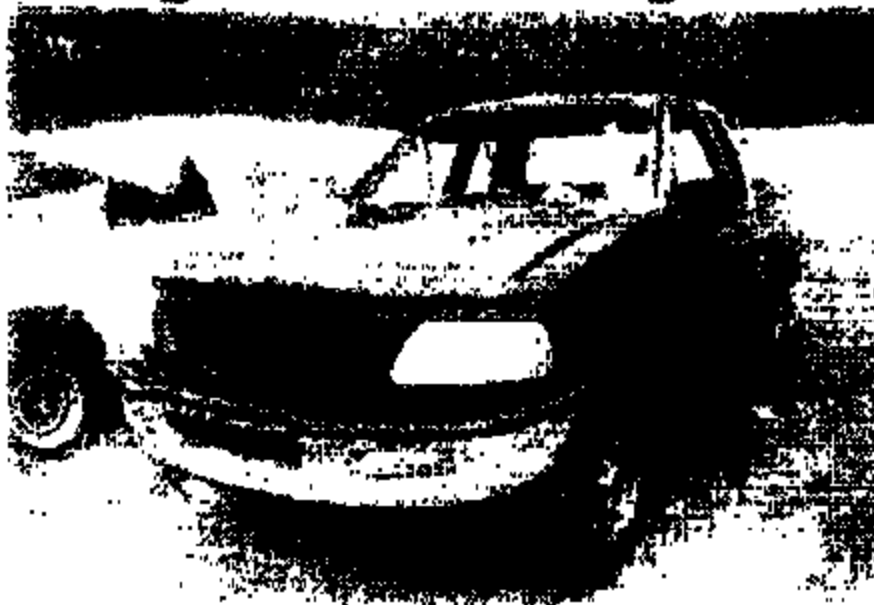
Photograph 1

Left front view of the 1965 Ford F-100 pickup. It appeared to have the original factory painted finish.

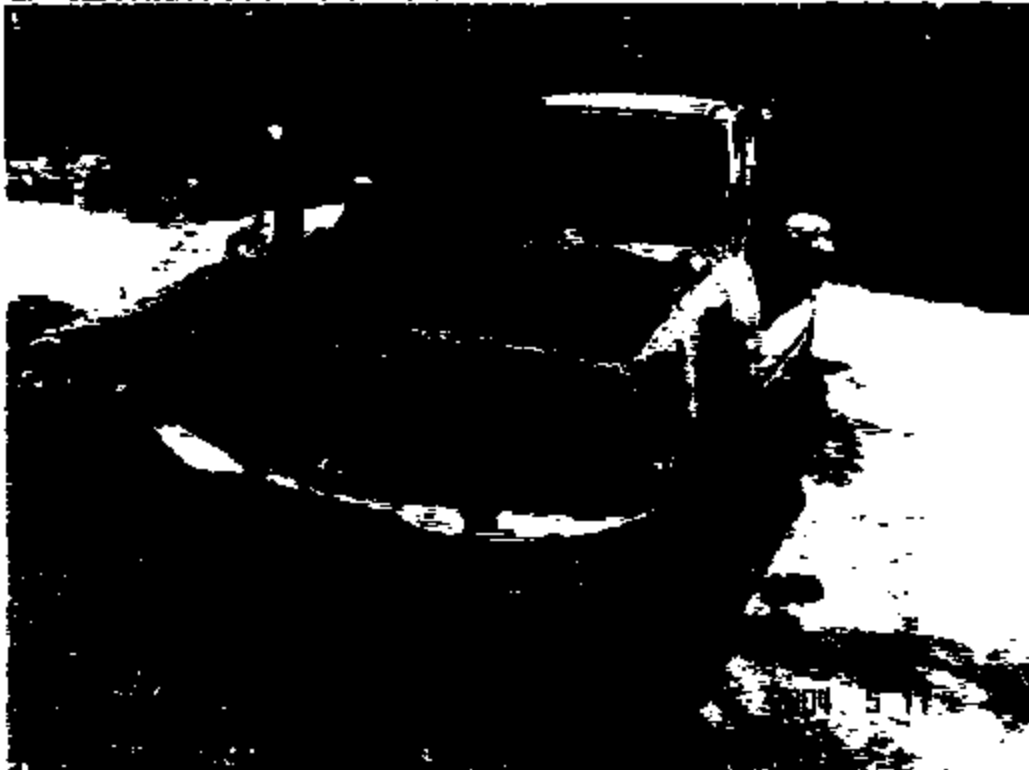
2. An overall view of the left front.

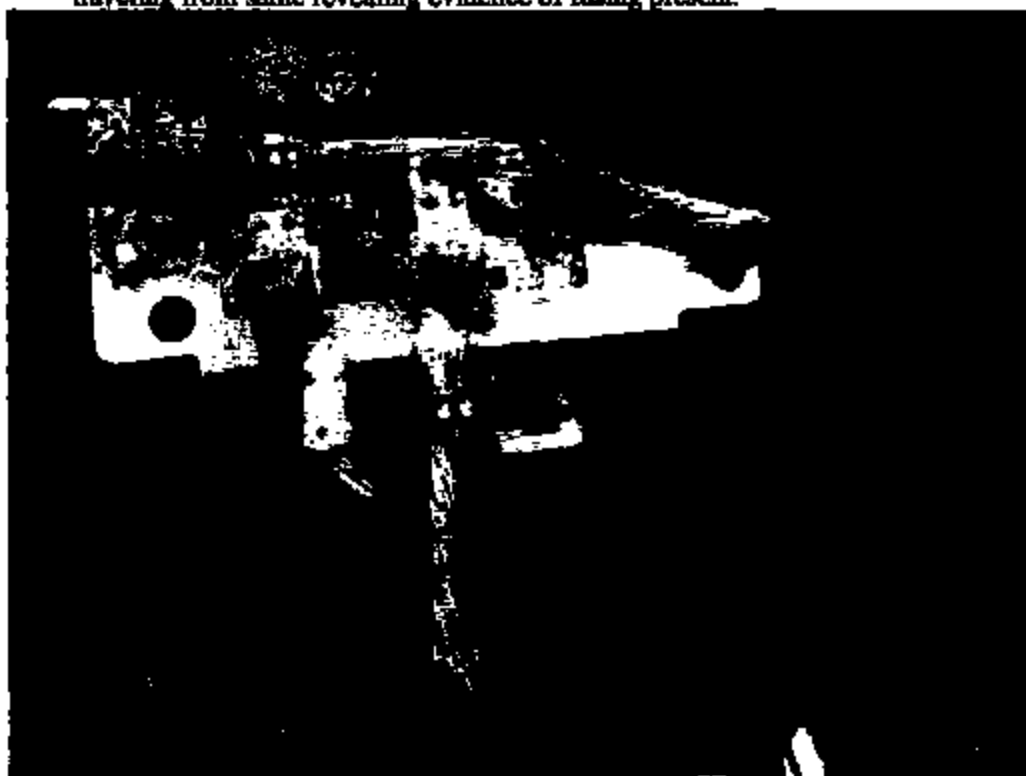
37. A close-up view of the lug and remains of the cable, which traveled from the positive battery terminal to the cylinder with evidence of fusing present.

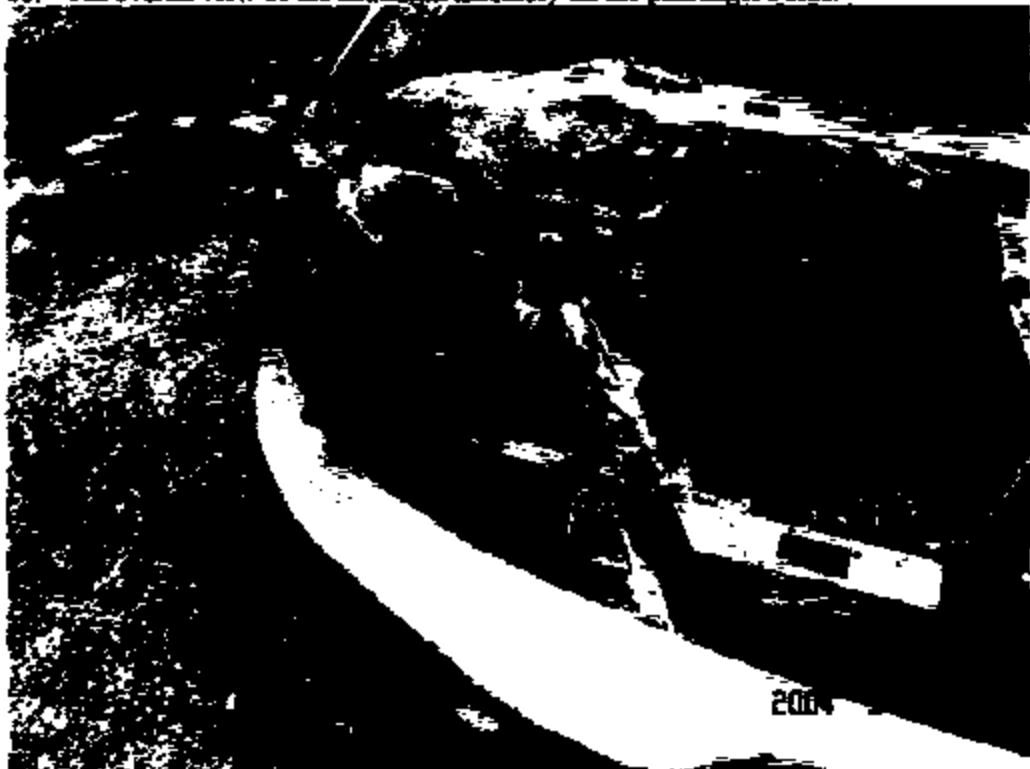
17. An overall view of the engine compartment from the passenger's side.

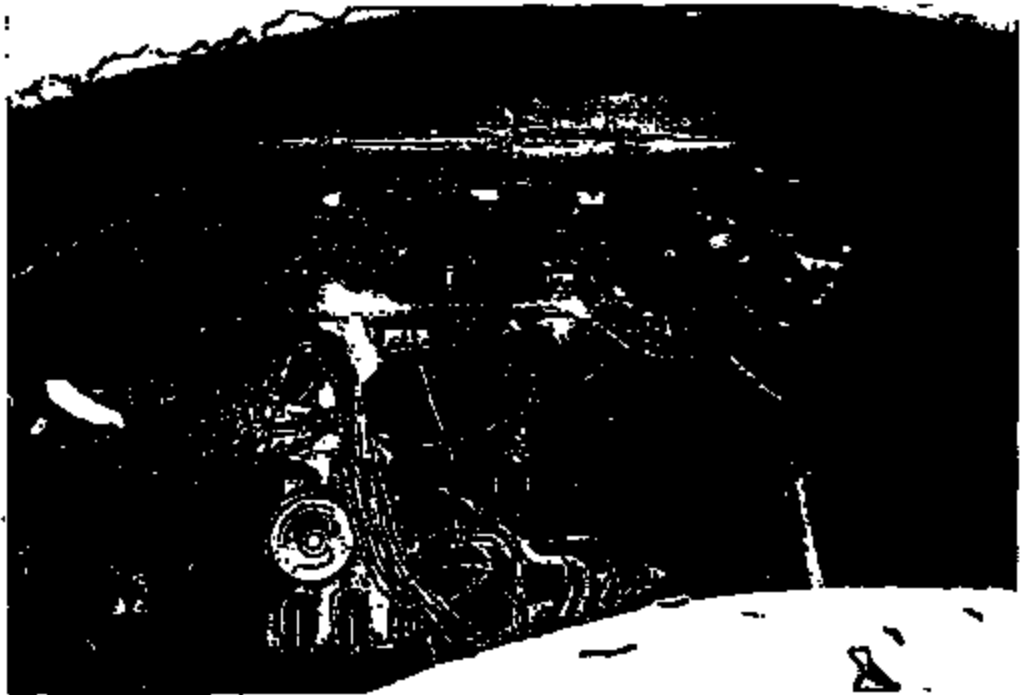
34-36. Views of the fire damage through the driver side wheel well.

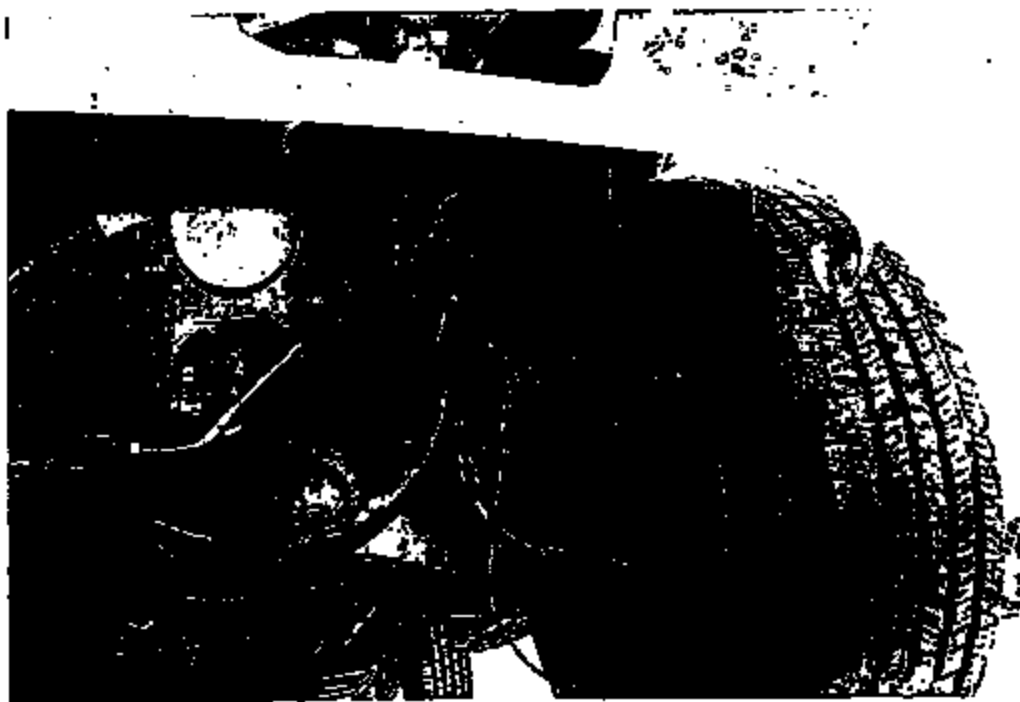
39-42. Views of the engine compartment from below the vehicle.

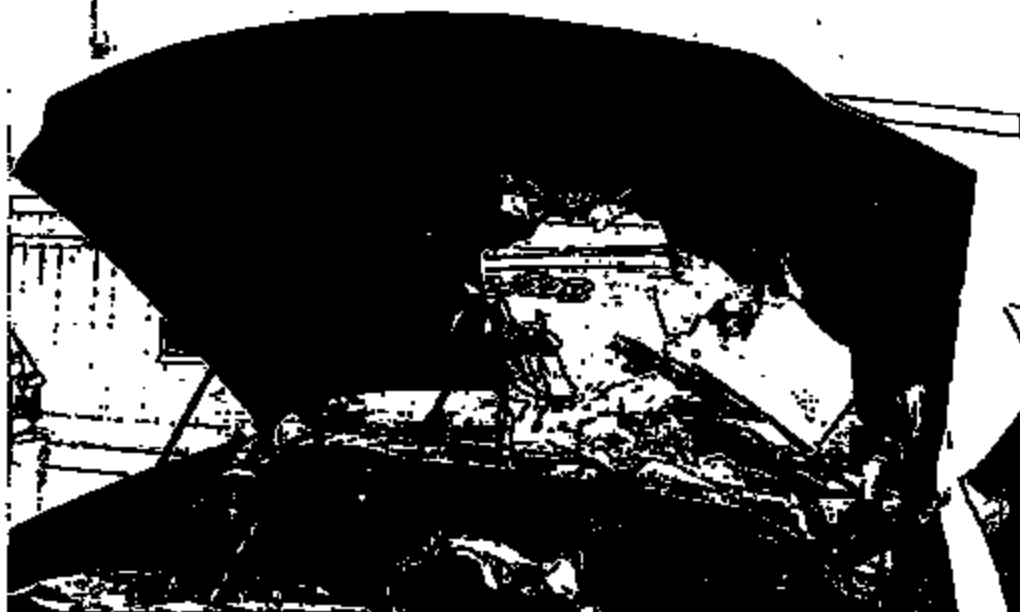
The hood of the engine compartment had a hole located on the driver's side of the vehicle. This was caused by the subject fire which had melted the metal of the vehicles hood. The wind shield of the vehicle on the driver's side had sustained fire damage as a result of radiant heat from the engine compartment.

43. View of the under side of the hood.

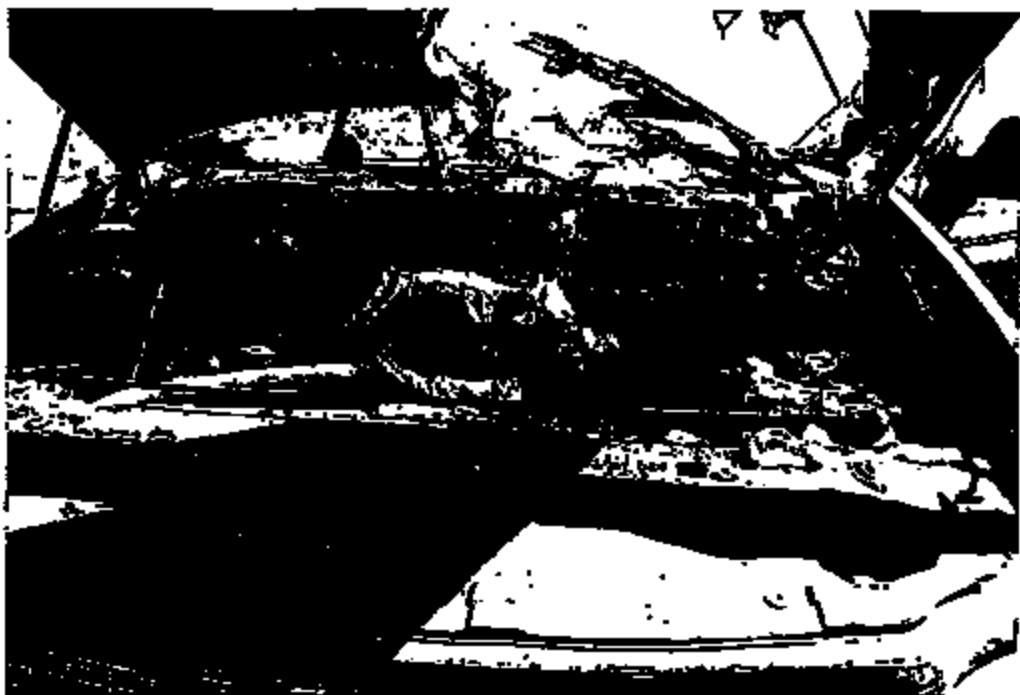
The engine compartment was systematically and thoroughly inspected and photo documented. The area of fire origin was determined to be located within the engine compartment on the driver's side of the vehicle. Evidence remaining indicated that the cause of the fire was most probably electrical in nature. After all debris was inspected in place in an effort to identify any fire causing item or items, suspect electrical components were collected. A preliminary examination of some of these components was conducted on site. These same components were retained for further examination.

44-47. Views of the fire damage within the engine compartment.
