PROPERTY INVOLVED:

1995 Ford F150 pickup truck, color black, VIN# 1FTDF15Y05 [REDACTED] This vehicle was equipped with a 4.9 liter 6 cylinder engine, 5 speed manual transmission, and air conditioning. There was no impact damage noted regarding this vehicle. Mileage at the time of loss could not be verified, due to the fire damage and destruction of the dash and instrument panel. The owner insured indicated an estimated mileage of 73,000, and this may be verified through service records at Marshall Ford in Chattanooga, Tennessee. There was no indication that this vehicle had been altered from original factory manufactured specifications, and no installations of after market electrical items were noted. The steering column and the ignition cylinder had not been breached. Tires were Trail Blazer ATP235-75R15 and were in good condition. This vehicle displayed Tennessee tag [REDACTED] registered in Hamilton County.

VEHICLE EXAMINATION:

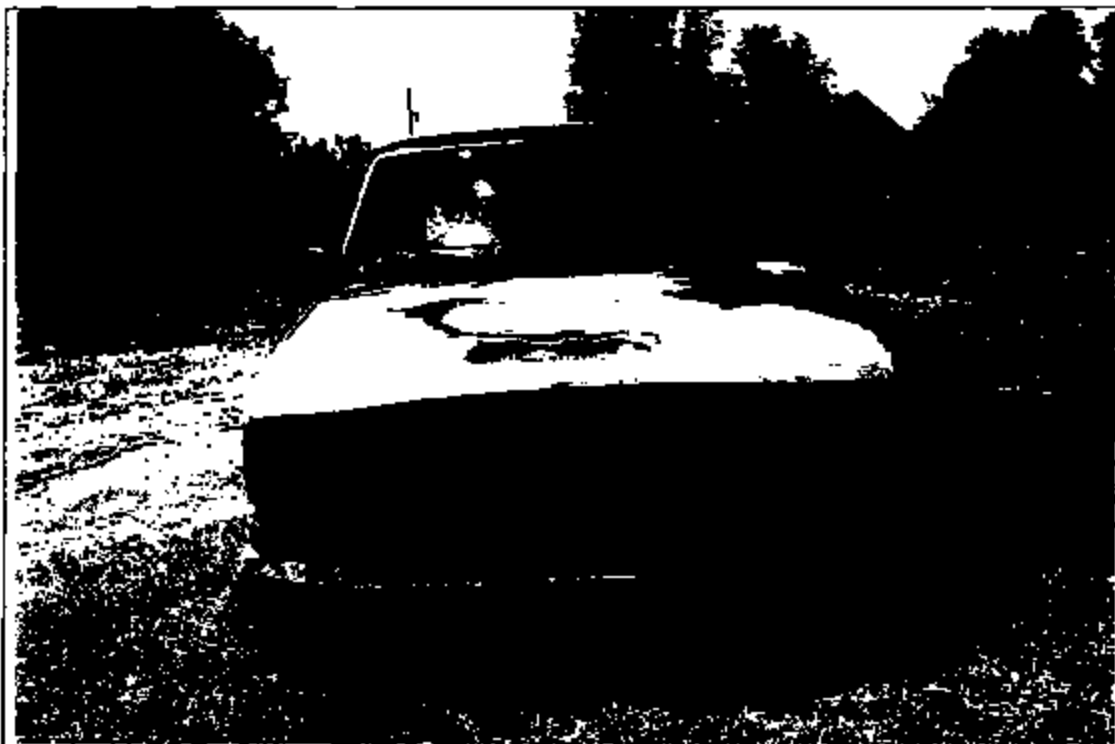
As can be seen in photographs #1 through #4, the most fire damage visible from the exterior was confined to the engine compartment. Burn patterns on the hood were outward from the rear center with a concentrated hot spot directly above the throttle body location, as can be seen in photographs #5 and #6. Overall interior examination of the engine compartment revealed heat stress was highly concentrated at the upper top portion of the engine block at the location of the throttle body. The intake manifold on the passenger side of the engine block still remained partially intact, as can be seen in photograph #8. The intake manifold exhibited more destruction moving toward the driver's side of

Photograph # 1: Overall front view of the vehicle.

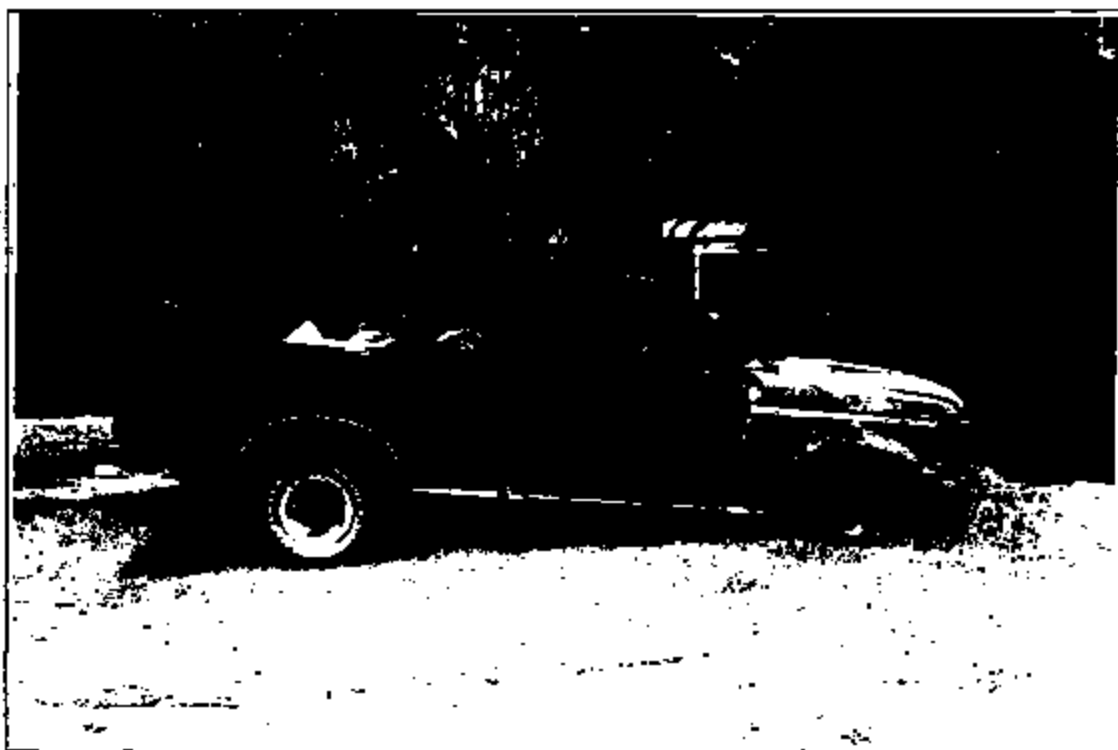
Photograph # 2: View from the passenger side.

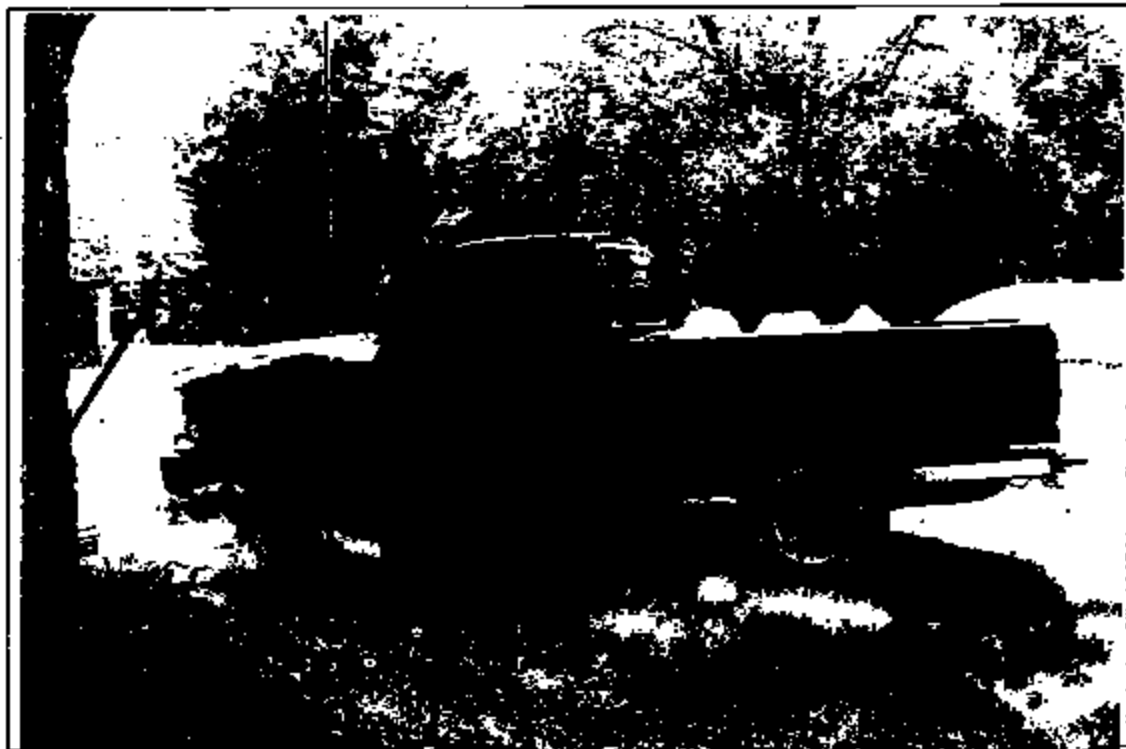
Photograph # 4: View from the driver's side.

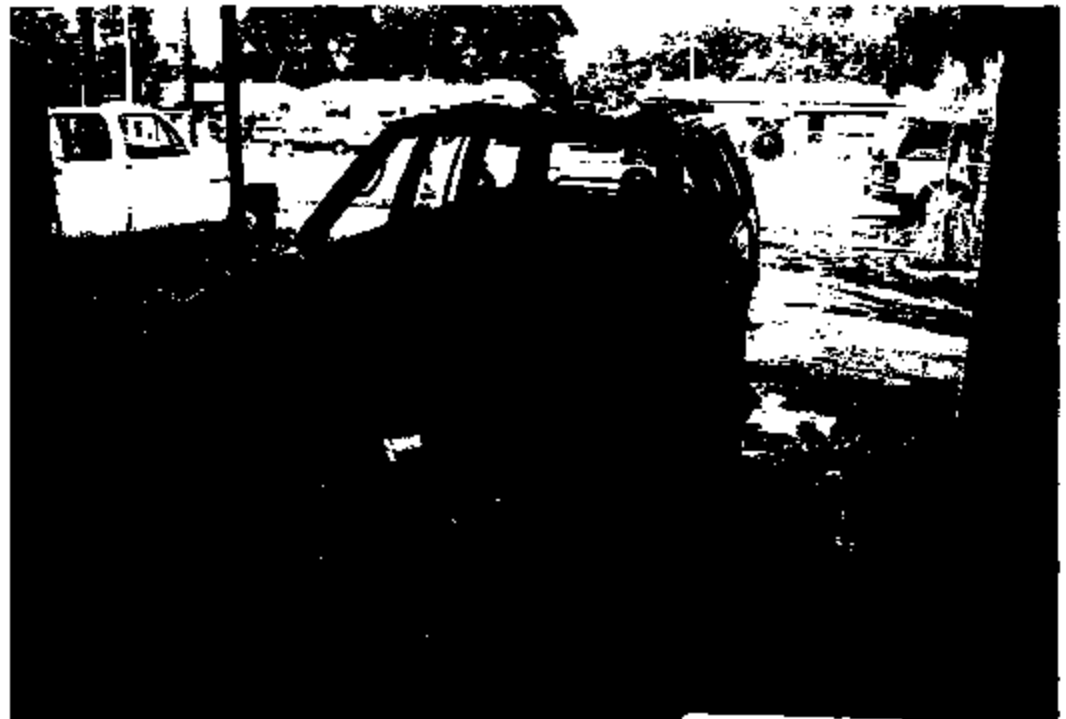
FRONT OF THE VEHICLE
SHOWING THE FIRE
DAMAGE AND BURN
PATTERNS.

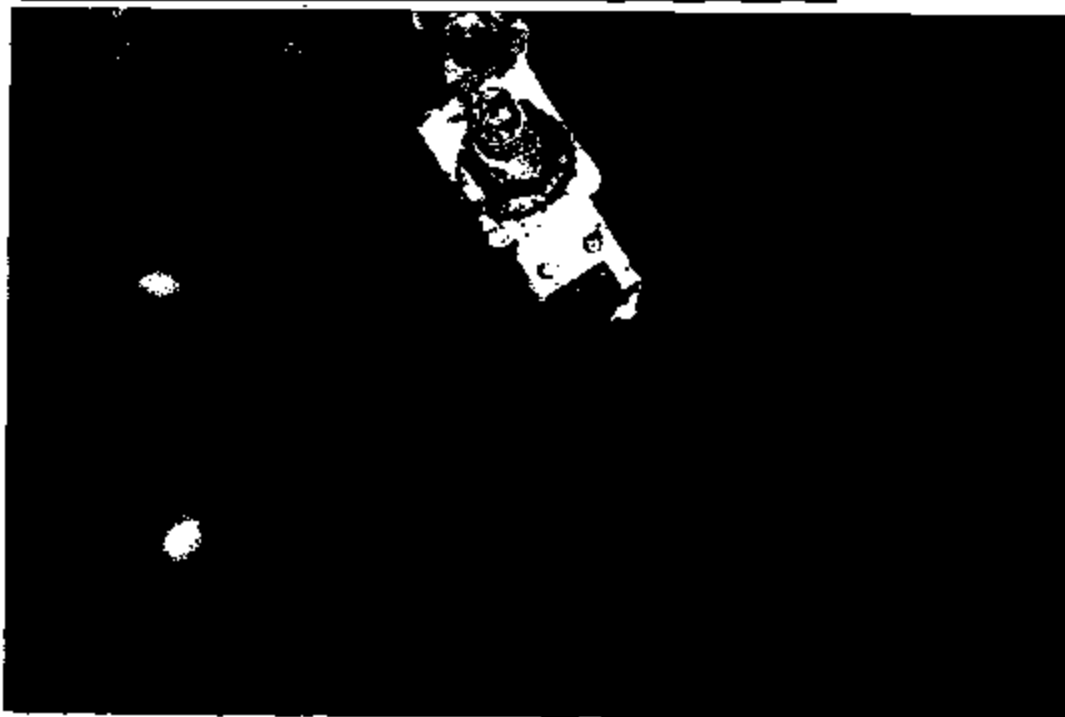
CLOSER VIEW OF THE
MEGA FUSE WITH
MELTING.

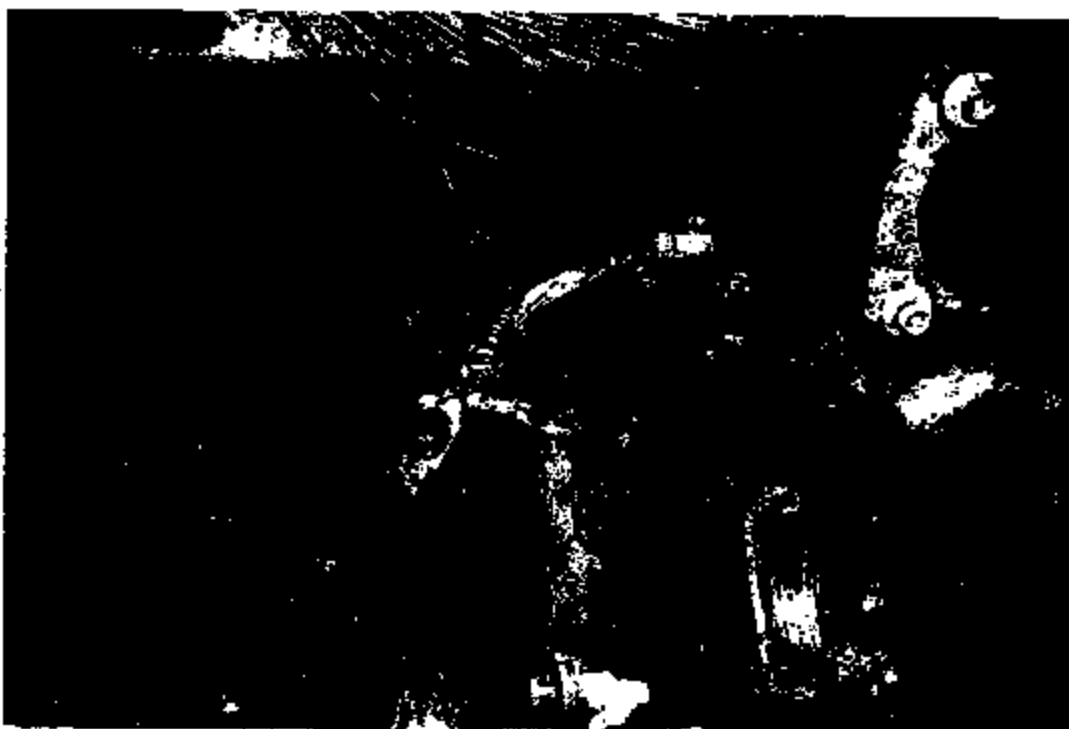
Photo # 76

CABLE WITH NO
ELECTRICAL SHORTING.
