FIRE CAUSE DETERMINATION

VEHICLE FIRE

**[REDACTED]
MACON, MS
1998 FORD EXPEDITION**

**CASE #4870
CLAIM # [REDACTED]
NOVEMBER 22, 1999**

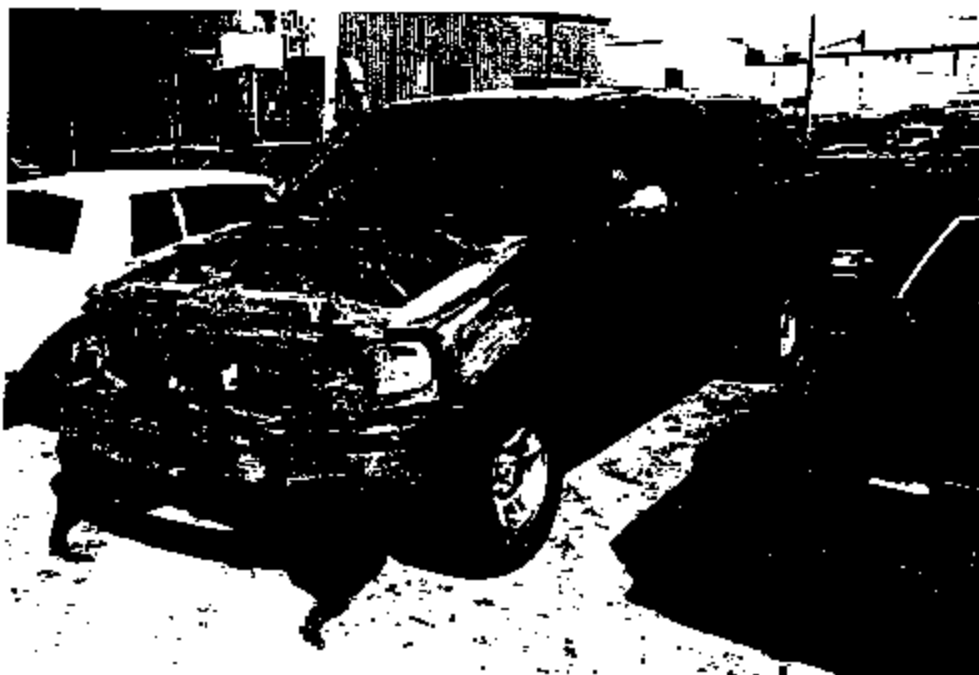
PHOTOGRAPH #5 - Overall view of the left front of the vehicle

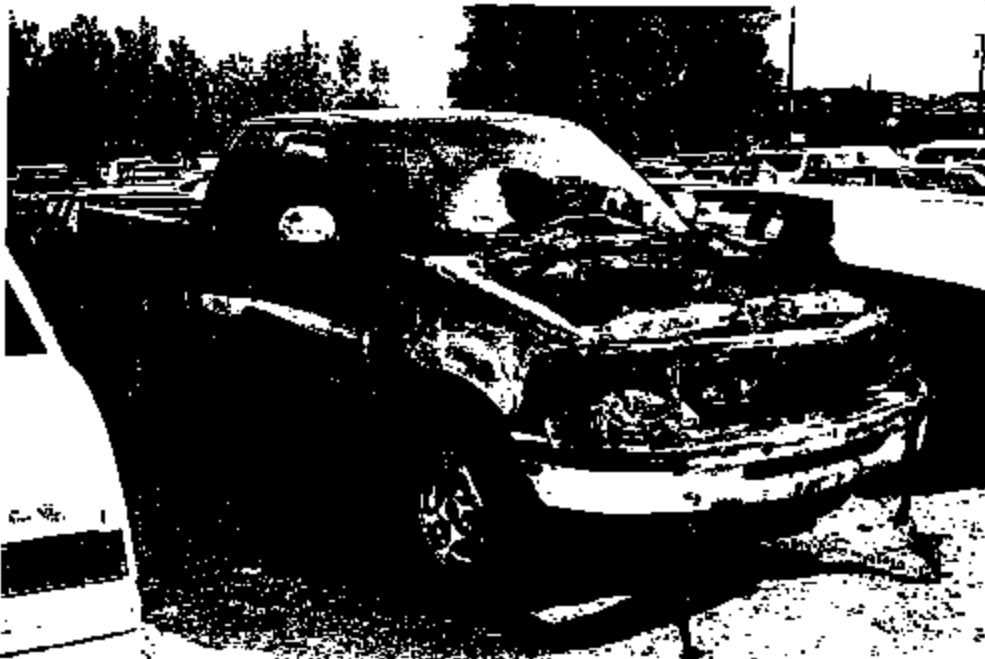
PHOTOGRAPH #6 - Overall view of the right front of the vehicle

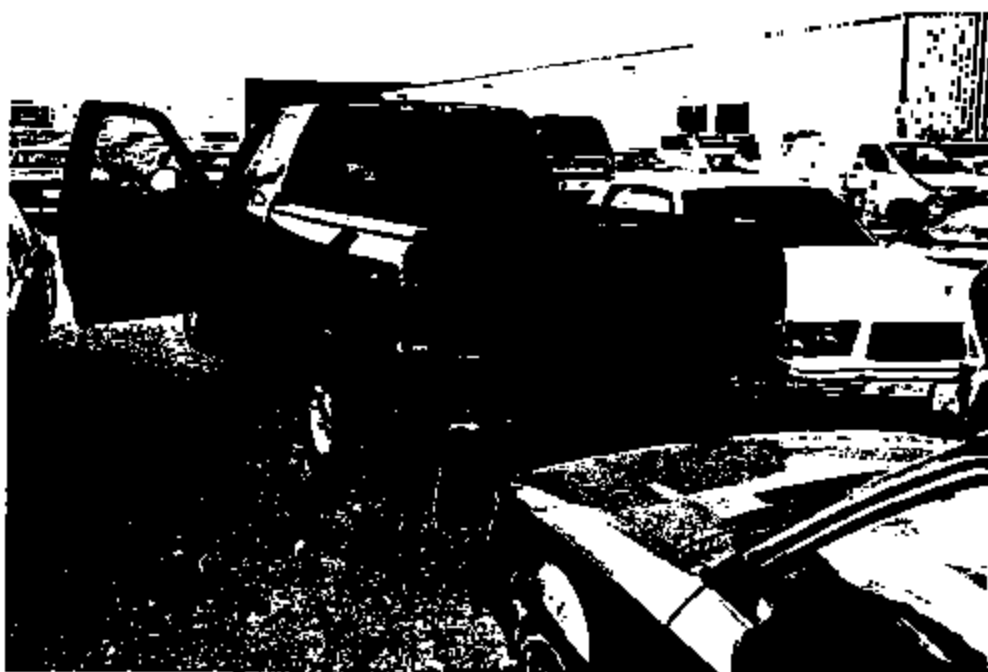
PHOTOGRAPH #7 - Overall view of the front of the vehicle

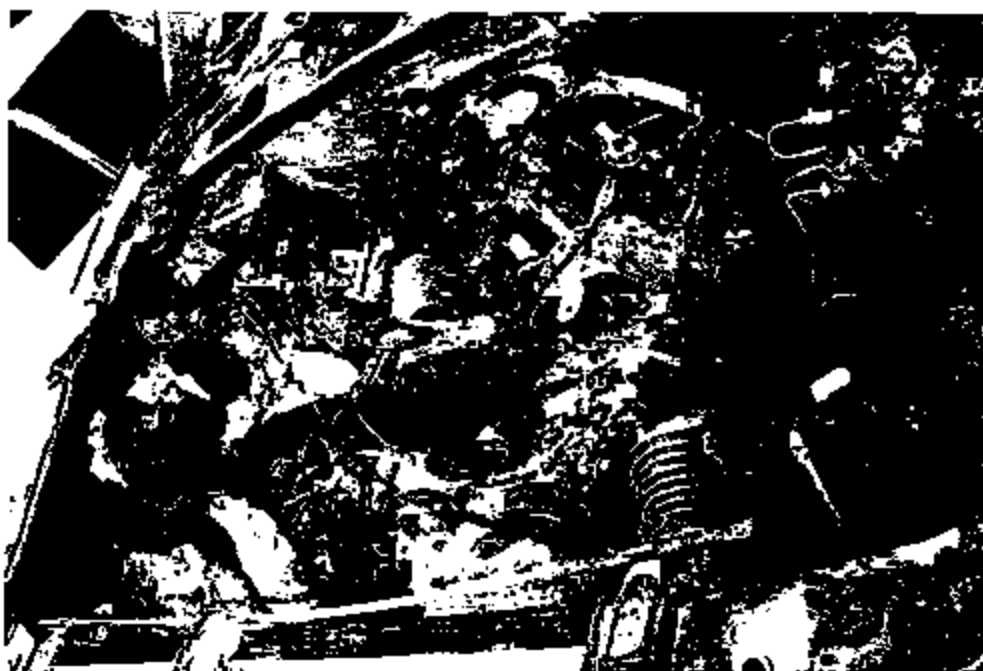
- 2.2 An interior inspection of the vehicle revealed small amounts of damage to the dash where the fire penetrated the windshield. There was also melting to plastic items that were as a result of the heat from the fire. The area of the passenger compartment can be ruled out as containing the area of origin. Photograph 9 shows an overall view of the interior of this vehicle.

PHOTOGRAPH #9 - Overall view of the interior of the vehicle

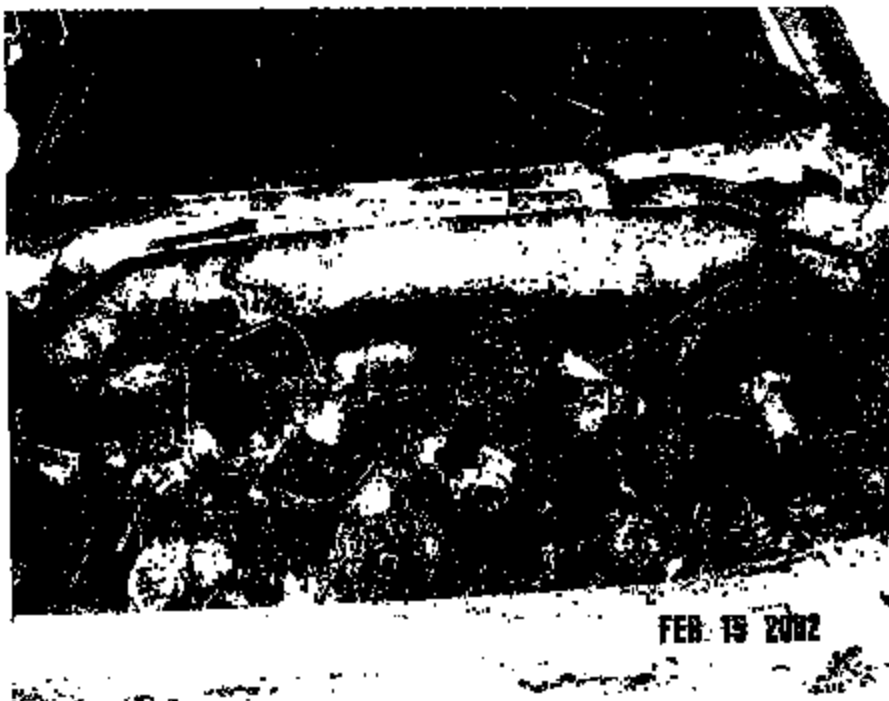
Photo 16
Photograph taken showing
an over view of the
vehicle engine
compartment.

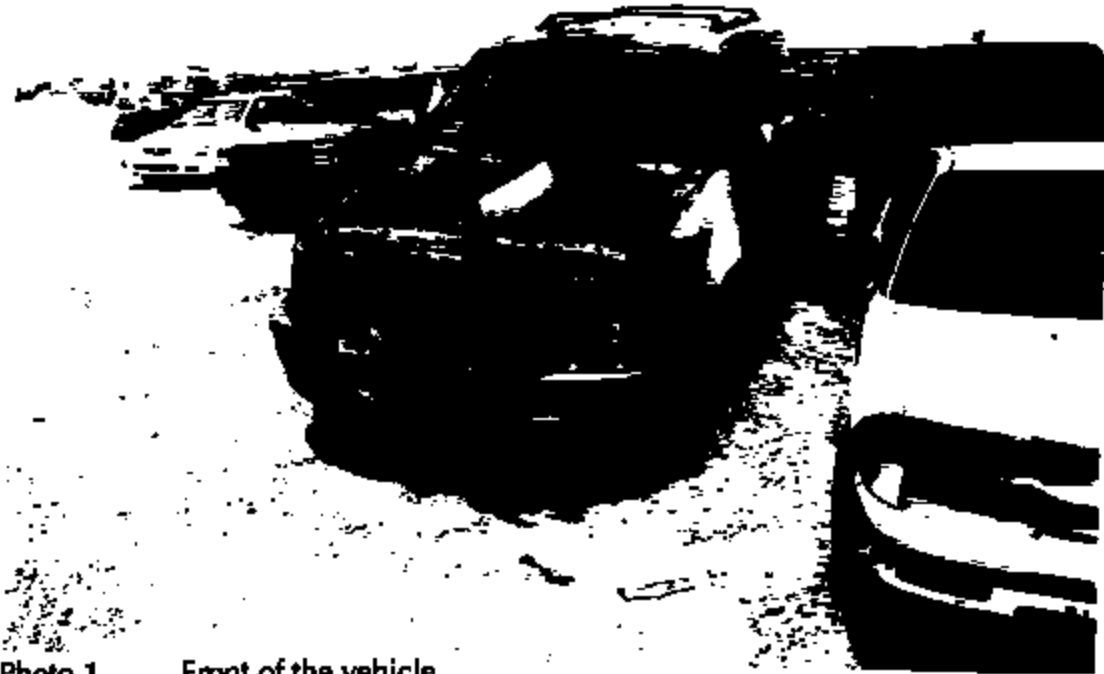
Photo 1. Front of the vehicle

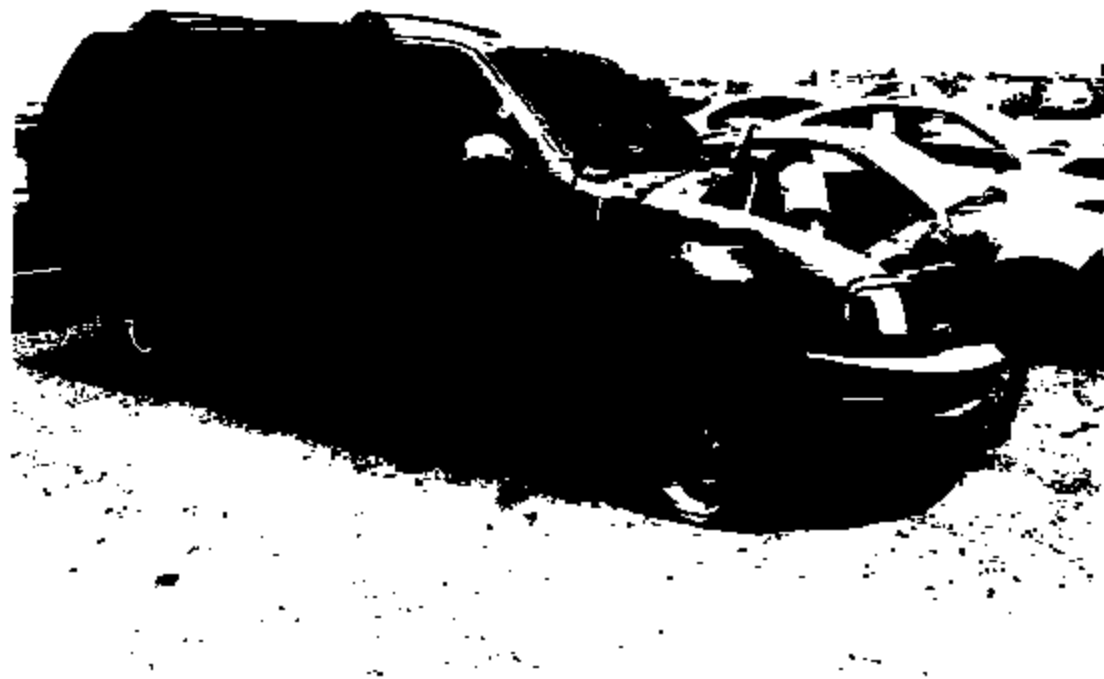
Photo 2. Right side of vehicle

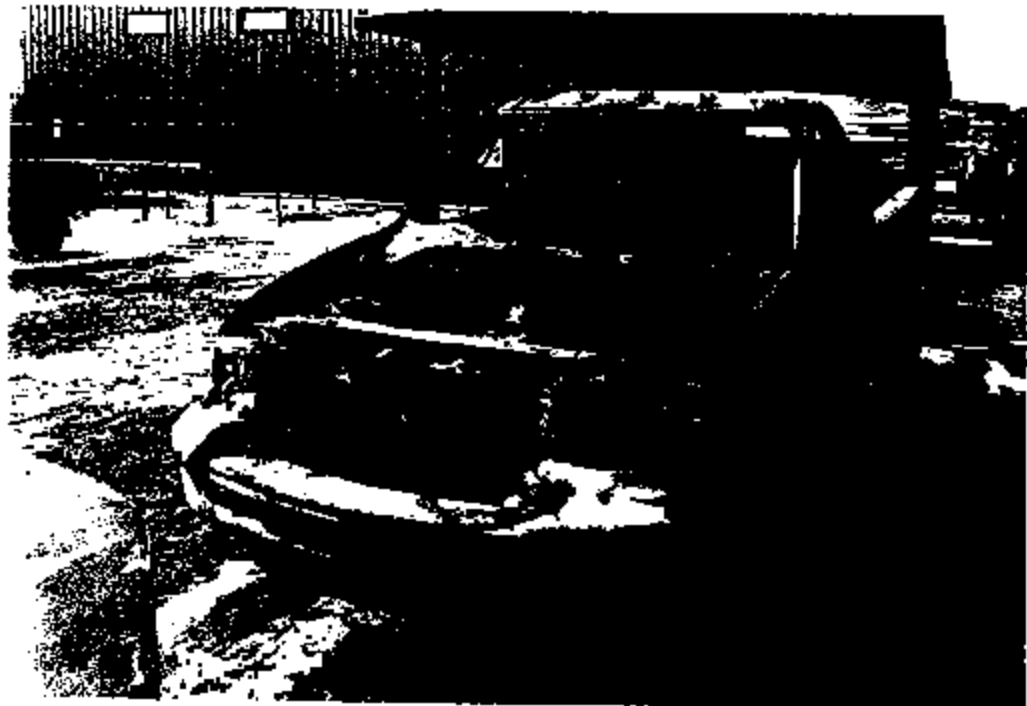
FIGURE #1

This is a view of the front and left side of the subject vehicle. Note that the grill assembly has been totally destroyed, the radiator and condenser are totally destroyed, the headlight assemblies have been almost totally destroyed, and the hood has burned completely off.

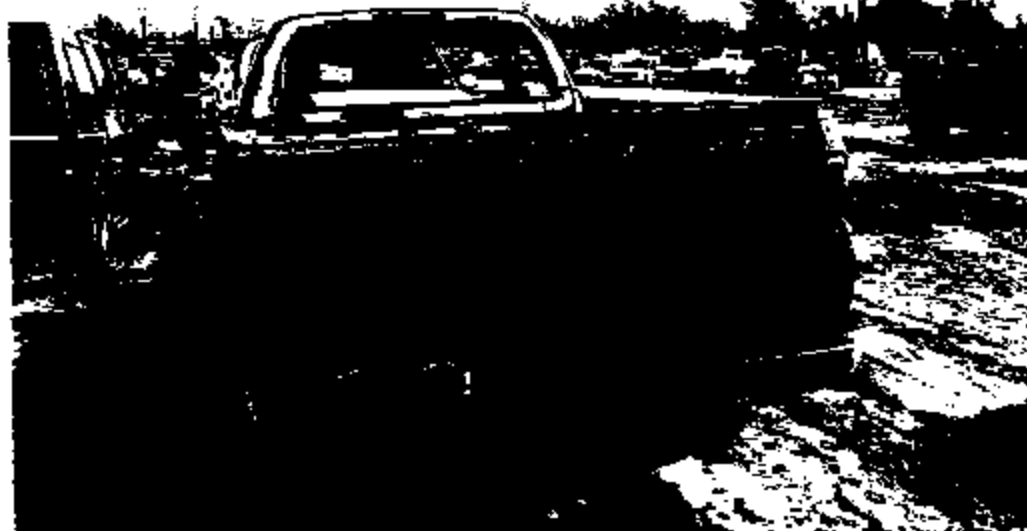
FIGURE #7

This is a view of the tailgate and rear license plate. Damage in the truck bed appears to be the result of the bed liner igniting and burning.

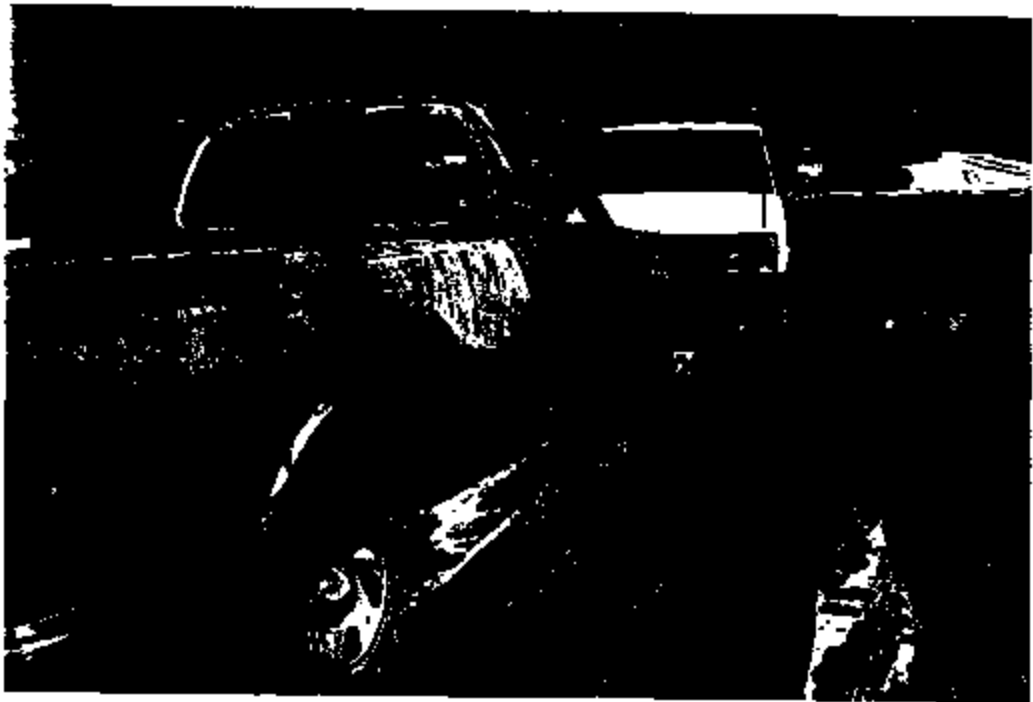
FIGURE #11

This is a view looking along the right side of the vehicle. The right front tire had been subjected to heat and was deflated, but it was not damaged as much as the left front tire. The condition of the right door of this vehicle indicates that it was open, or at least partially open, during the fire.

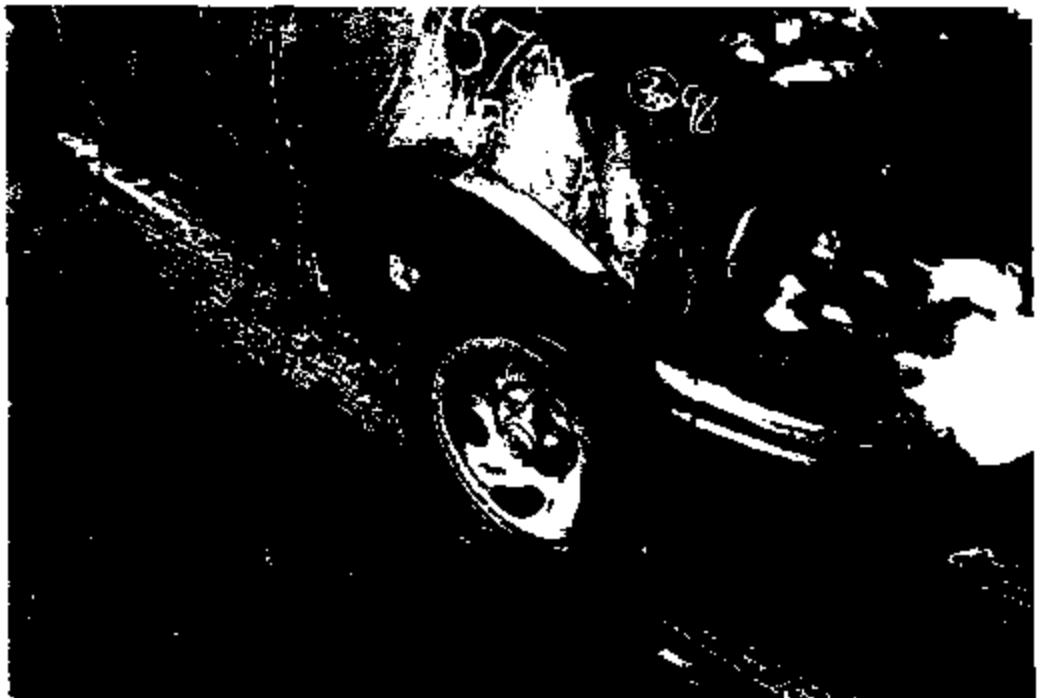
FIGURE #12

This is a view of the right front tire. Although deflated and partially burned, it was not damaged as extensively as the left front tire.

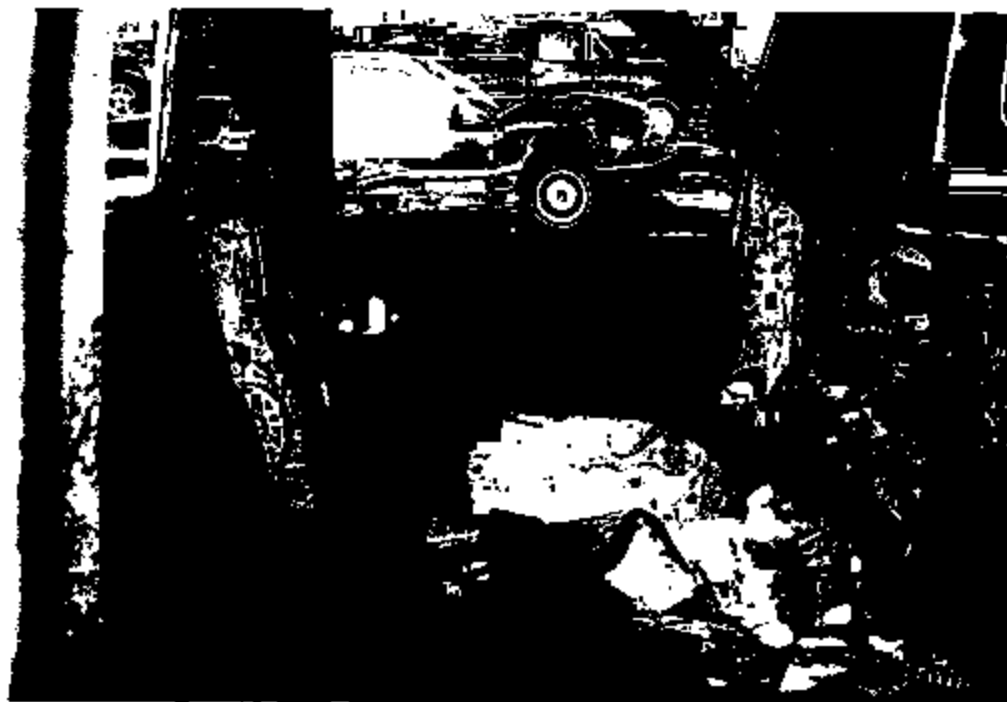
FIGURE #24

This is a view looking straight across the seat area from right to left. All combustible components in the passenger compartment had been destroyed.

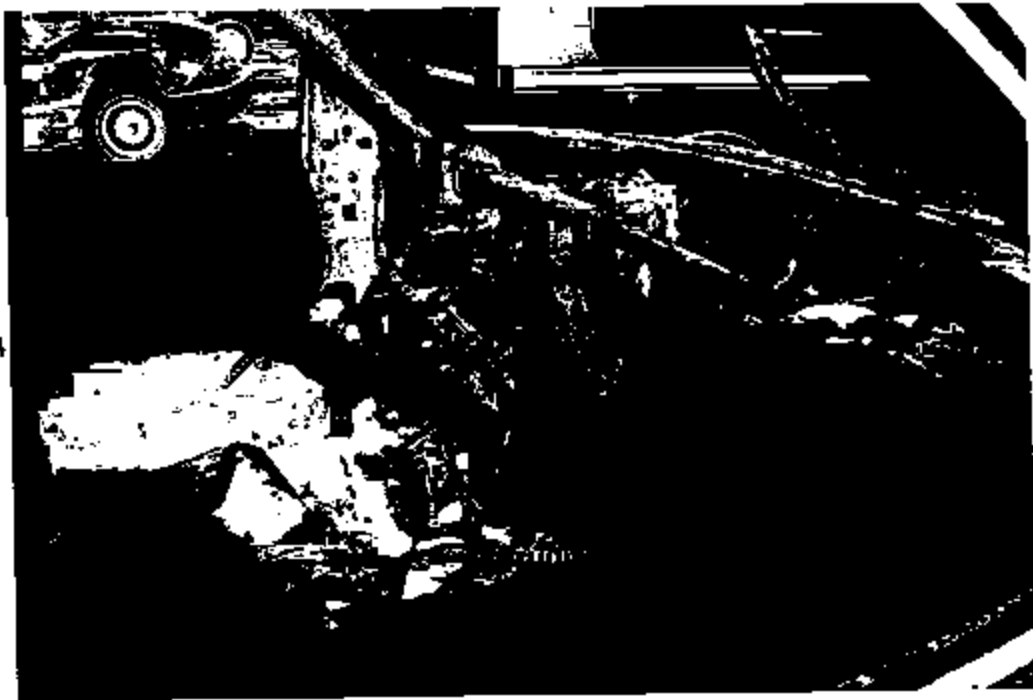
FIGURE #25

This is a view looking at the center section and left side dash area from the right side of the vehicle. Again, oxidation was relatively uniform throughout the cab area with the exception of the heavier oxidation on the bulkhead.

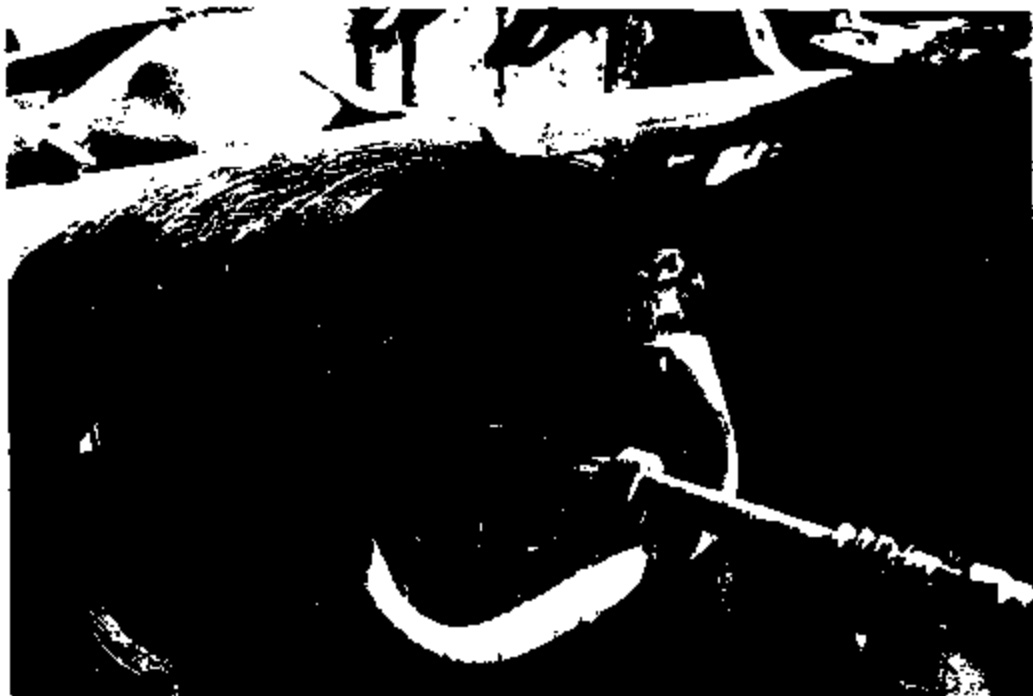
FIGURE #32

This is a view of the wiring where it passed over the steering column and instrument cluster area to the left side dash. No failures were found which could have caused a fire.

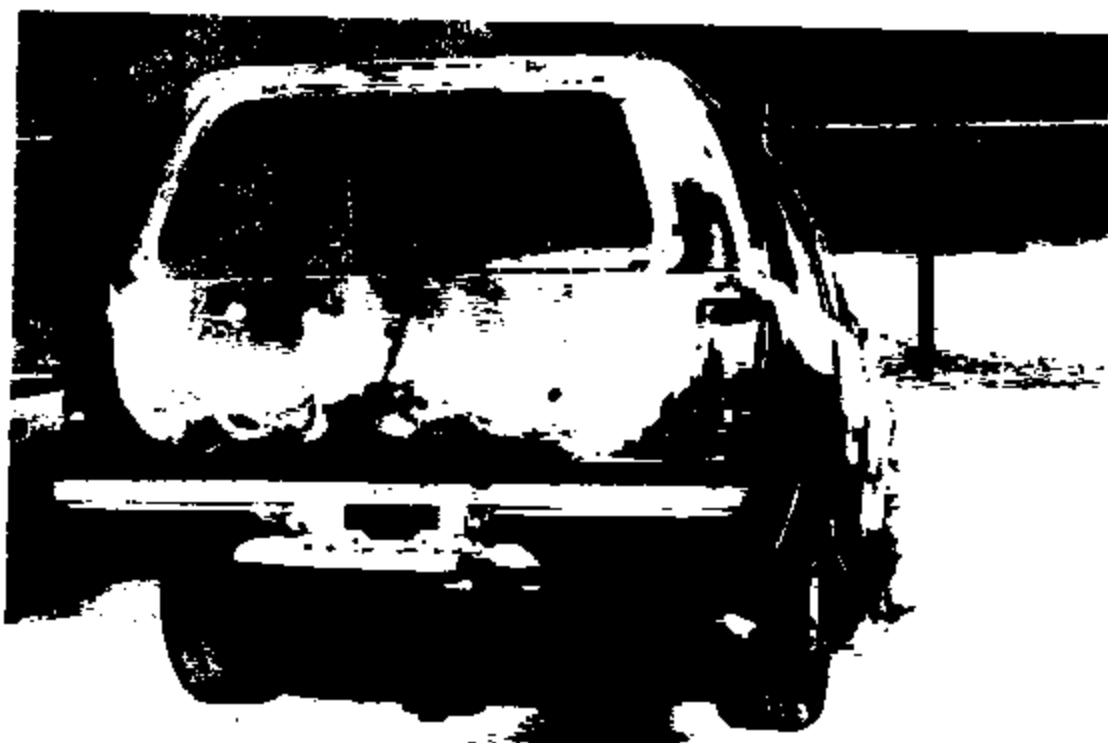
Figure 2. Rear view of vehicle.

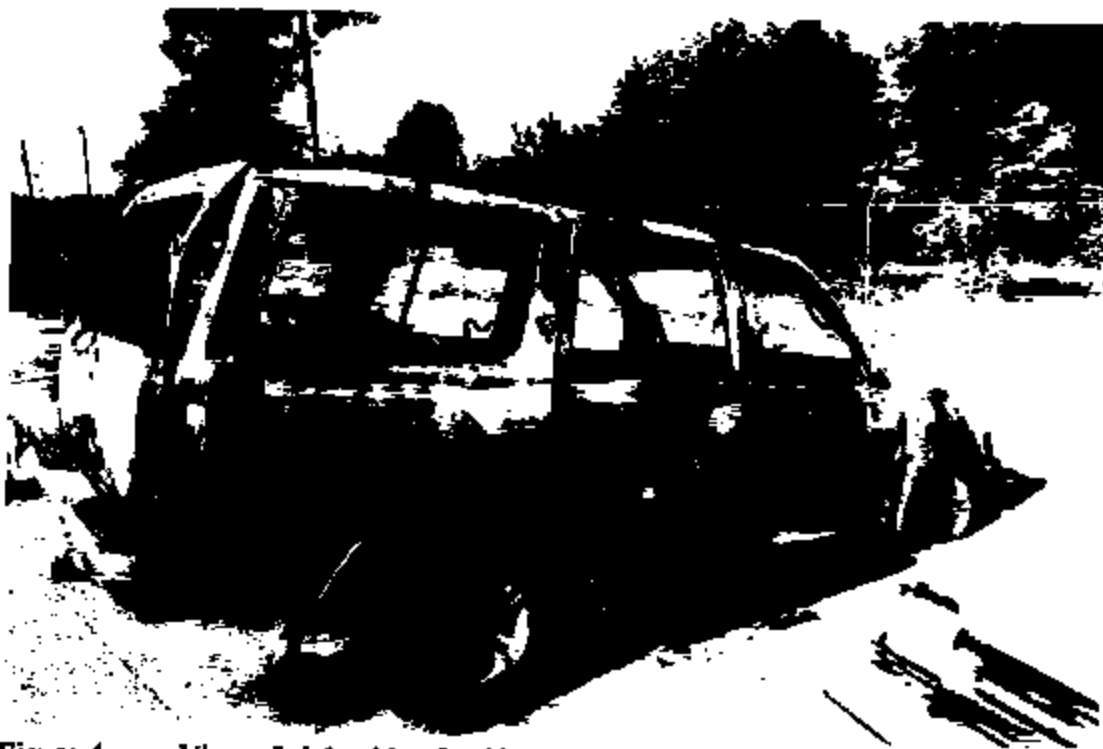
Figure 4. View of right side of vehicle.

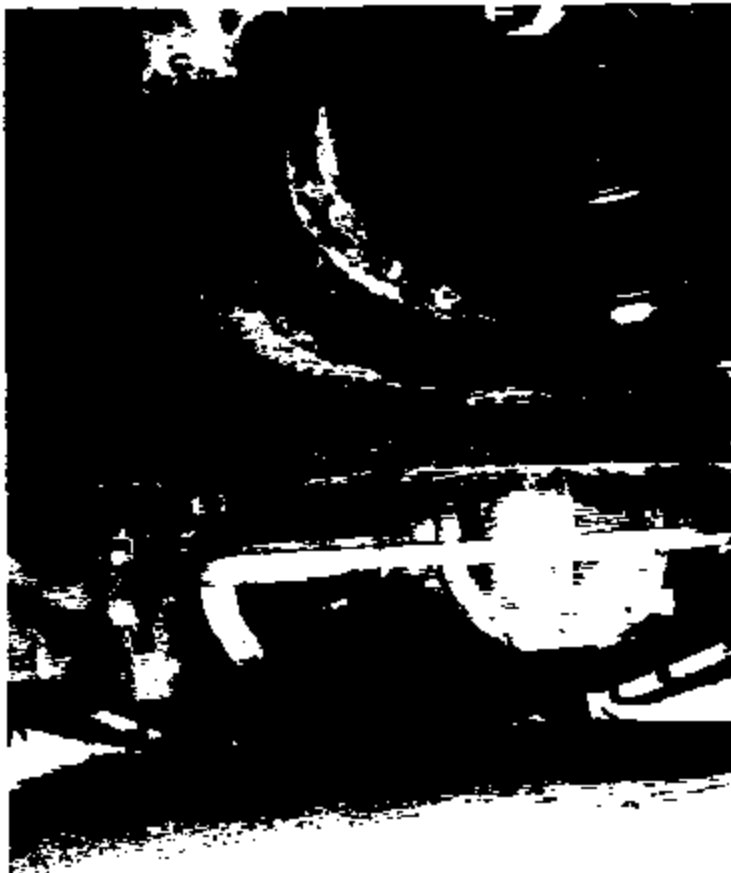
Figure 9. View under rear of vehicle.
