Monaco Motorhome Fire Trip Report

Date: November 29&30, 2007

Destination: Coparts Auto Auction
3300 Vandalia Road
Des Moines, IA

Purpose: Examine a vehicle that had experienced an engine compartment fire with representatives of the engine manufacturer, motorhome manufacturer, and vehicle owner's insurance company.

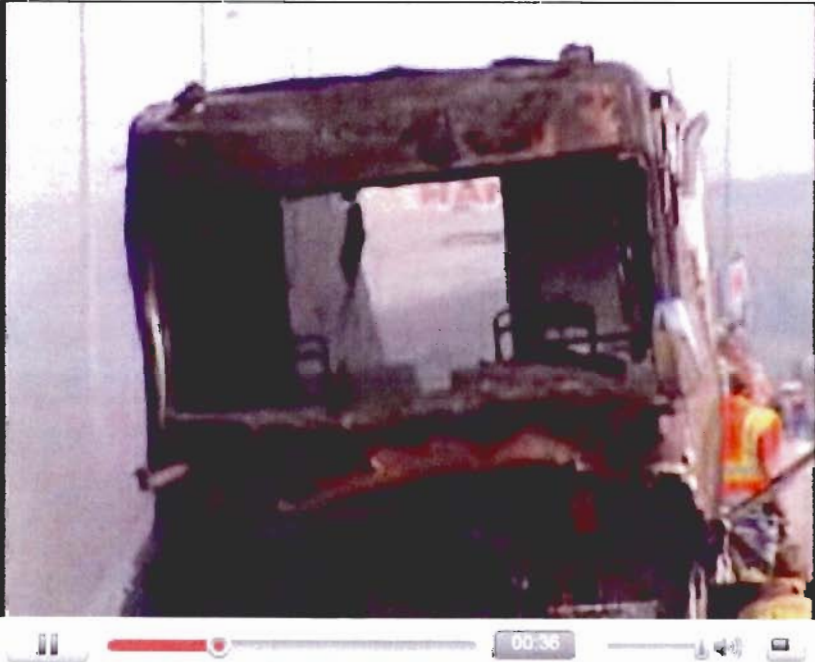
Figure 22 – The Front of the Motorhome at the Incident Site
