**National Highway
Traffic Safety
Administration**

ODI RESUME

Investigation: EA 09-010
Prompted by: RQ08-058
Date Opened: 06/18/2009
Investigator: Tom Bowman
Approver: Richard Boyd
Subject: Air Brake System

Manufacturer: NEW FLYER INDUSTRIES LTD
Products: MY 2004 -2008 NEW FLYER TRANSIT VEHICLES
Population: 1,000
Problem Description: DIMINISHED VEHICLE BRAKING / STOPPING PERFORMANCE

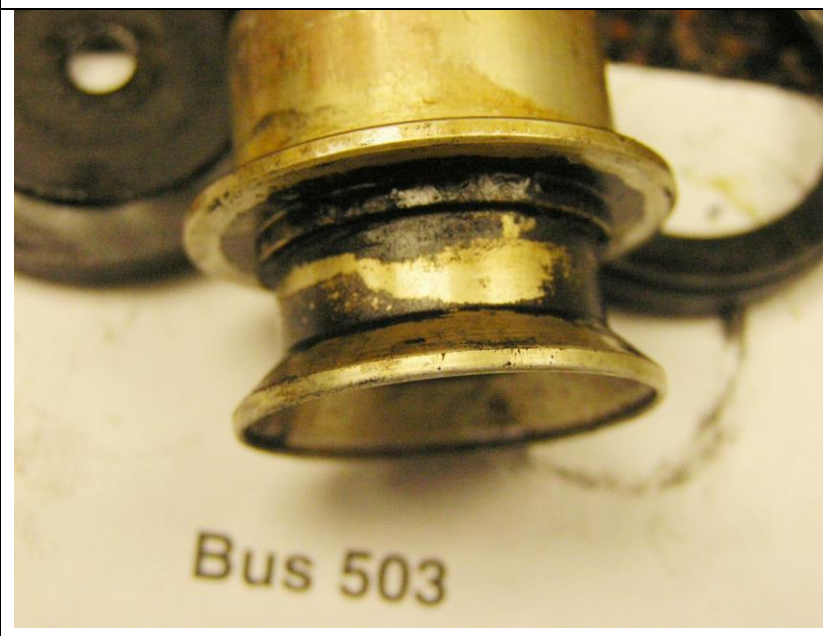
503 Date code 077A5K

503 - New Flyer relay valve seals

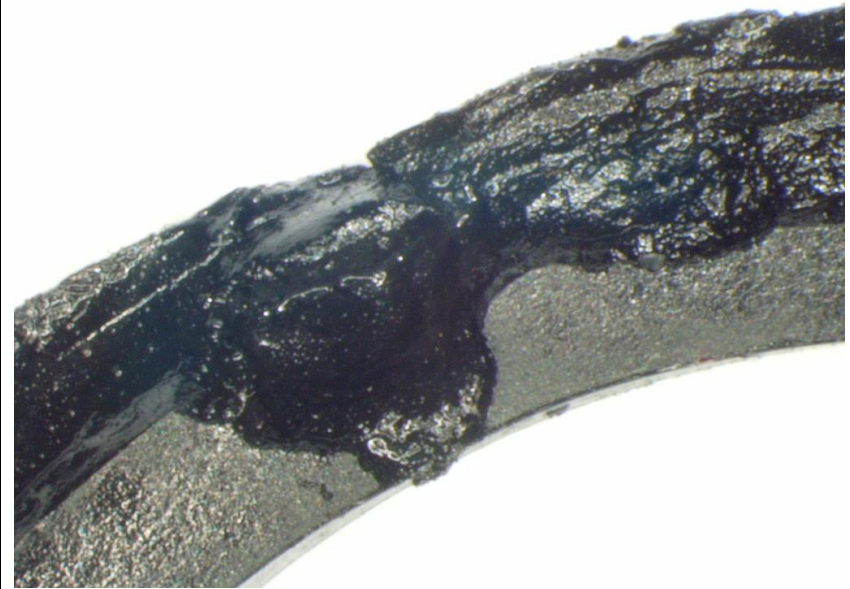
503 Date code 077A5K

● - New Flyer relay valve seals

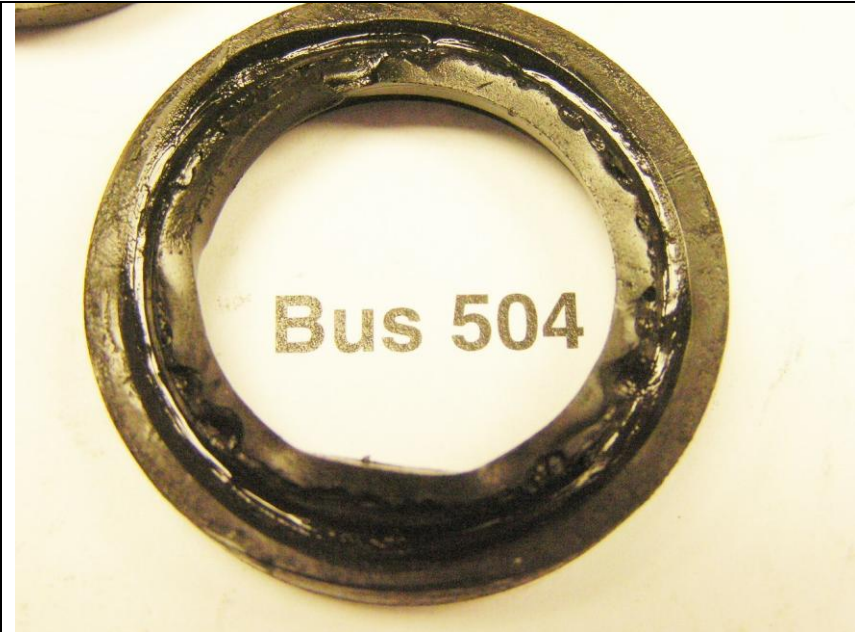
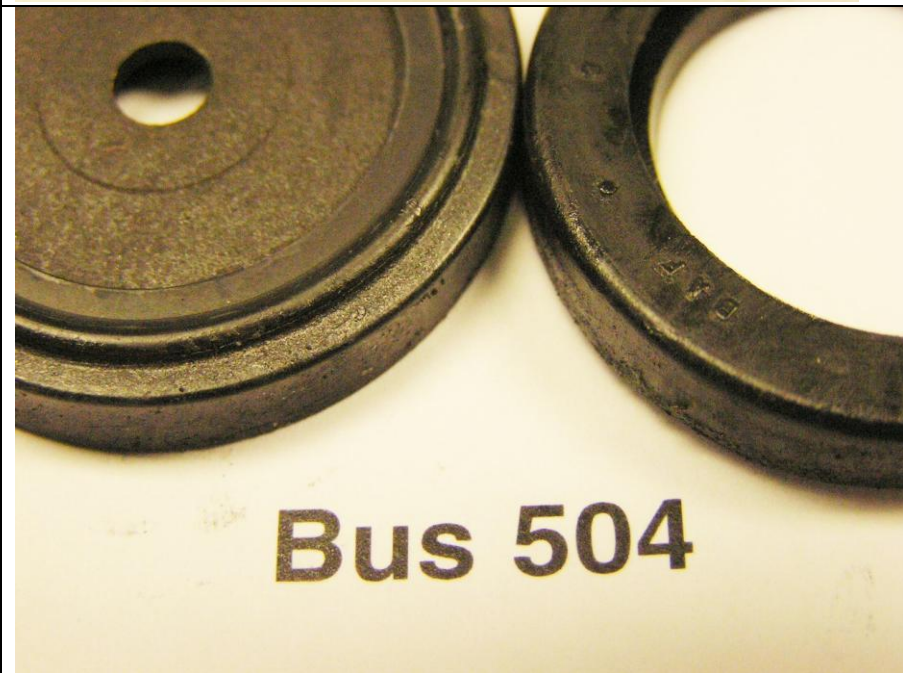
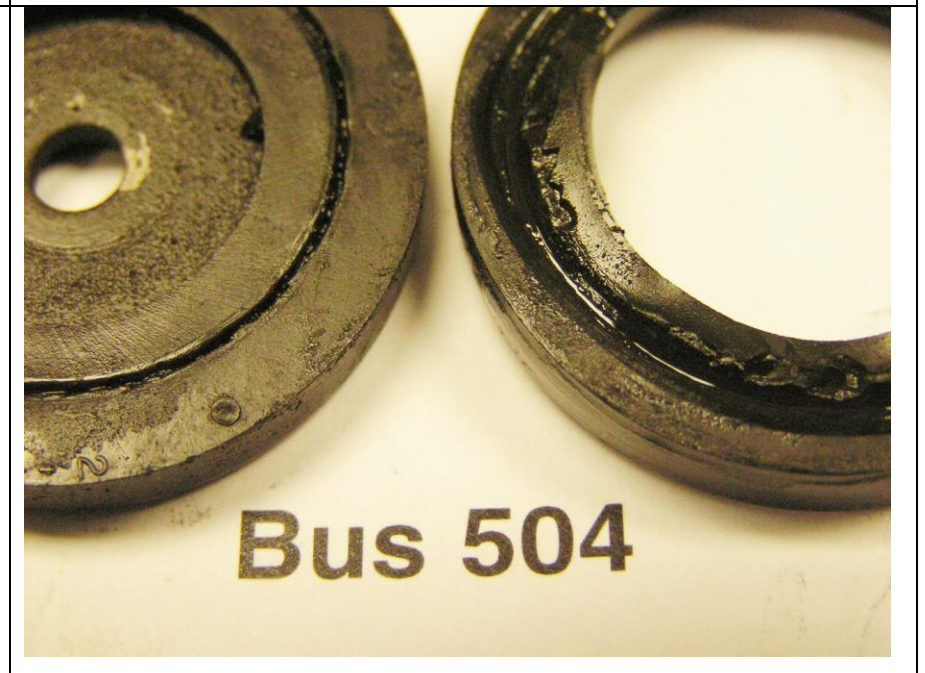
1504 Date code 077A5K

● - New Flyer relay valve seals

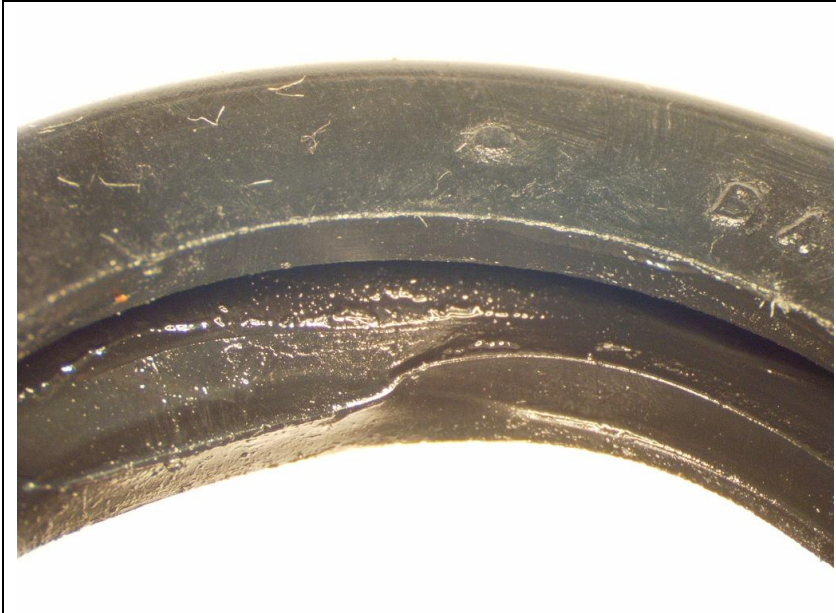
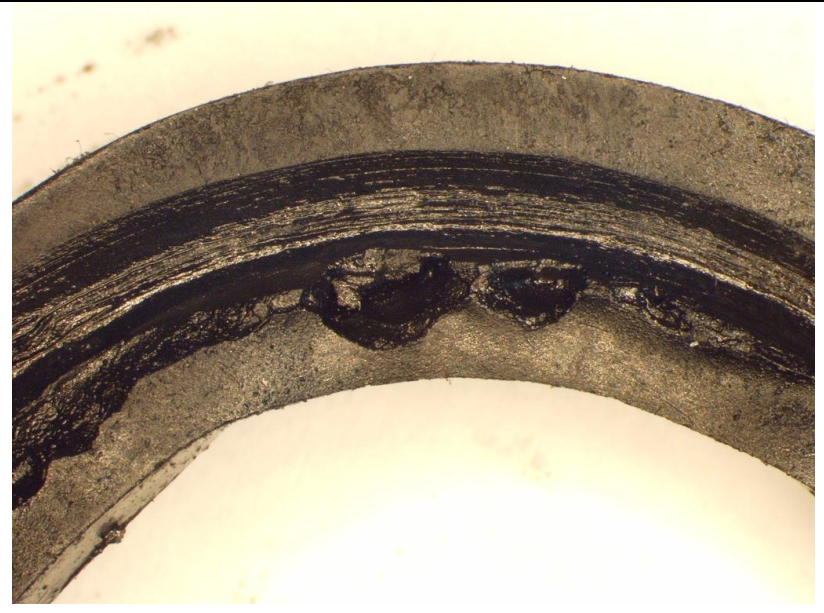
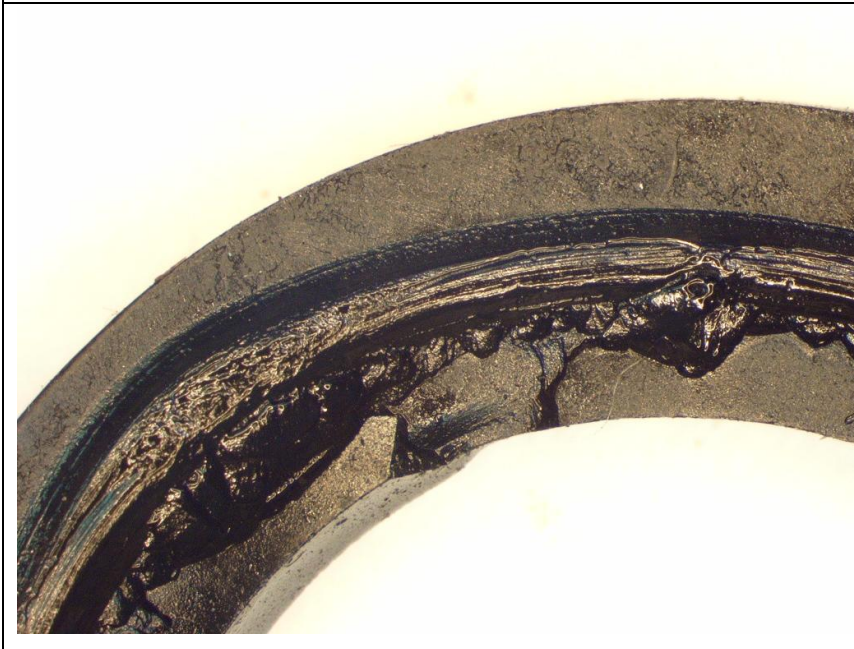
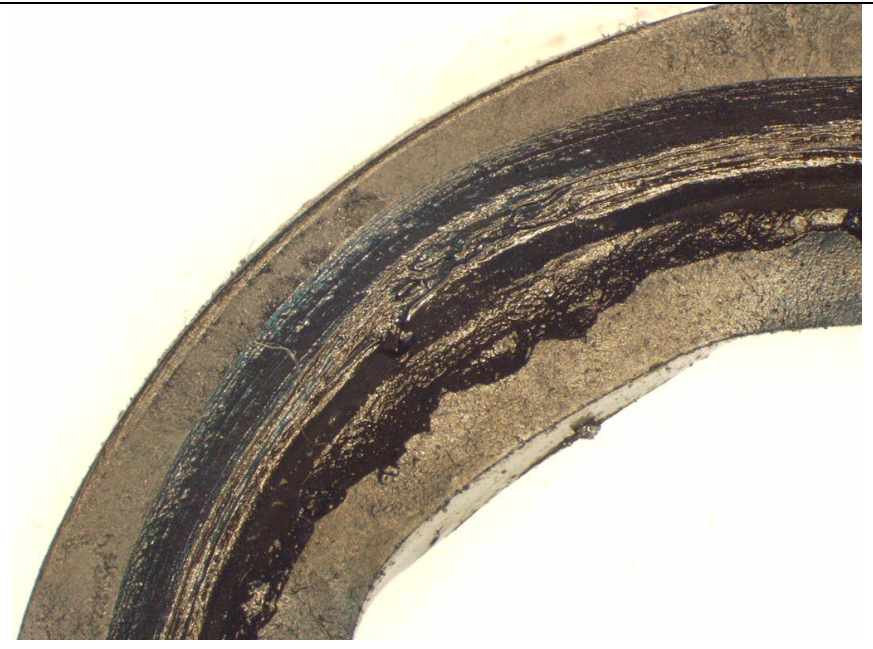
504 Date code 077A5K

504 - New Flyer relay valve seals

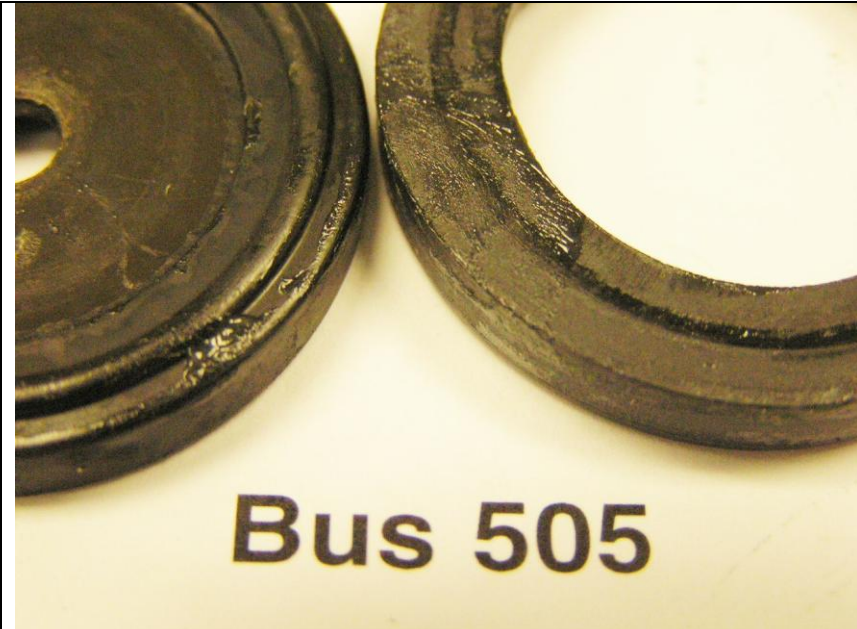
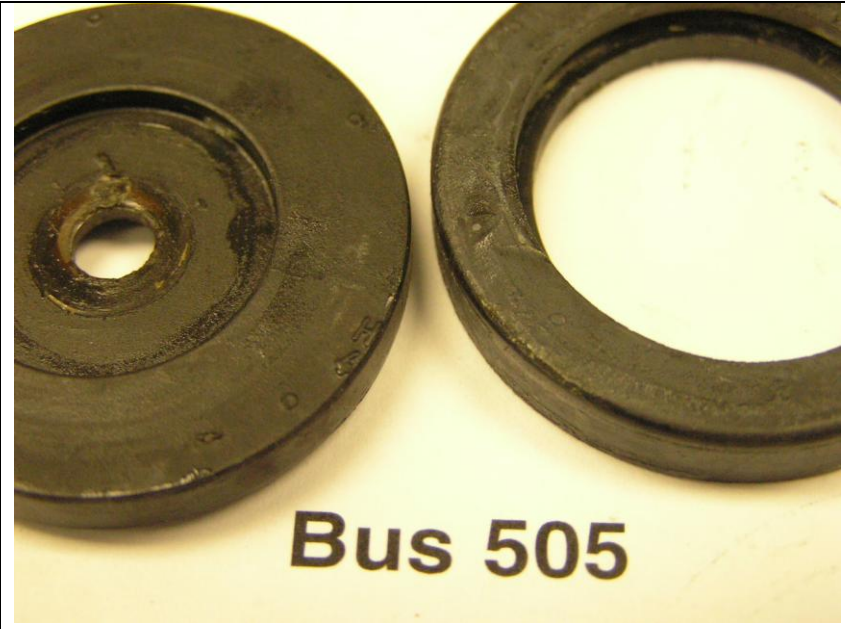
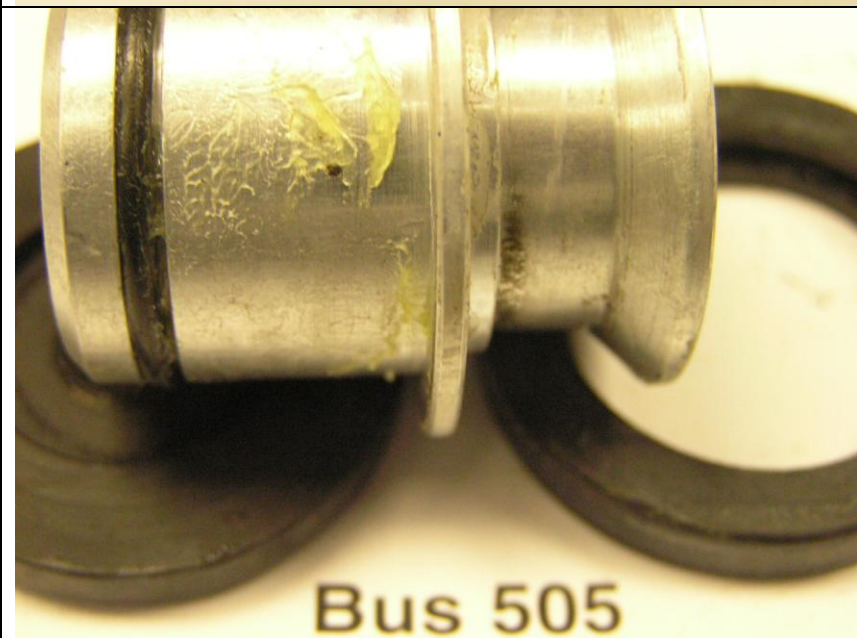
505 Date code 041A9K

505 - New Flyer relay valve seals

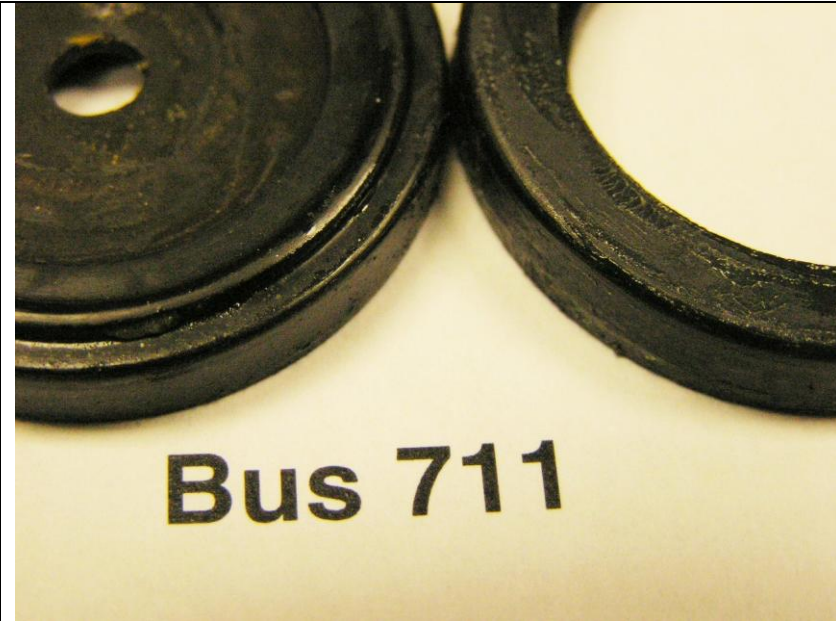
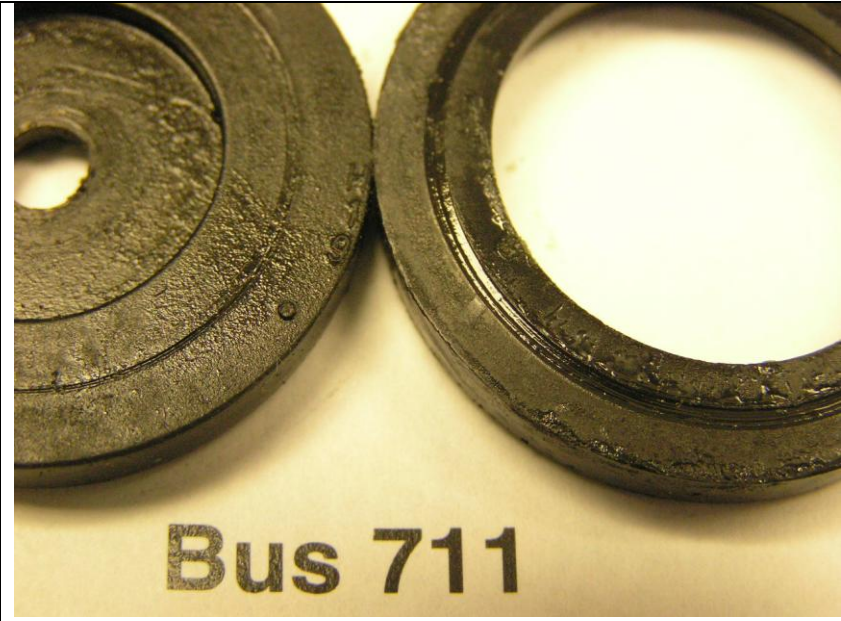
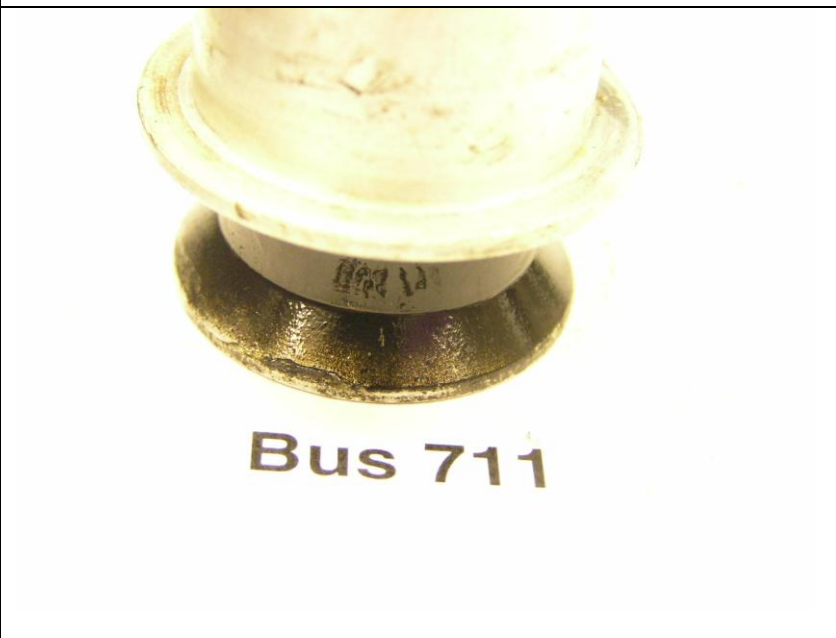
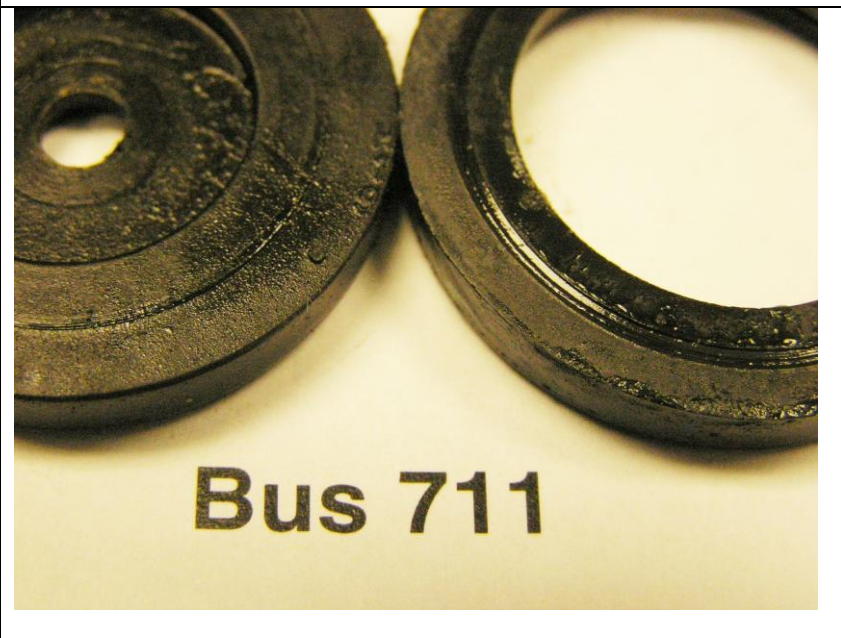
711 Date code 0401A9K

● - New Flyer relay valve seals

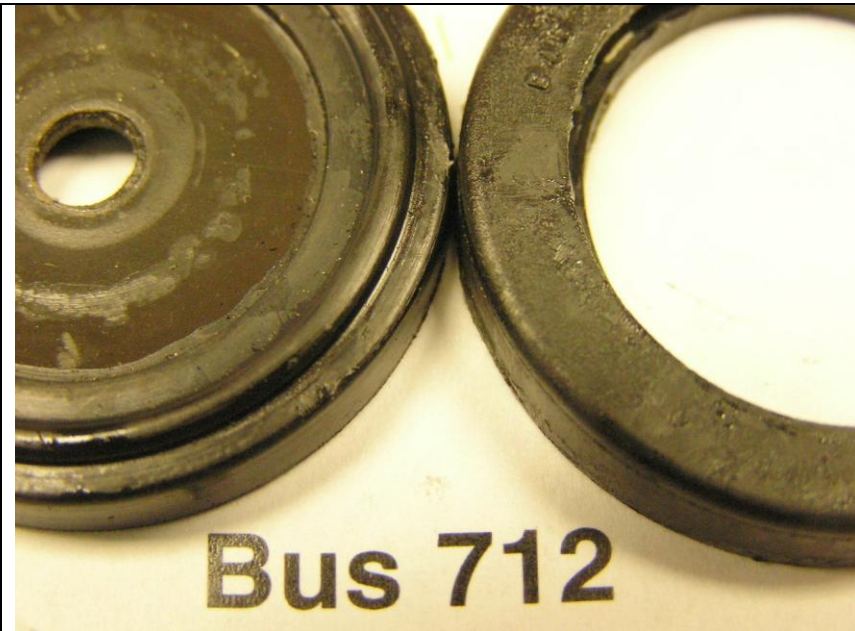
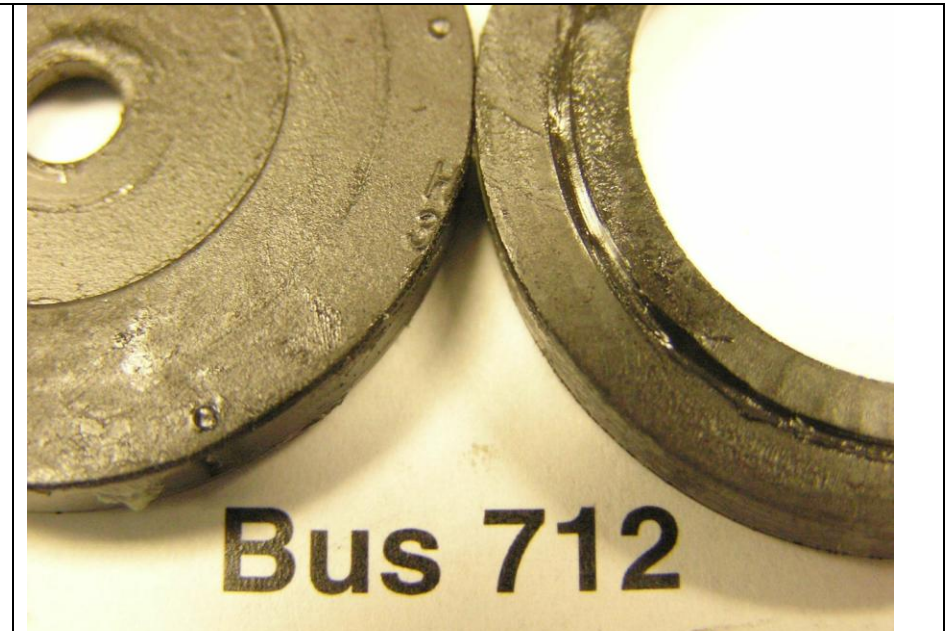
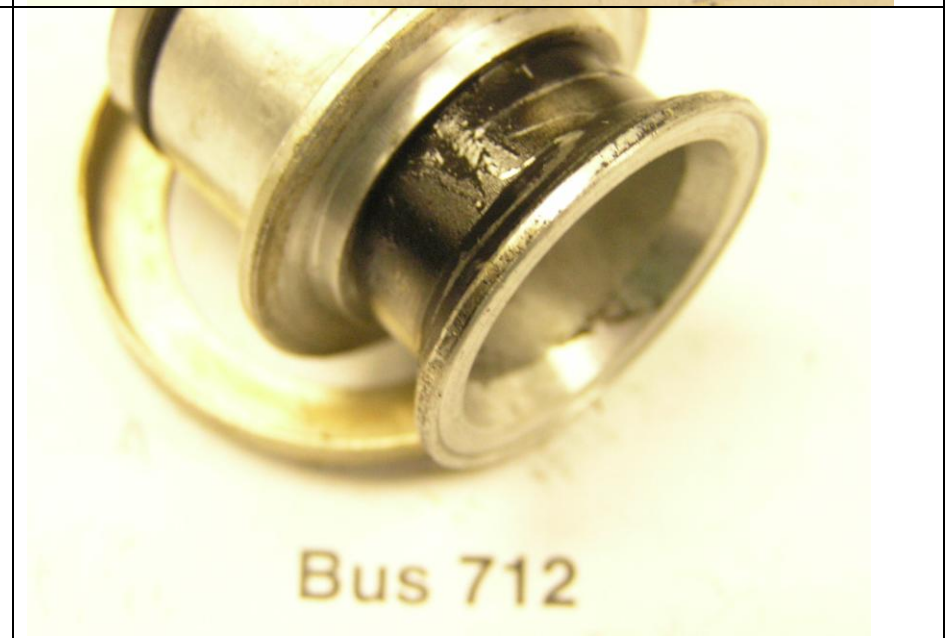
712 Date code 0401A9K

● - New Flyer relay valve seals

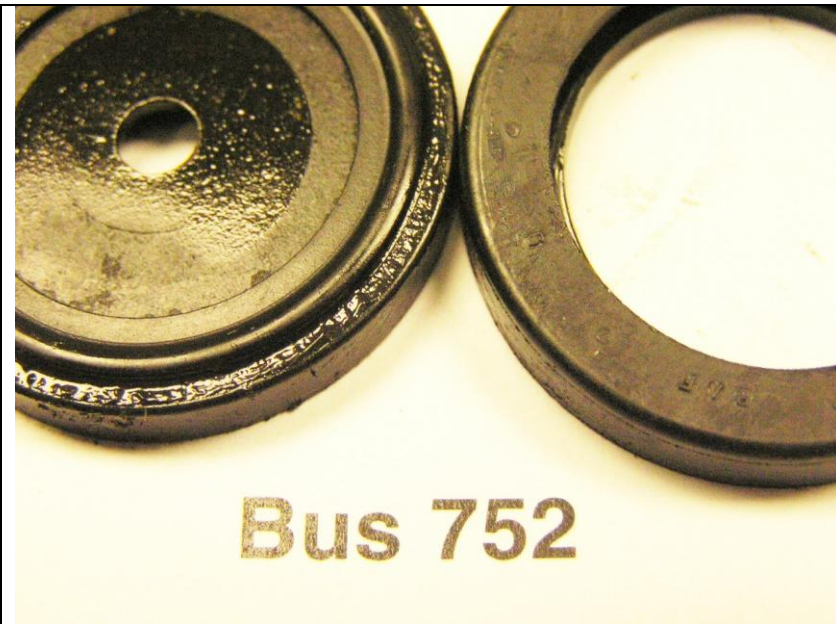
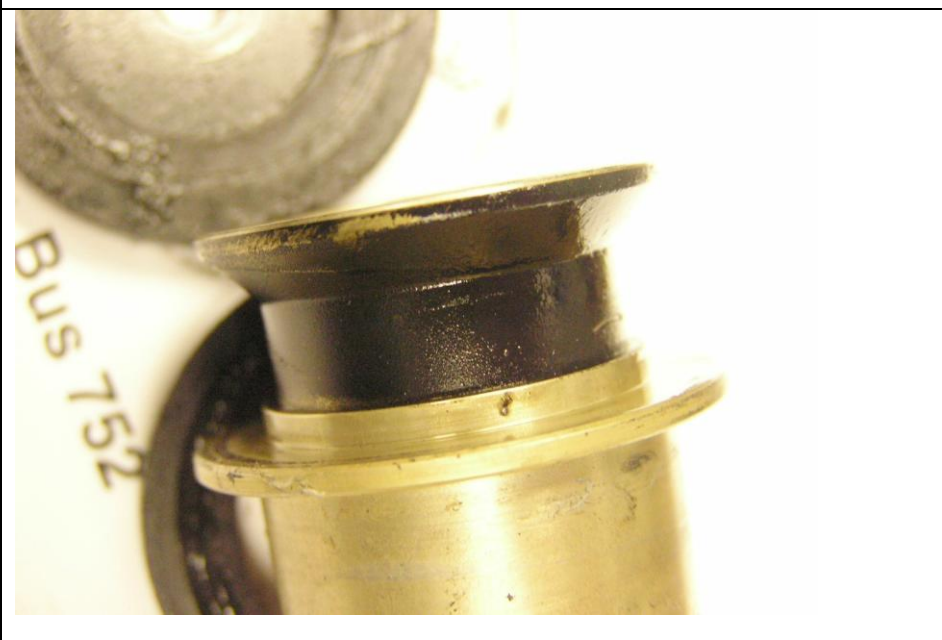
752 Date code 204A7K

● - New Flyer relay valve seals

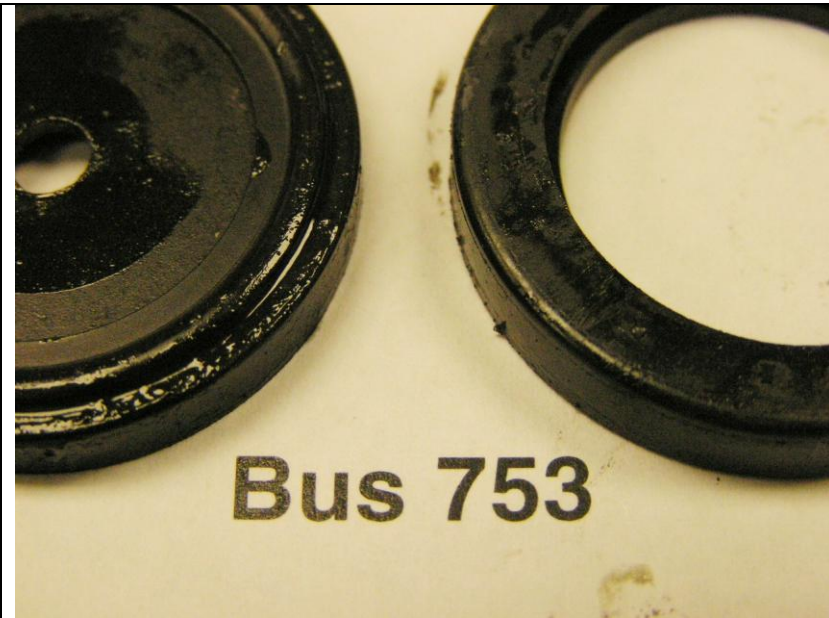
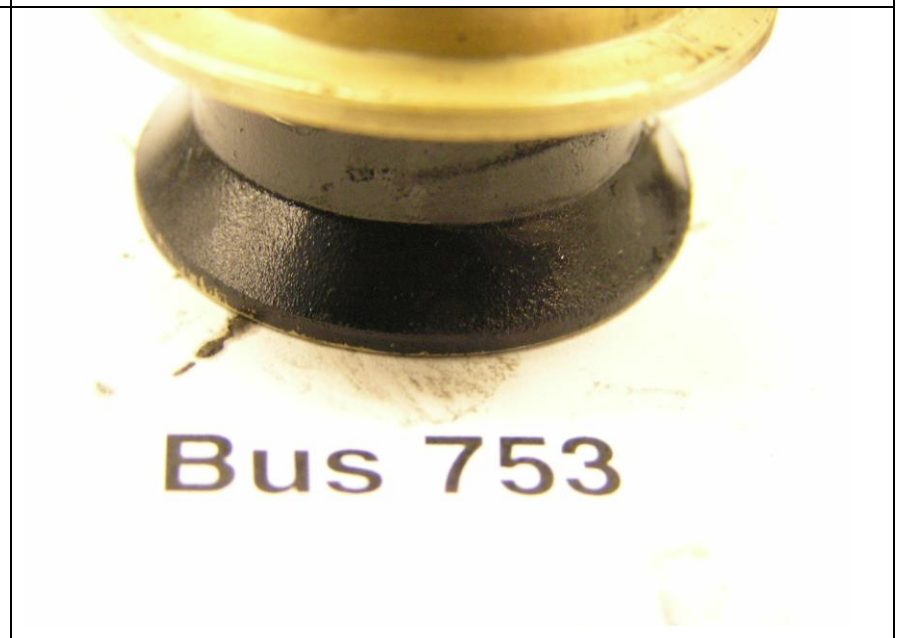
753 Date code 204A7K

● - New Flyer relay valve seals

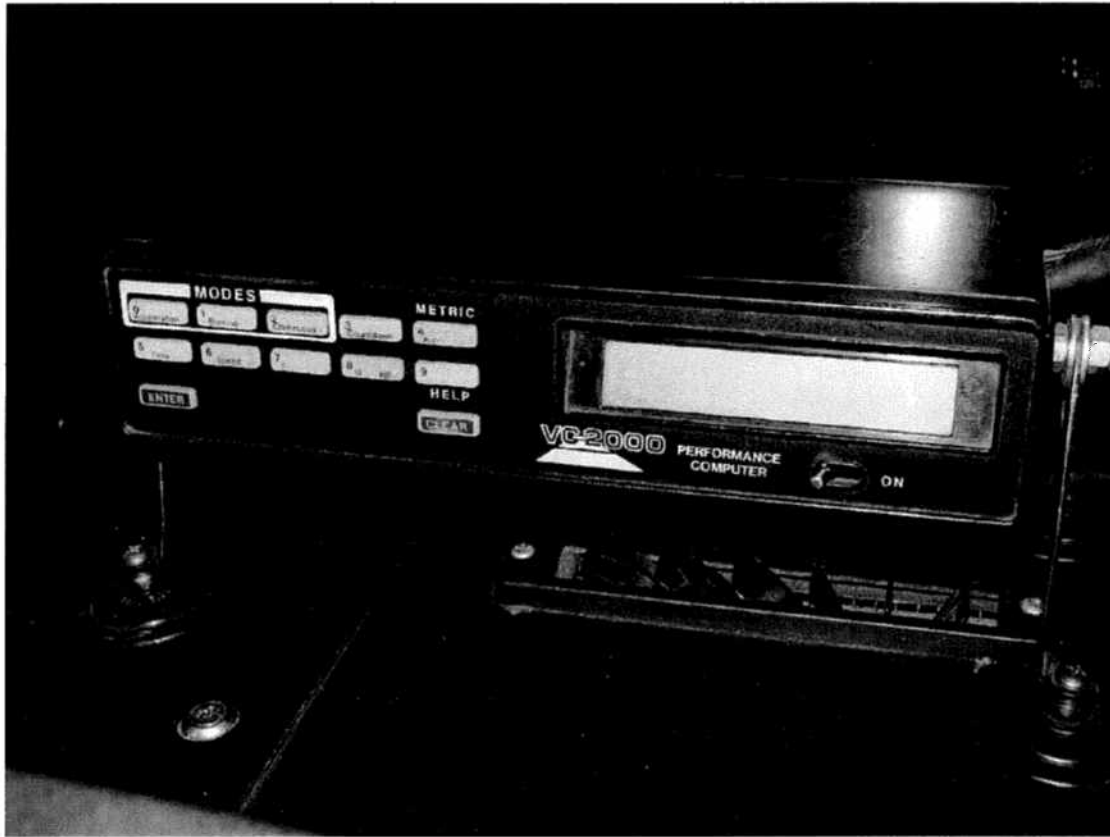
Vehicle 501 was road tested in the as-received condition and exhibited stops (adjusted / corrected to 20 mph) of 20.3', 20.0', 22', 20.6, and 21.1 feet) as measured with an in-cab mounted Vericom VC2000 decelerometer. [ODI note: equivalent to 0.58 – 0.63 g deceleration.]

[ODI note: All of the trial sops satisfy the XXX pass-fail criteria of less than 22.5'. According to fleet practice, if stopping distance is between 22.5' and 25', service at next maintenance interval. If the stopping distance is greater than 25', service immediately.]
