Description: Engine/Transmission Driveability Issues

Vehicles: Windstar, Freestar, Monterey

From: Kulkarni, Arvind (A.)
Sent: Wednesday, May 25, 2005 10:49 PM
To: Fang, Andy (A.); Stodola, Robert (R.J.); Tigchelaar, Doug (D.G.)
Cc: Nasar, John (H.S.); Cordeau, Roger (T.); Hearn, Mark (E.)
Subject: Analysis of CQIS data of water leak into PCM

V229 Wipe Cowl Module – Water Leak Paths

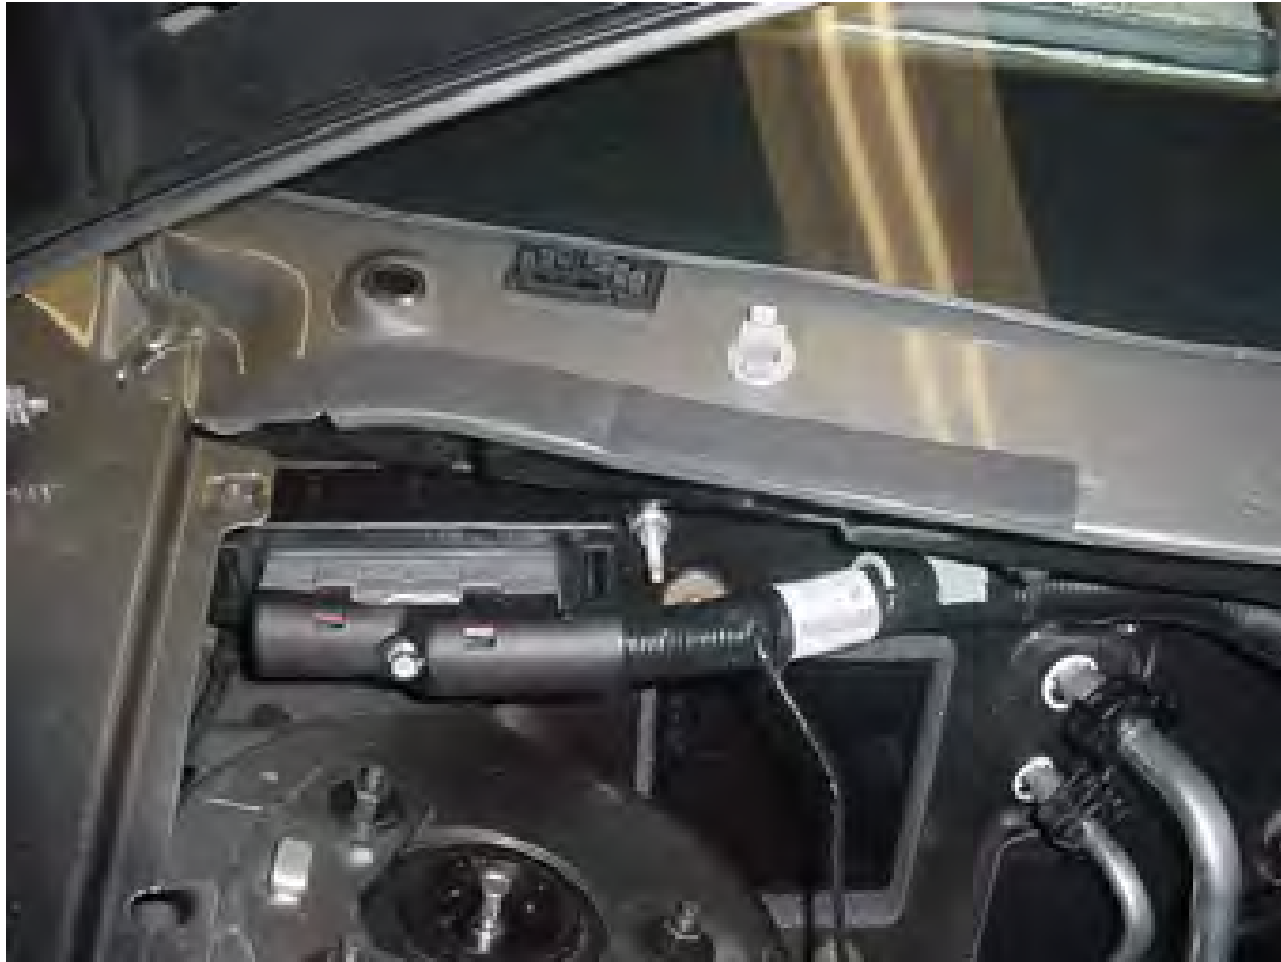
Foam Patch by the TRS area

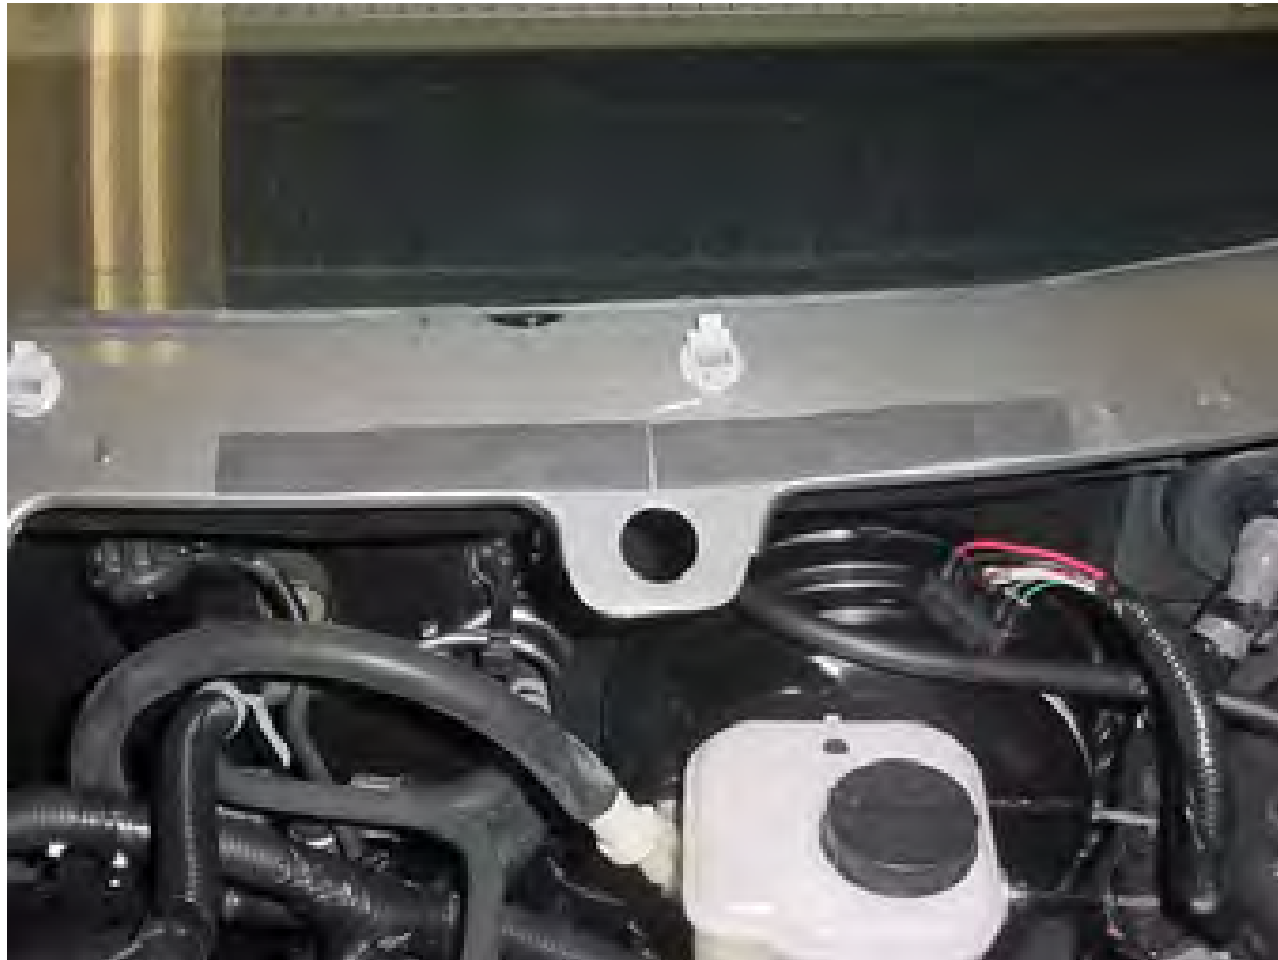
Bird view above the TRS area

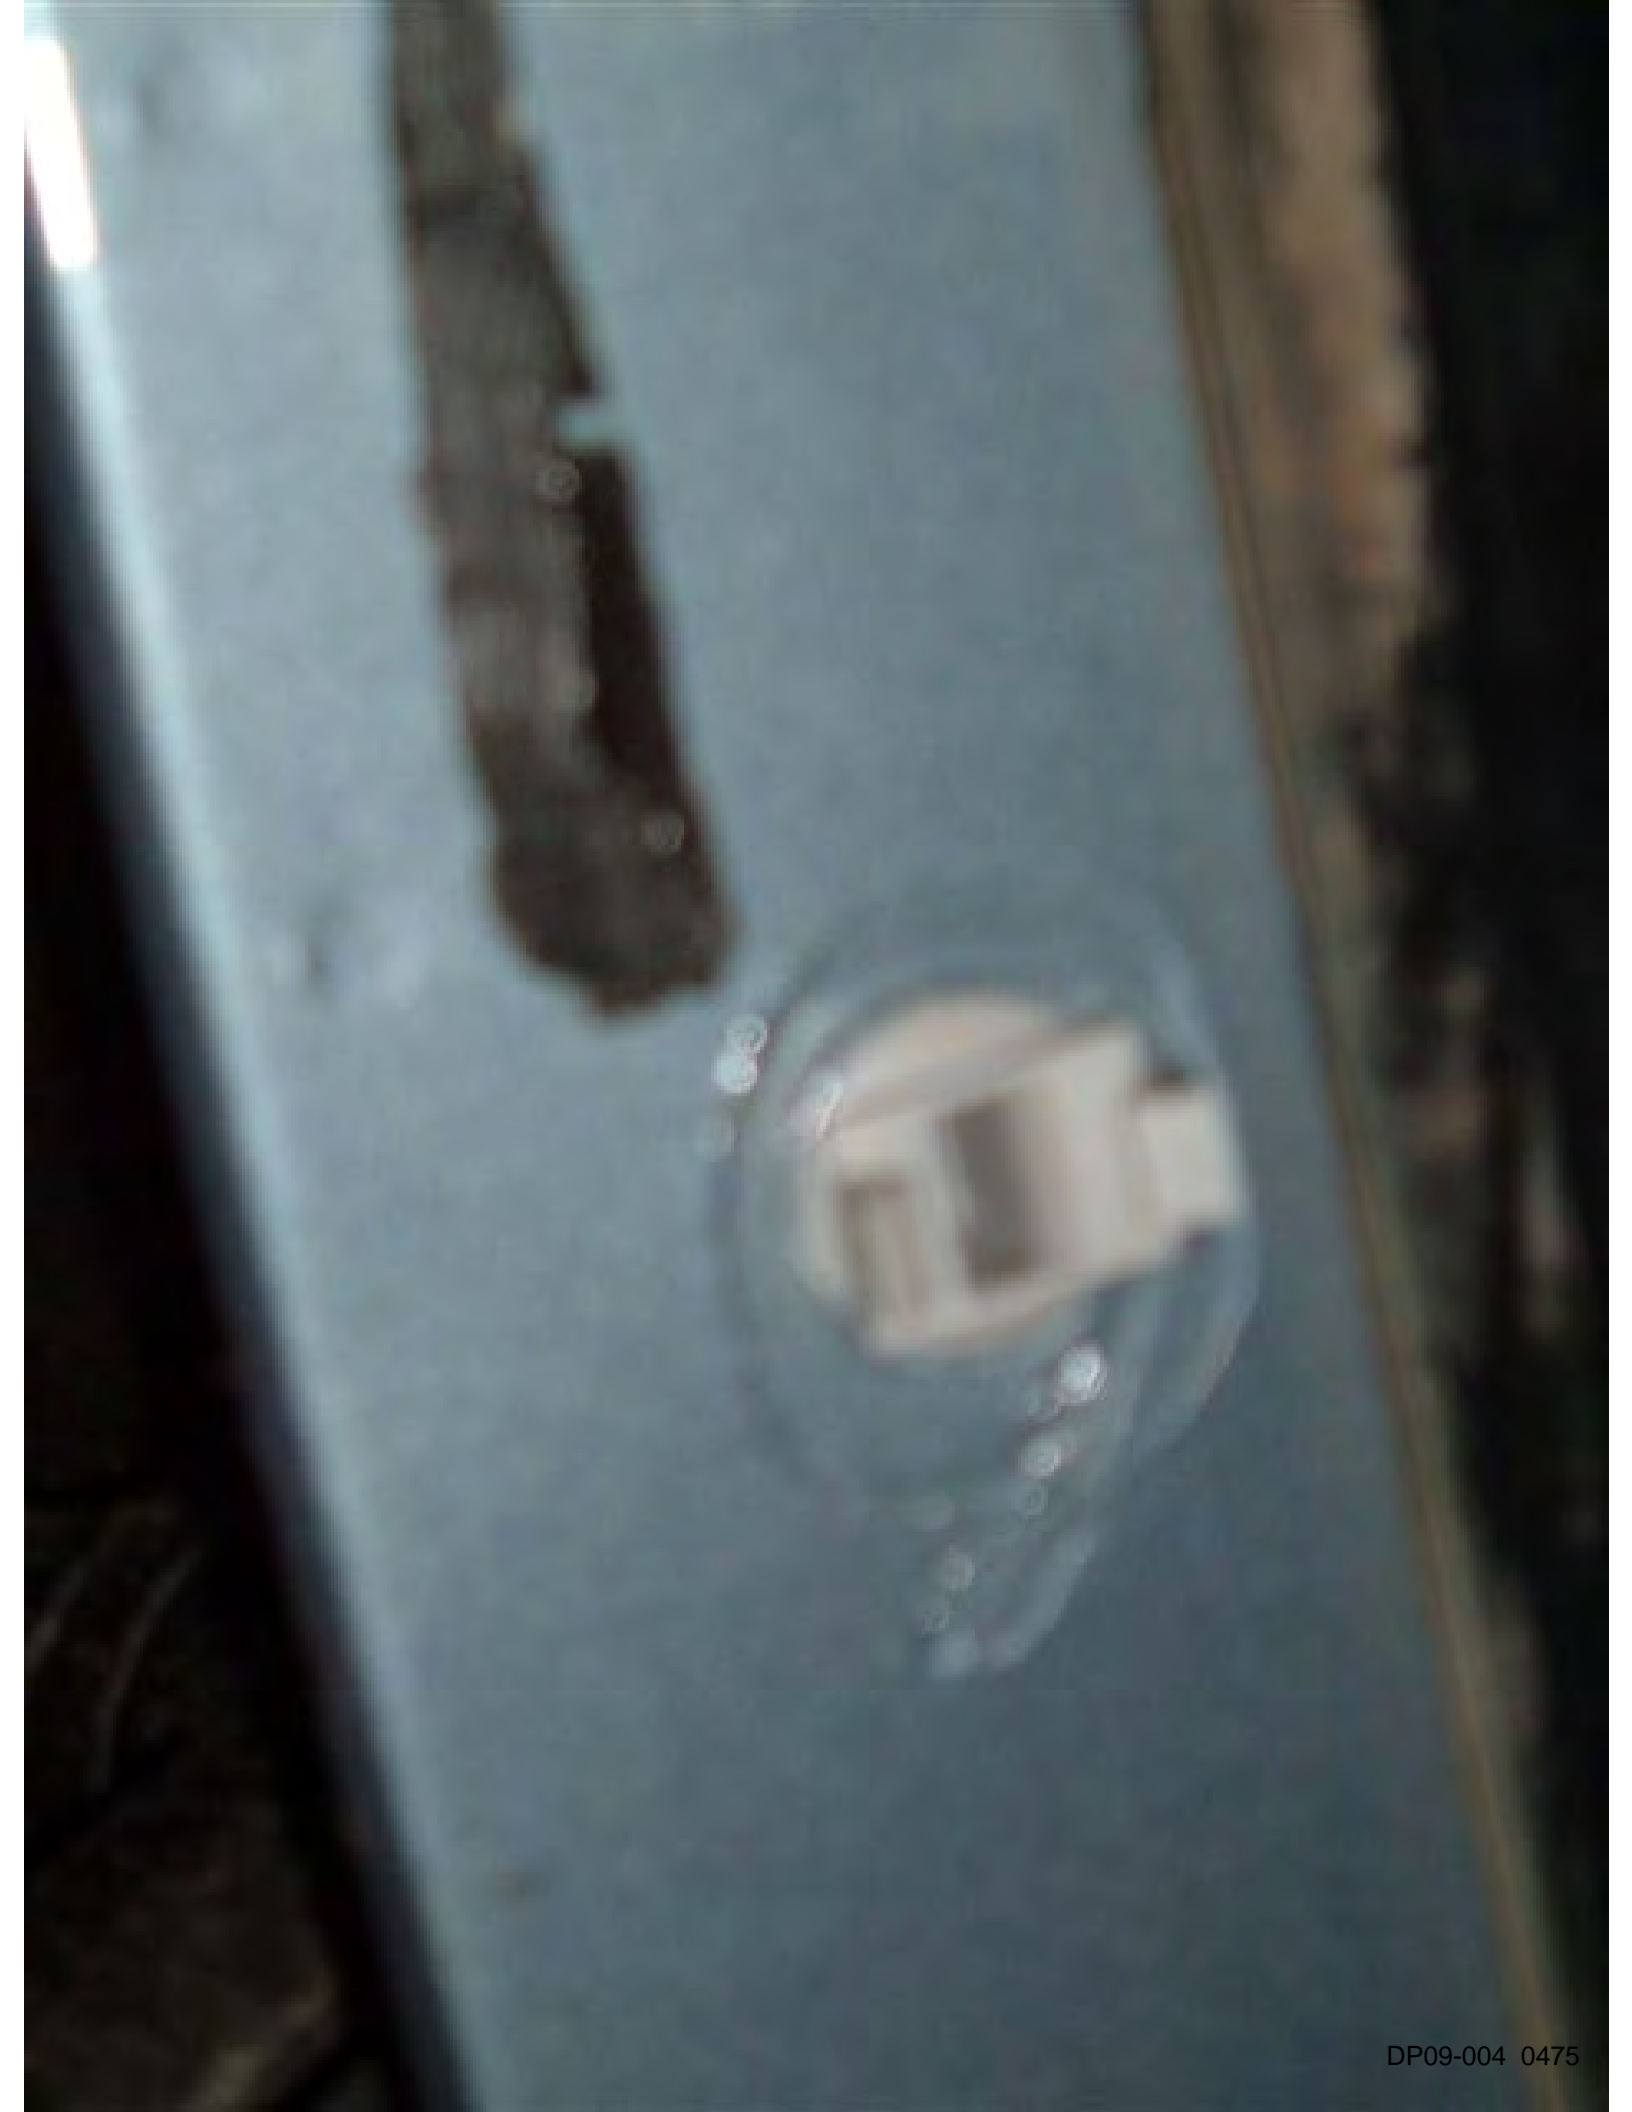
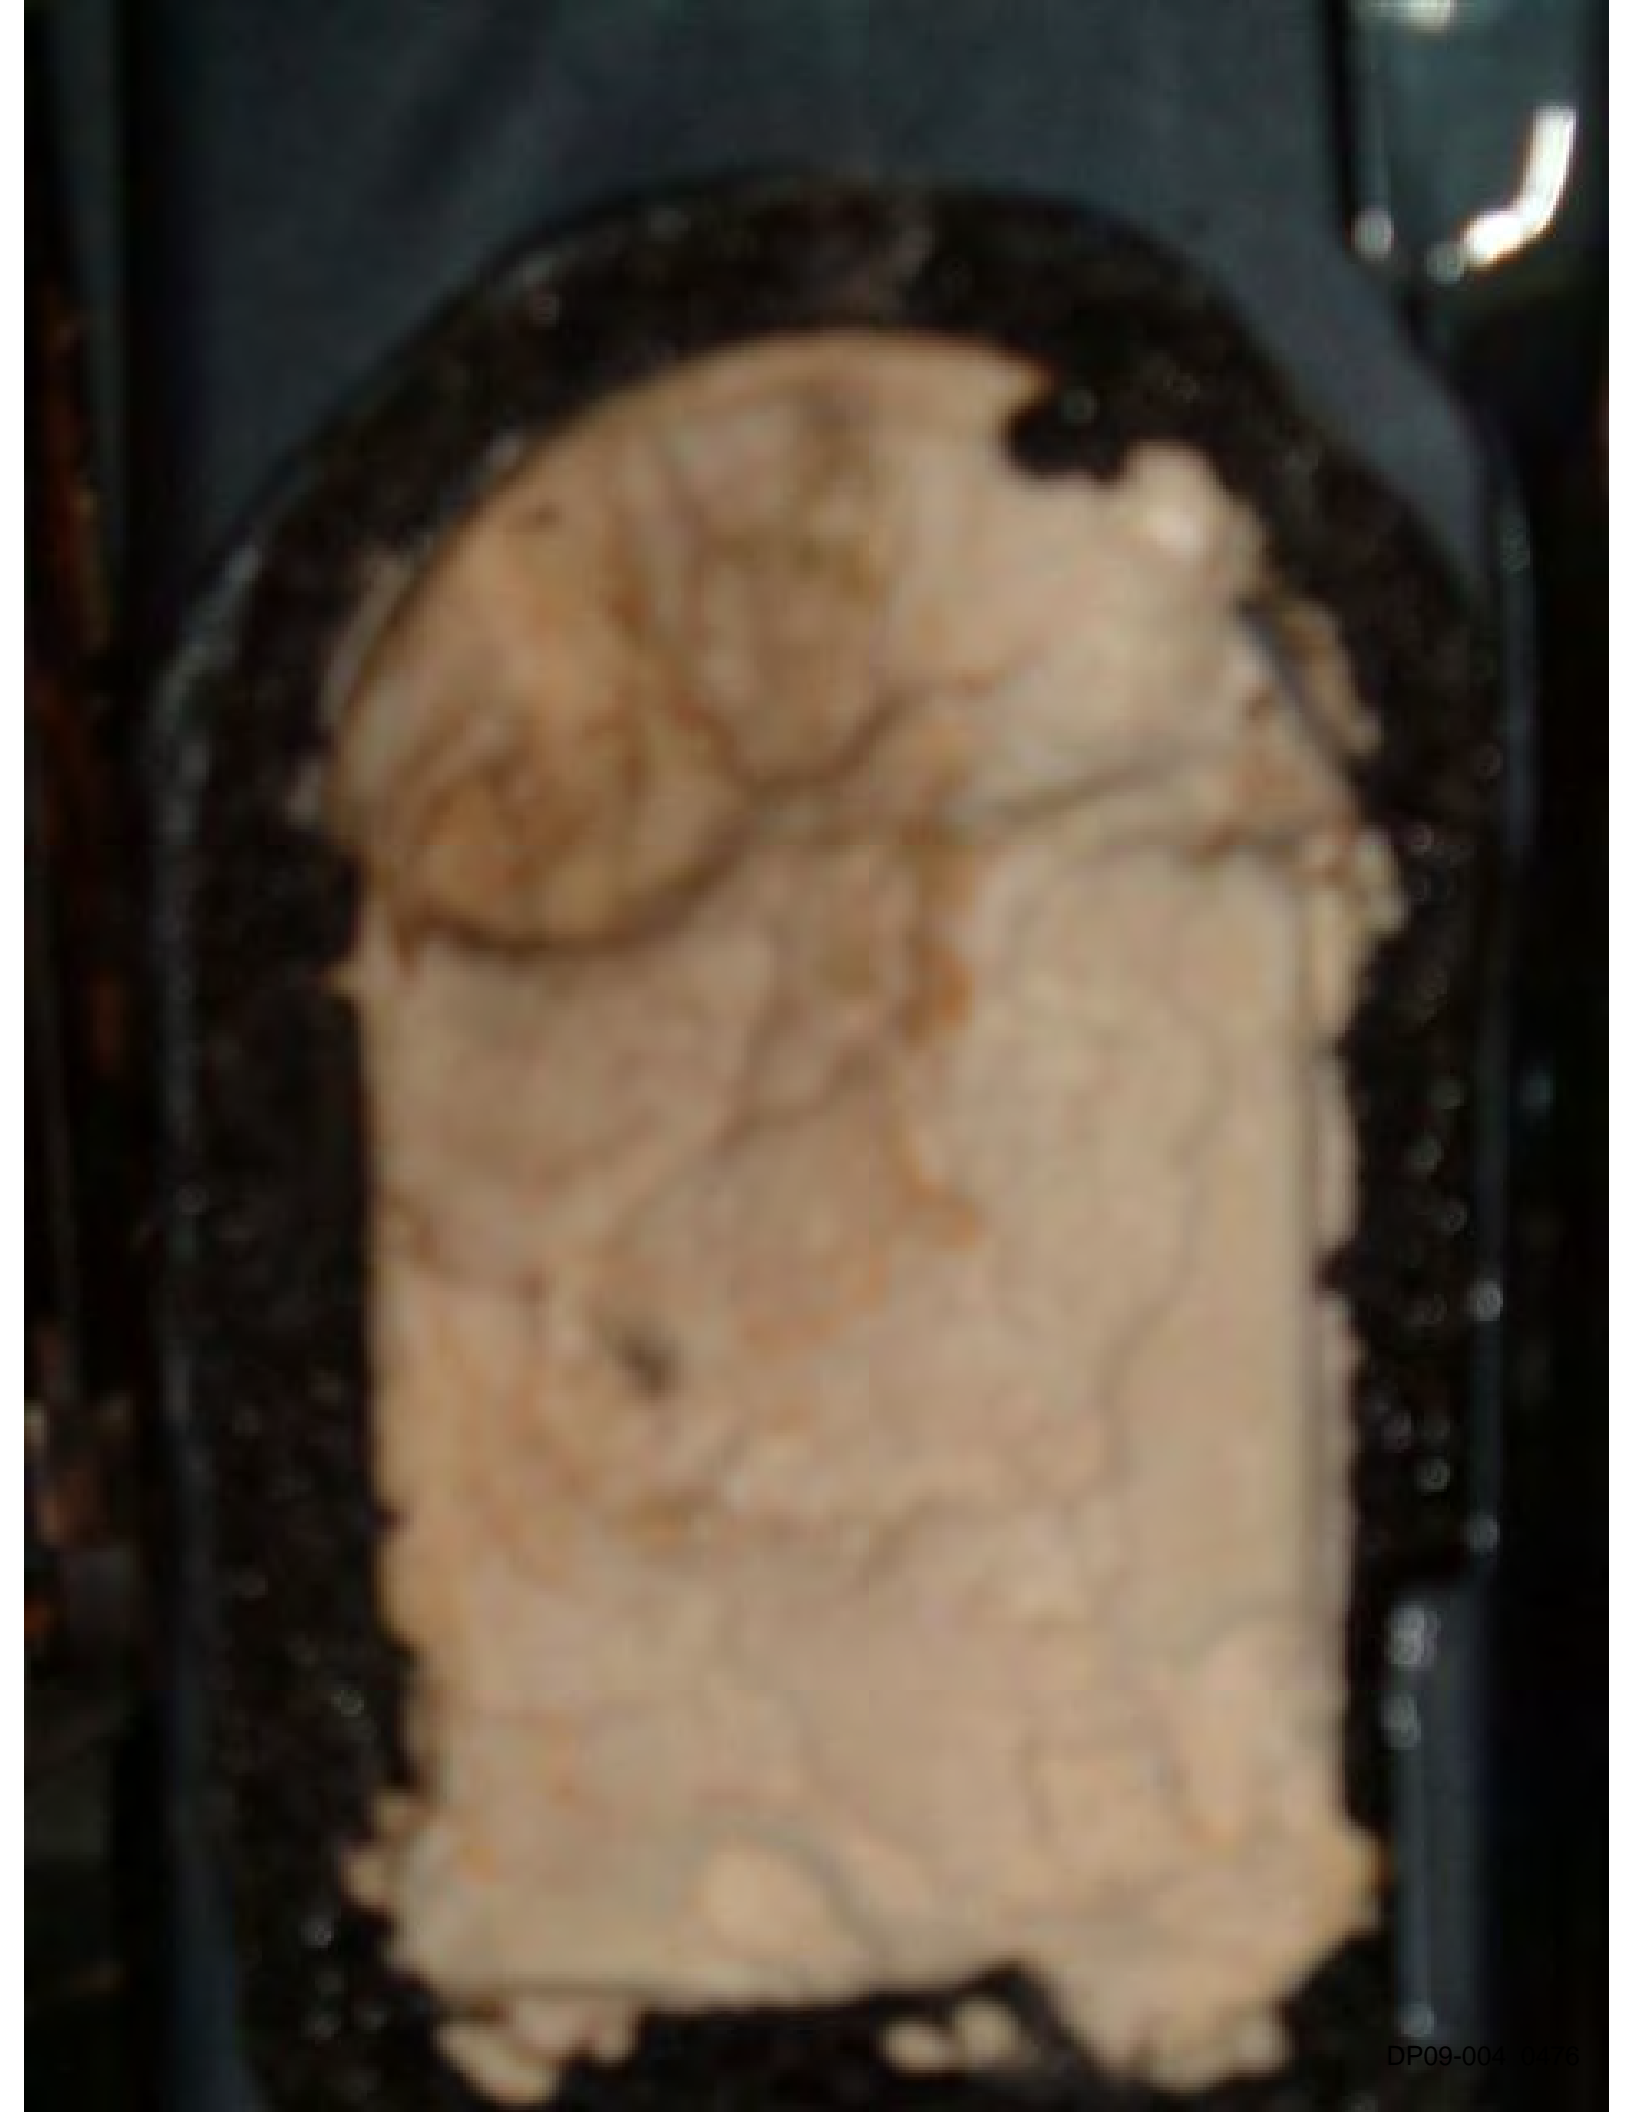
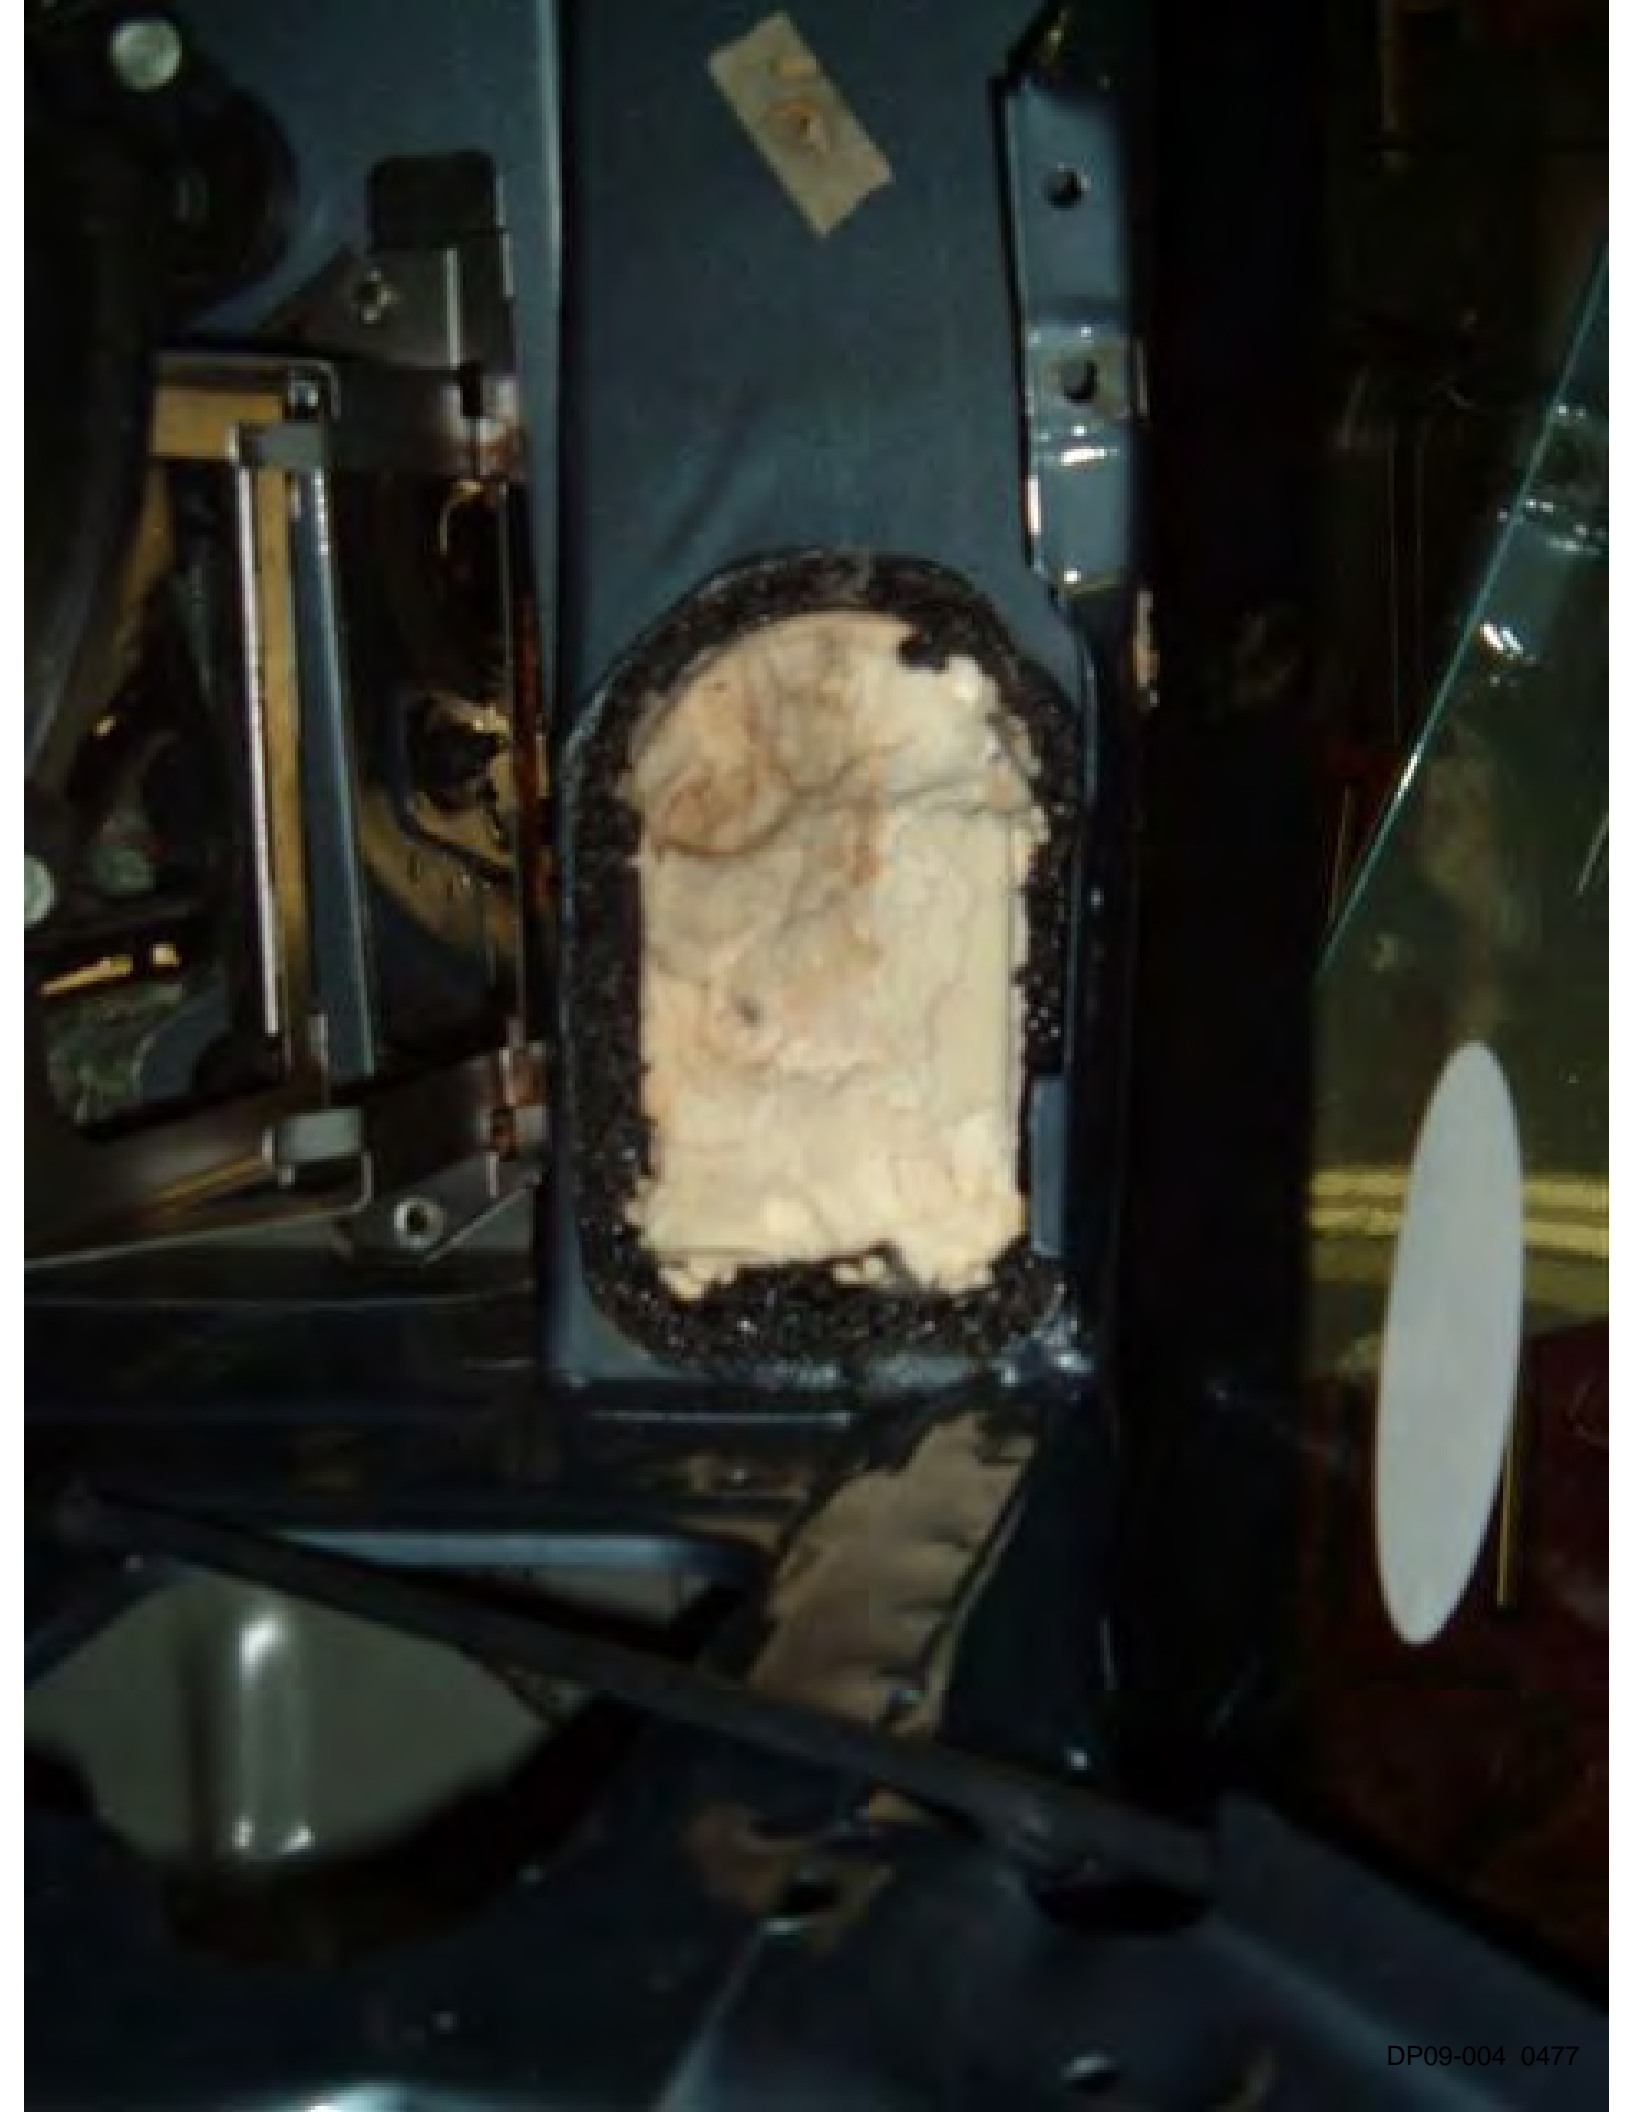
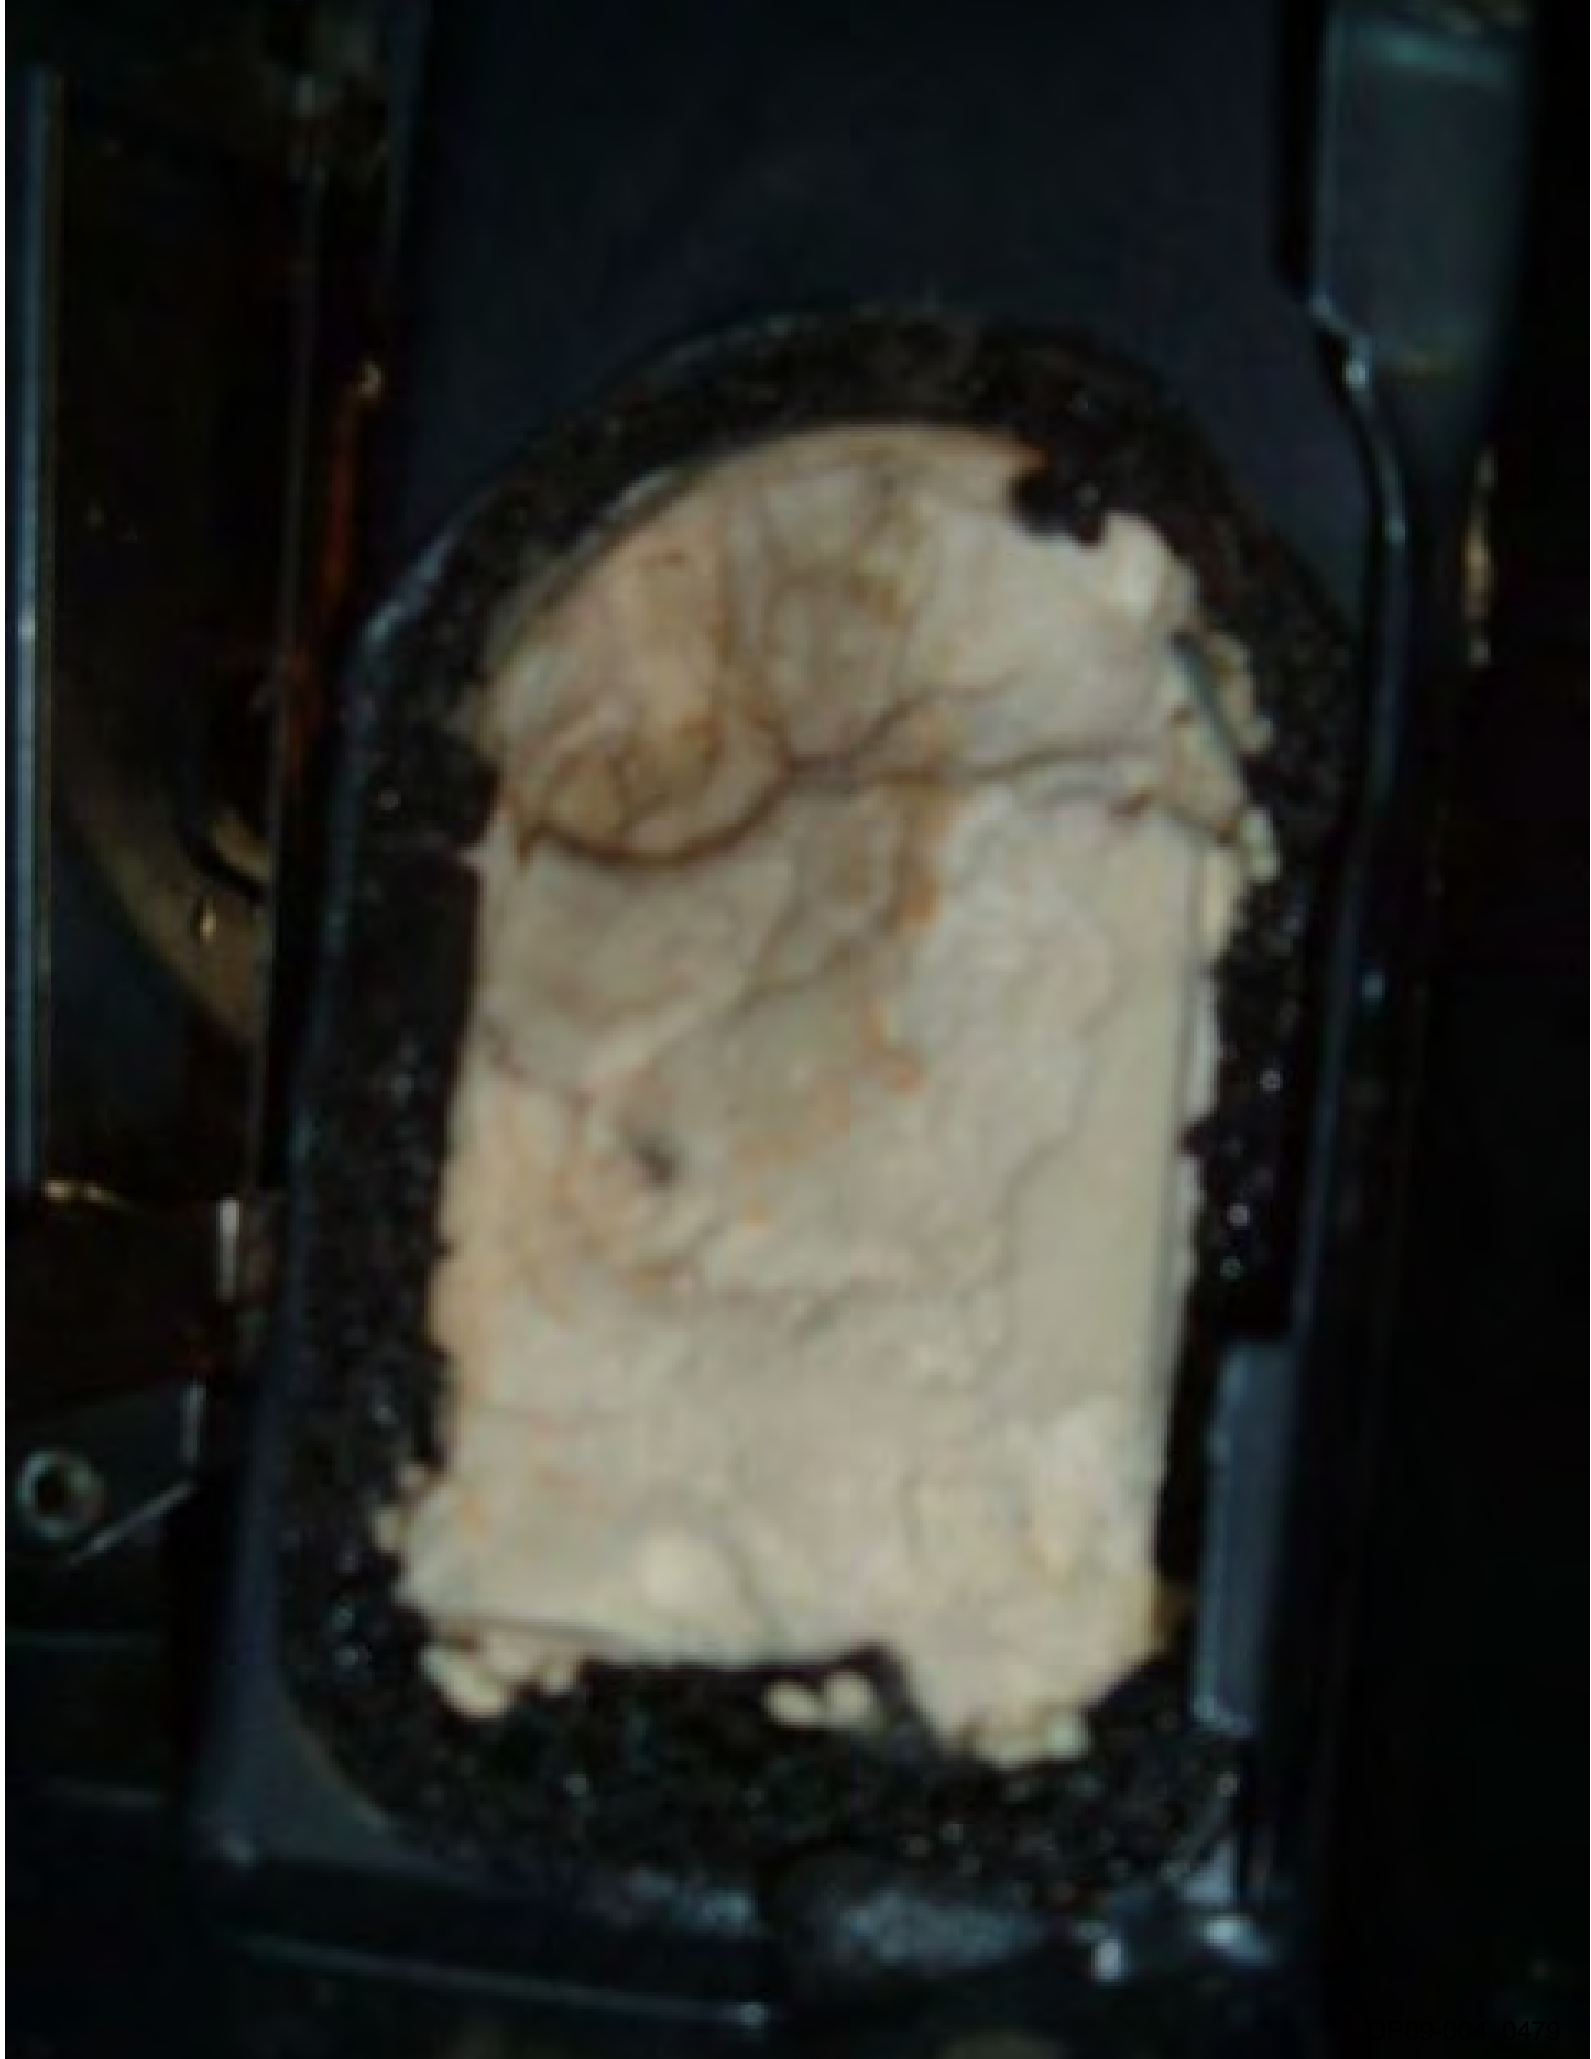
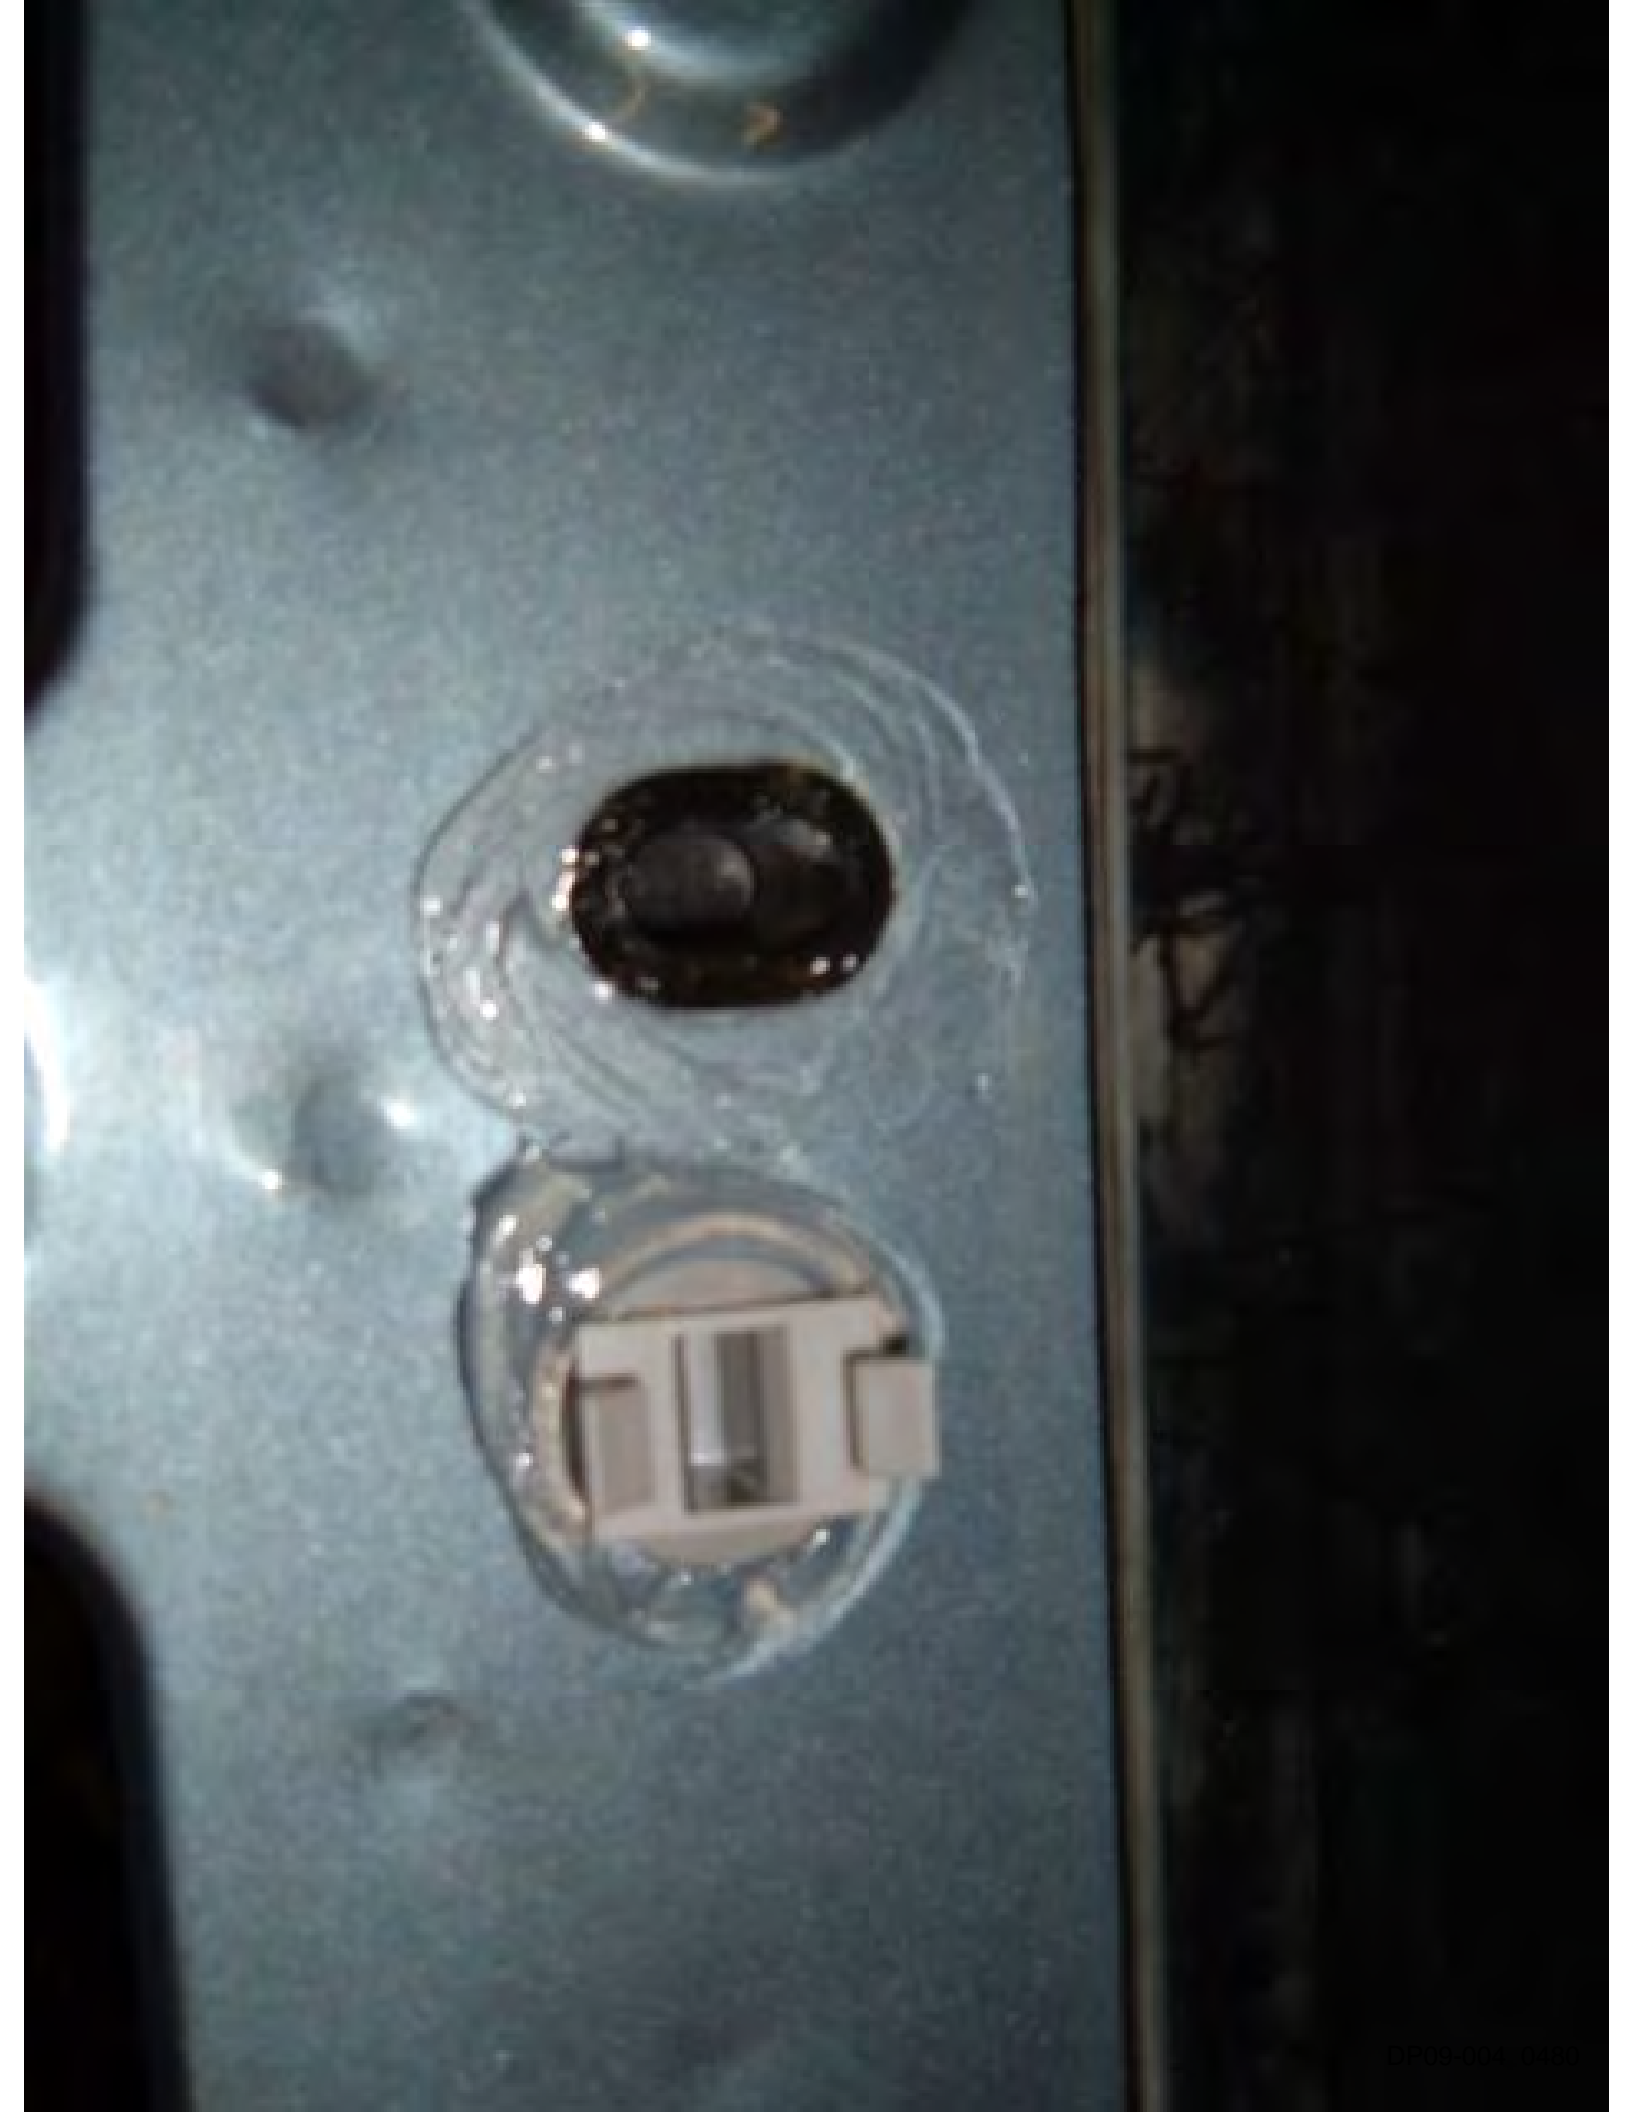
more pictures.
