Description: Engine/Transmission Driveability Issues

Vehicles: Windstar, Freestar, Monterey

From: Kulkarni, Arvind (A.)
Sent: Wednesday, May 25, 2005 10:49 PM
To: Fang, Andy (A.); Stodola, Robert (R.J.); Tigchelaar, Doug (D.G.)
Cc: Nasar, John (H.S.); Cordeau, Roger (T.); Hearn, Mark (E.)
Subject: Analysis of CQIS data of water leak into PCM

V229 Wipe Cowl Module – Water Leak Paths

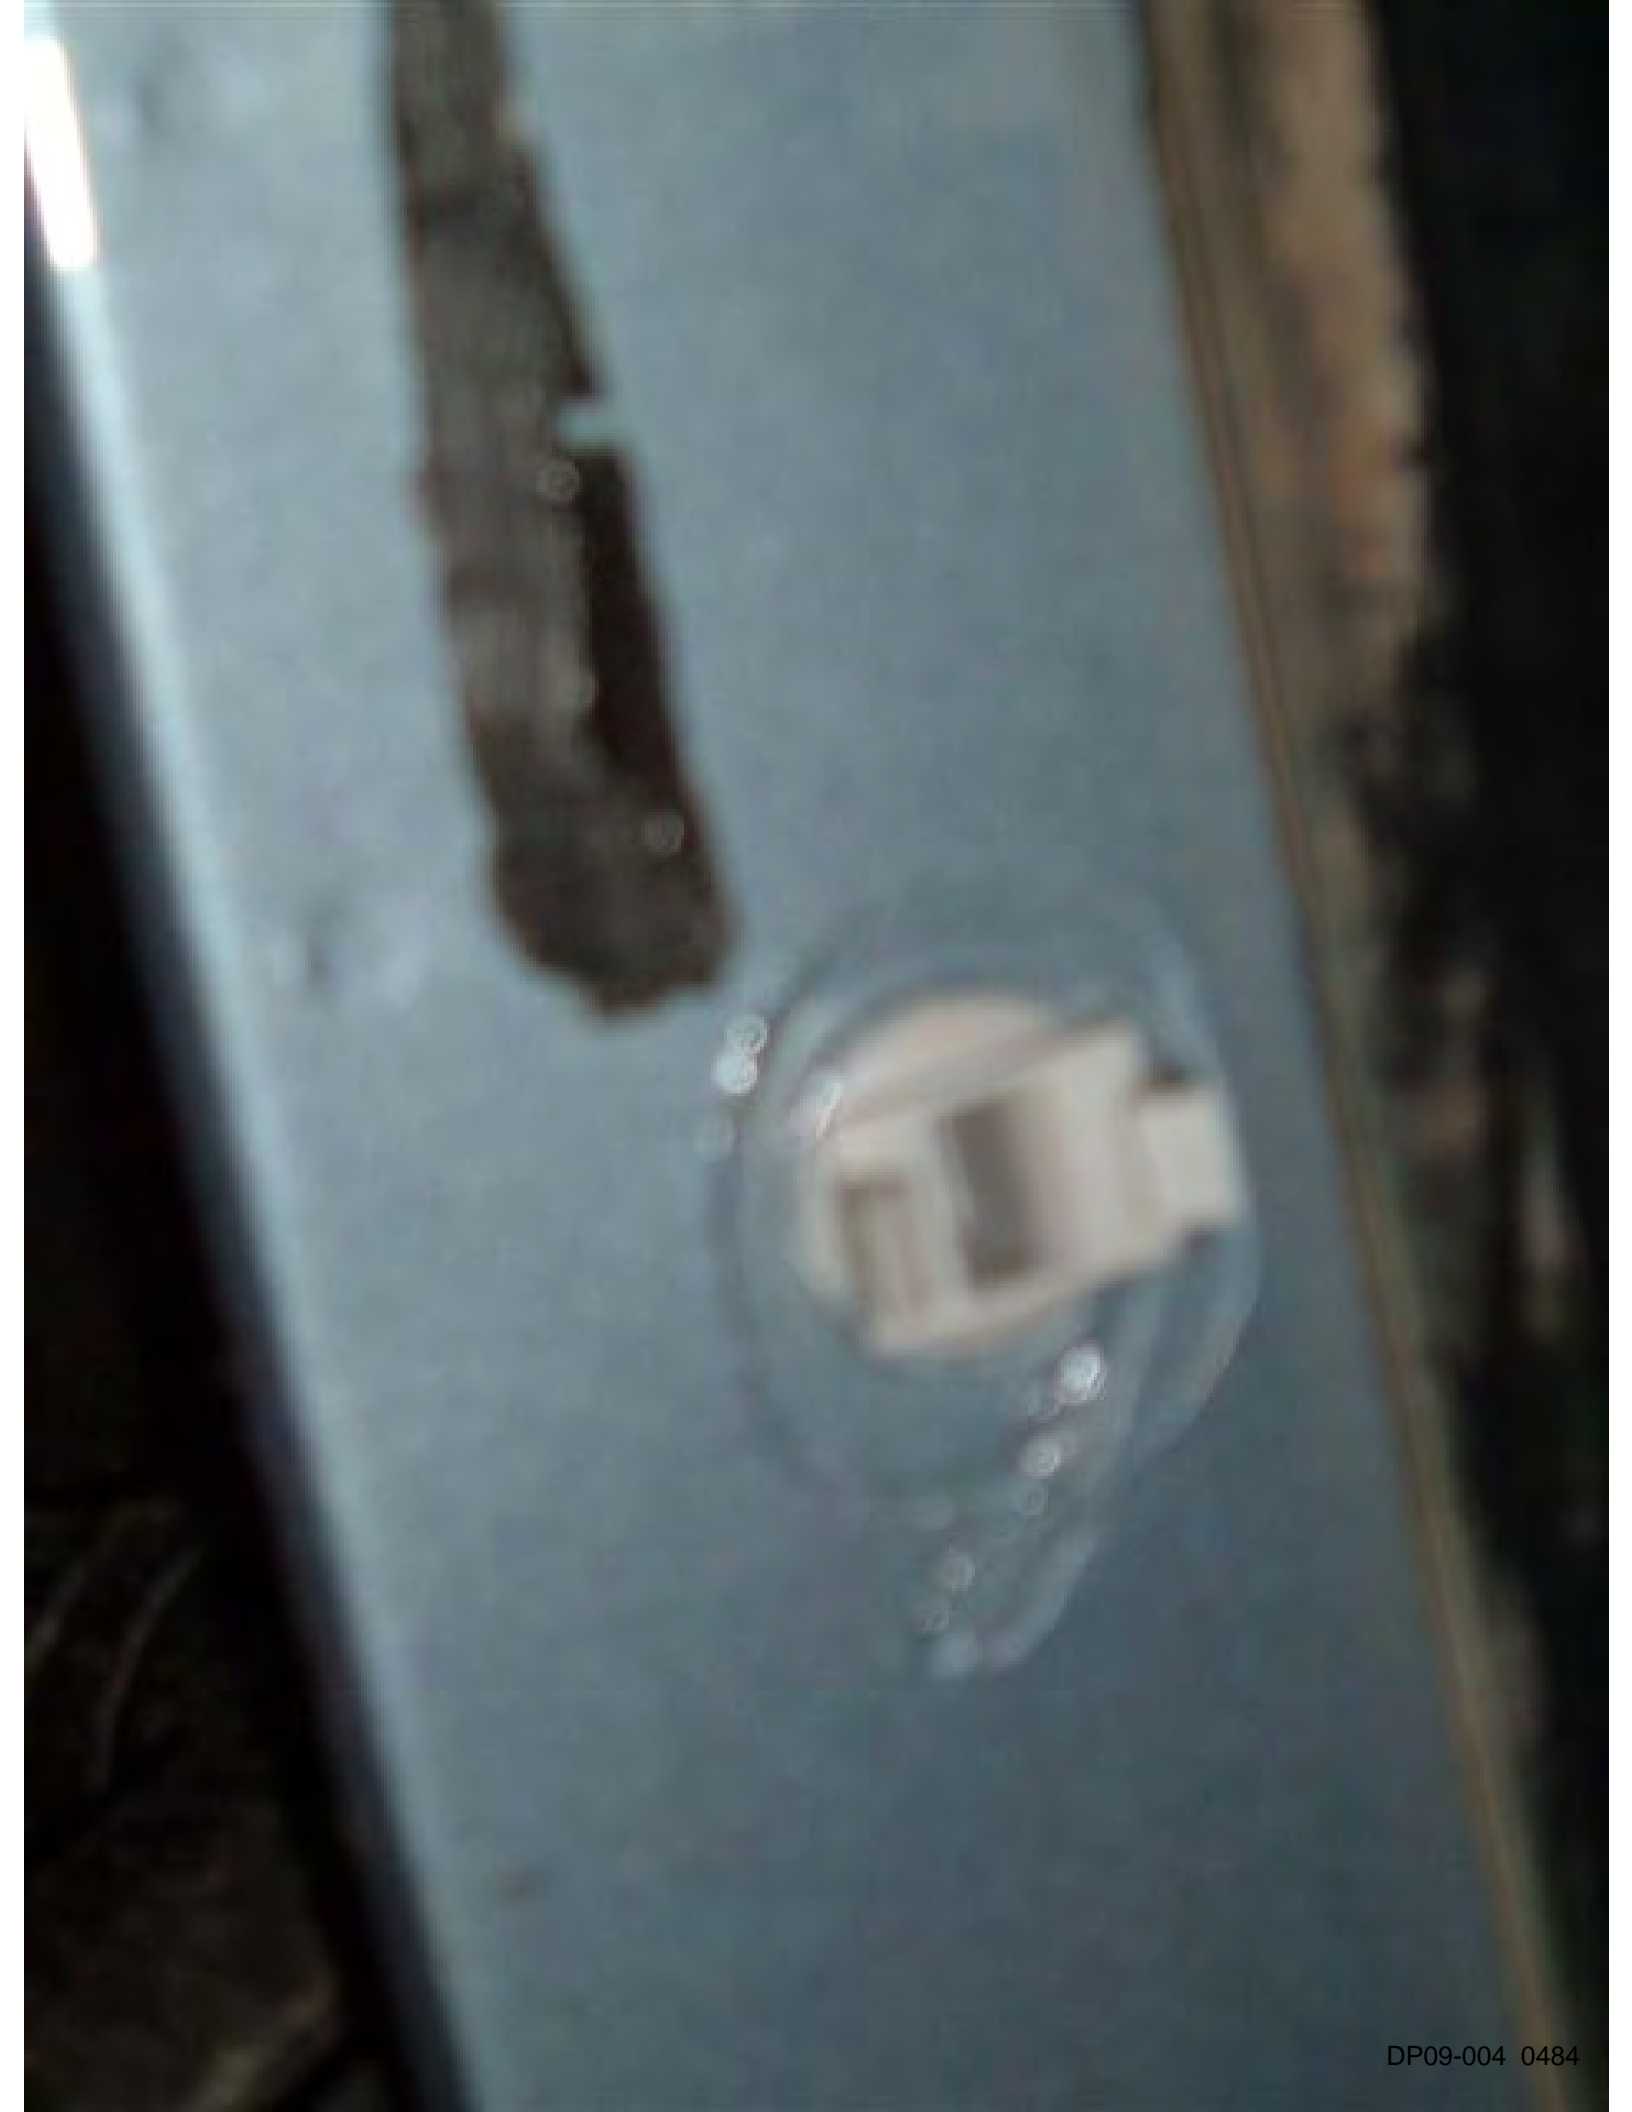
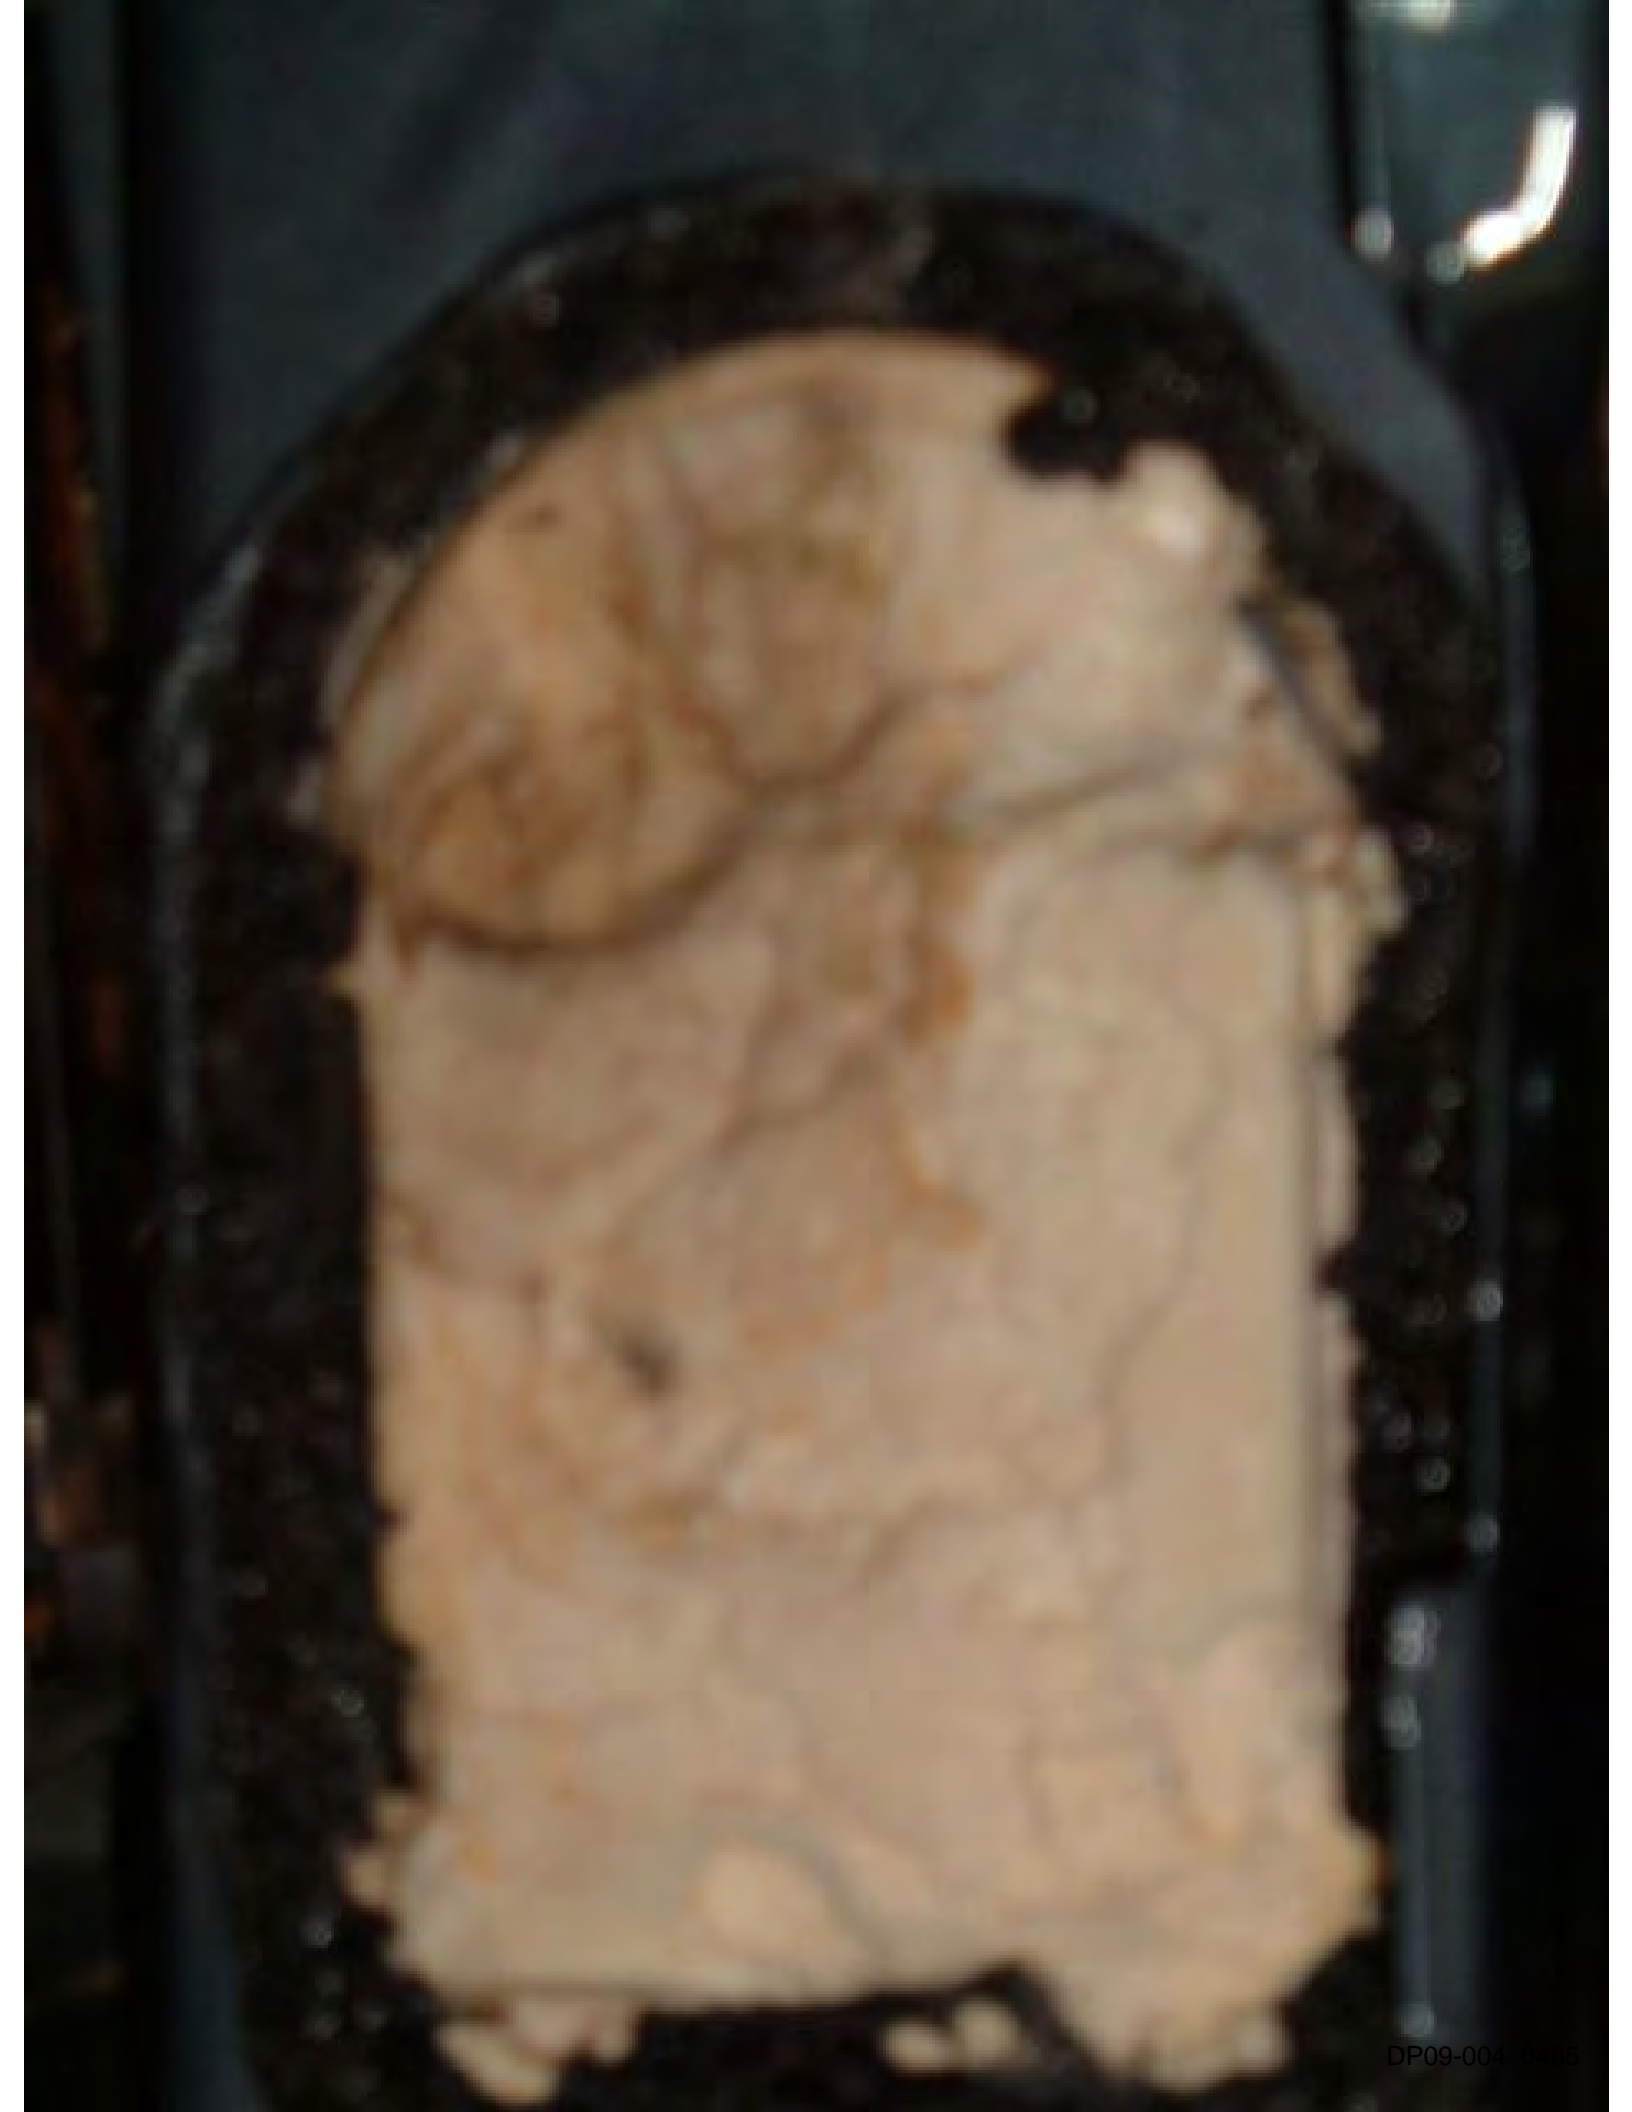
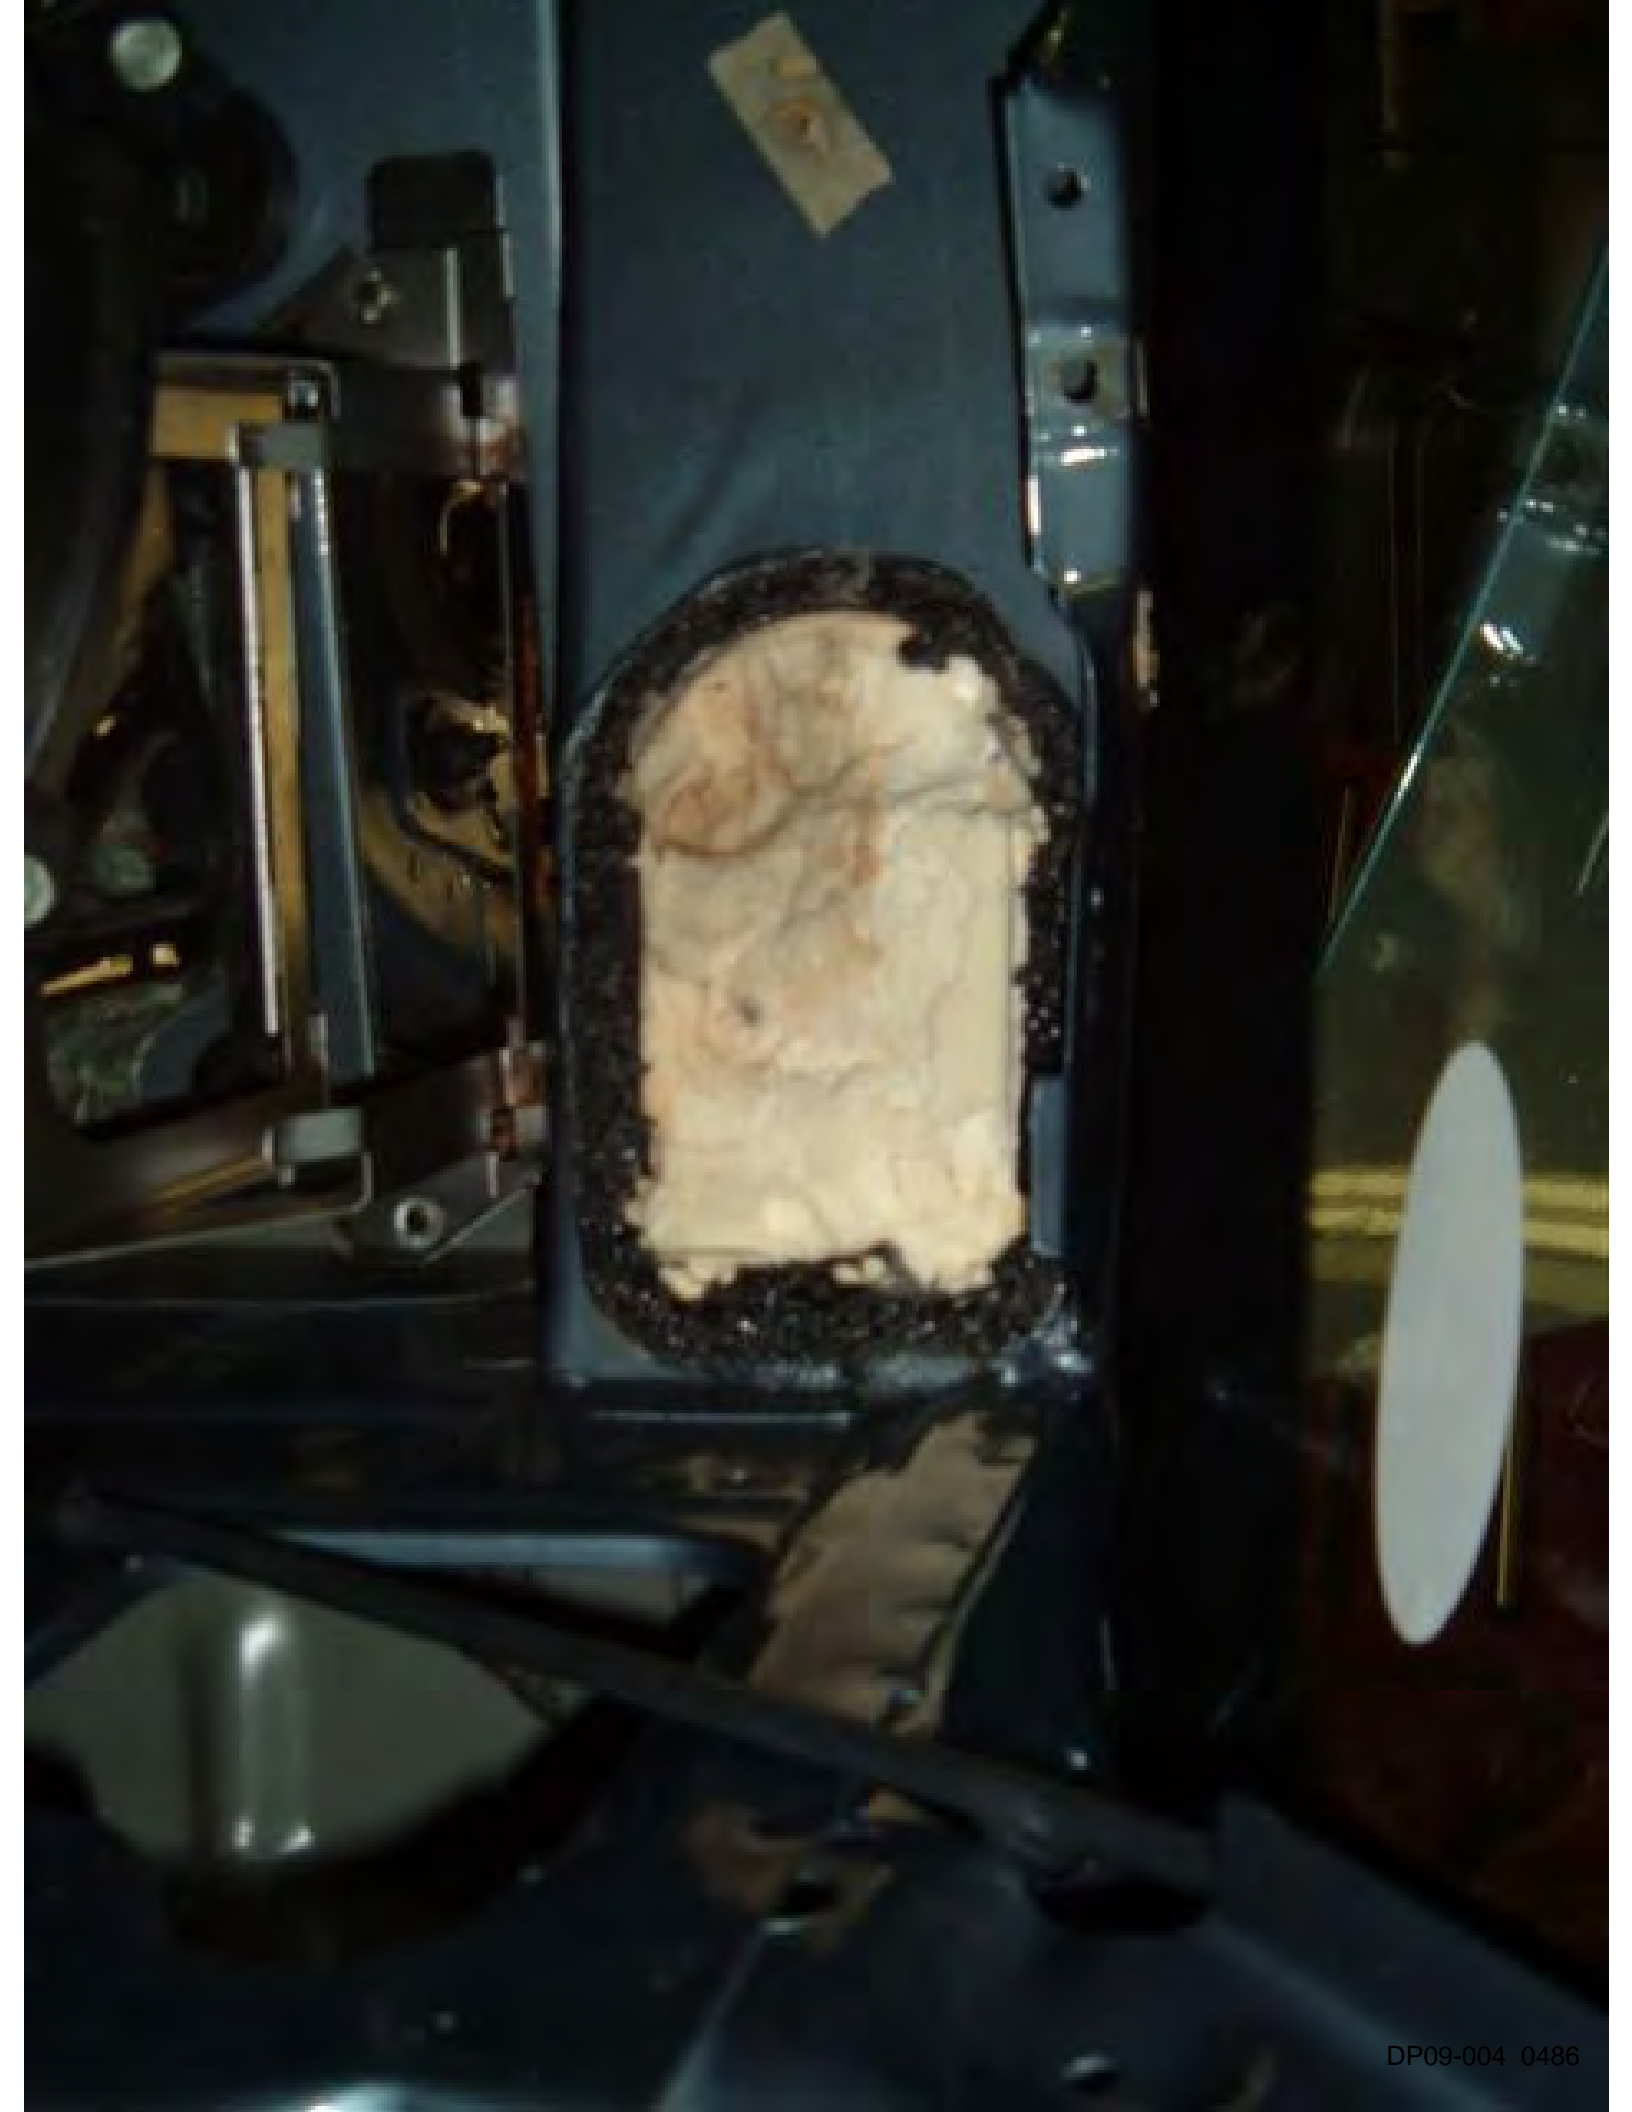
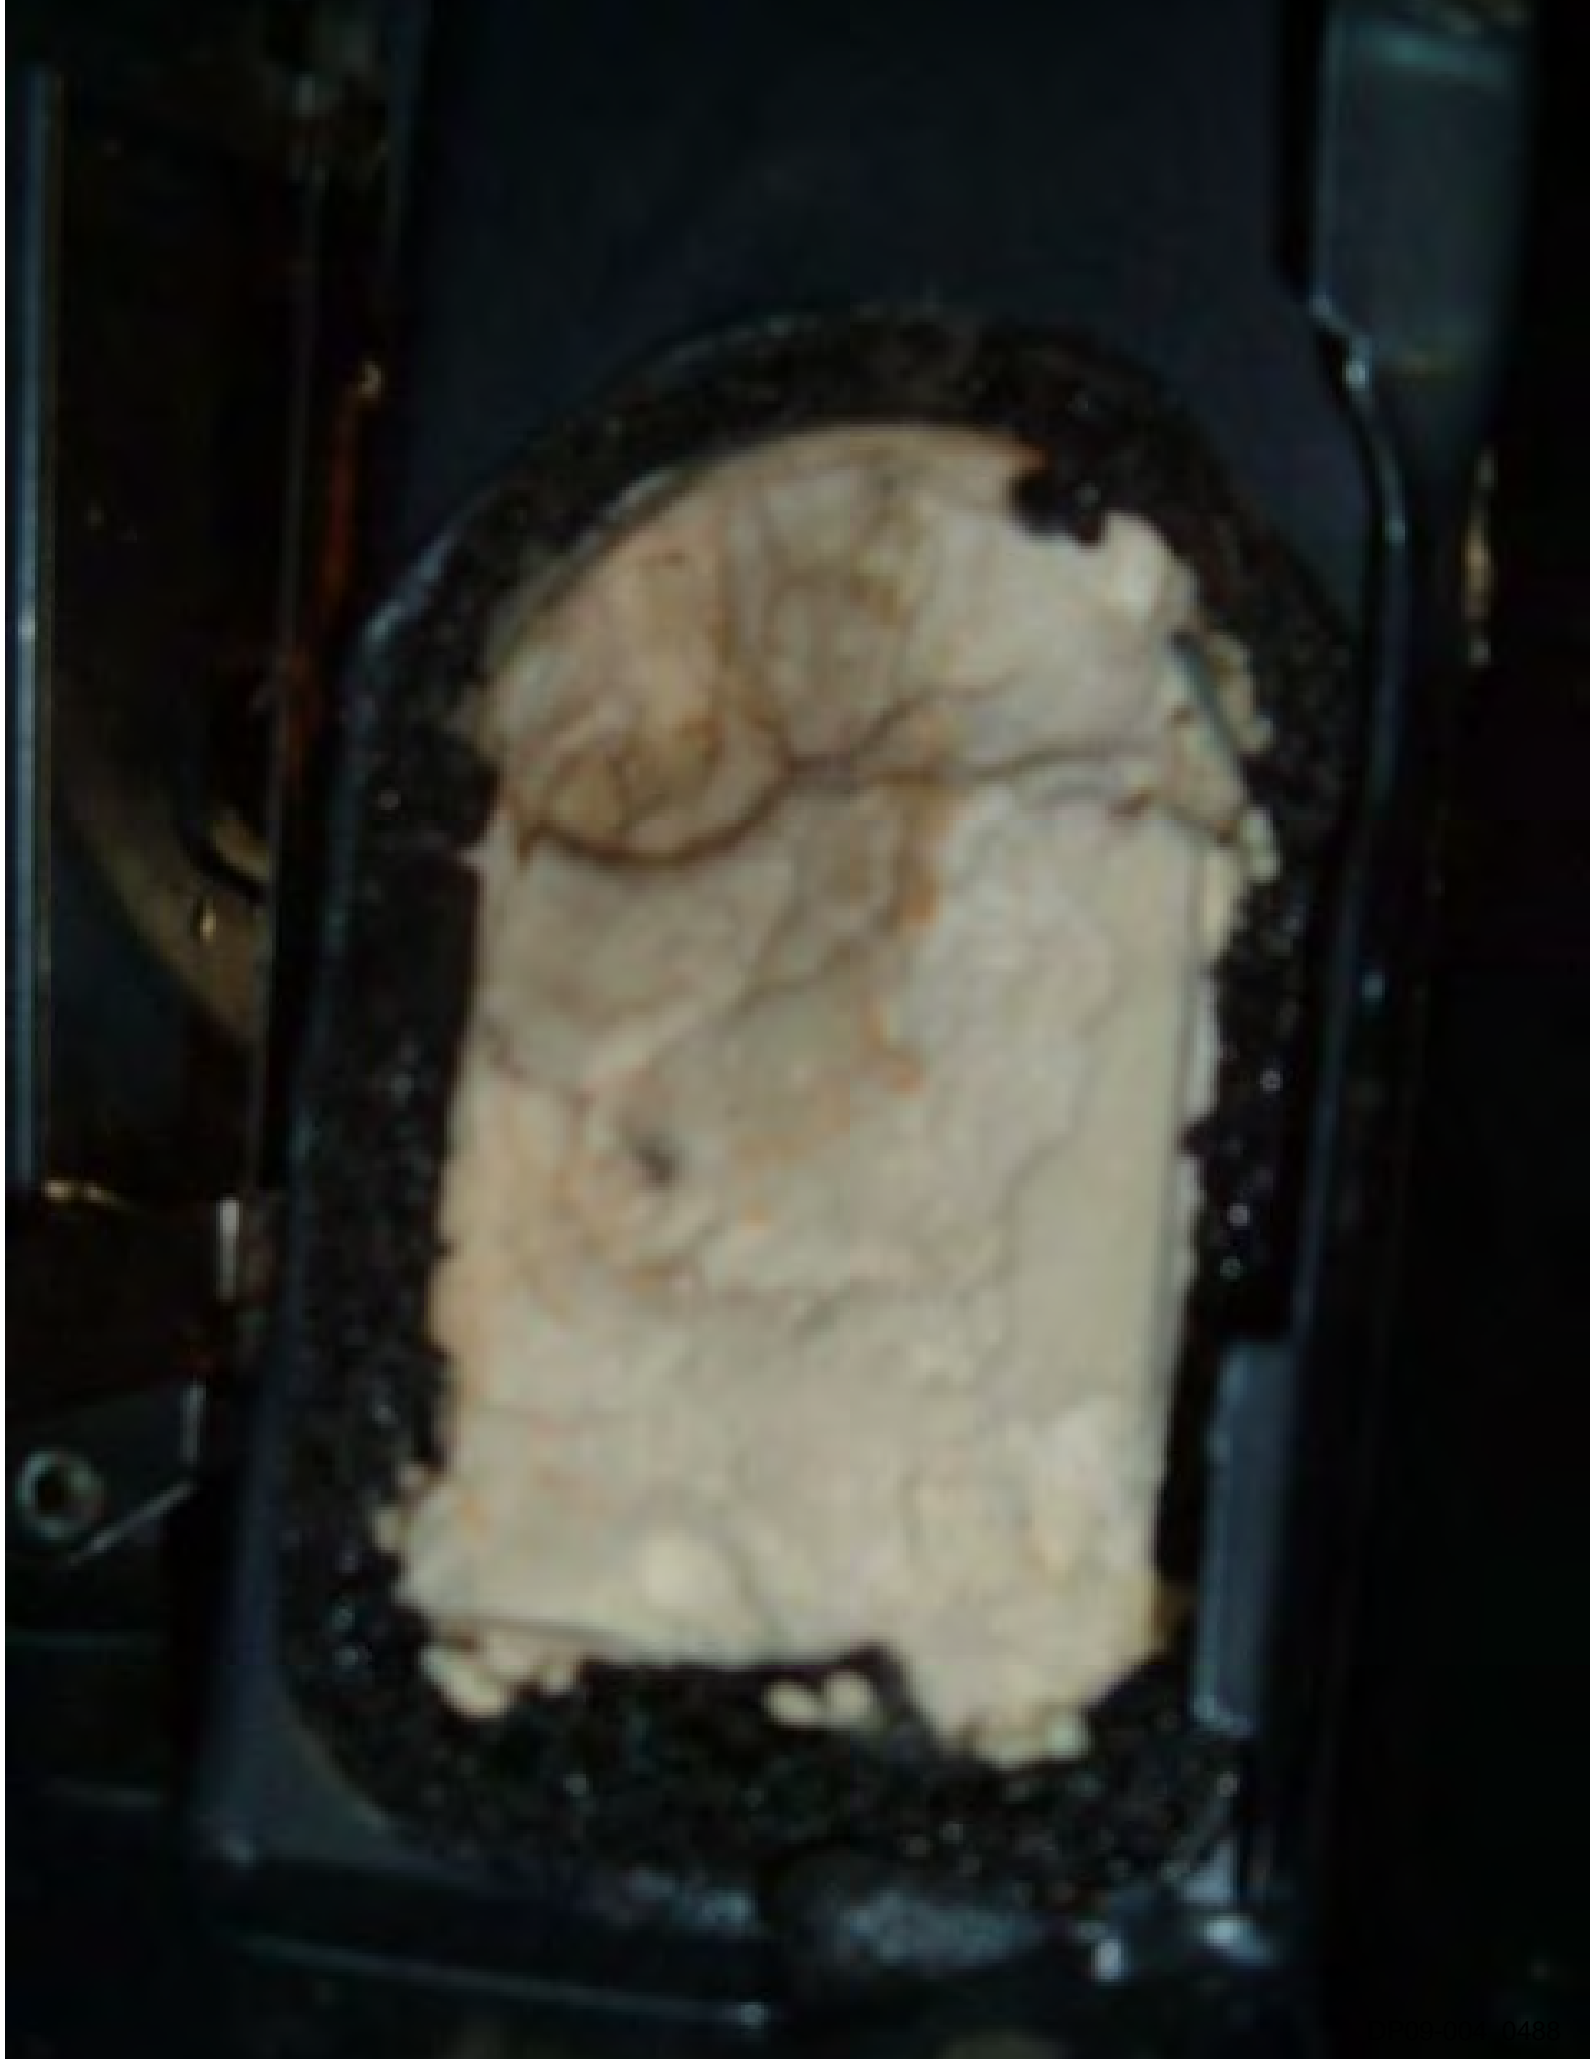
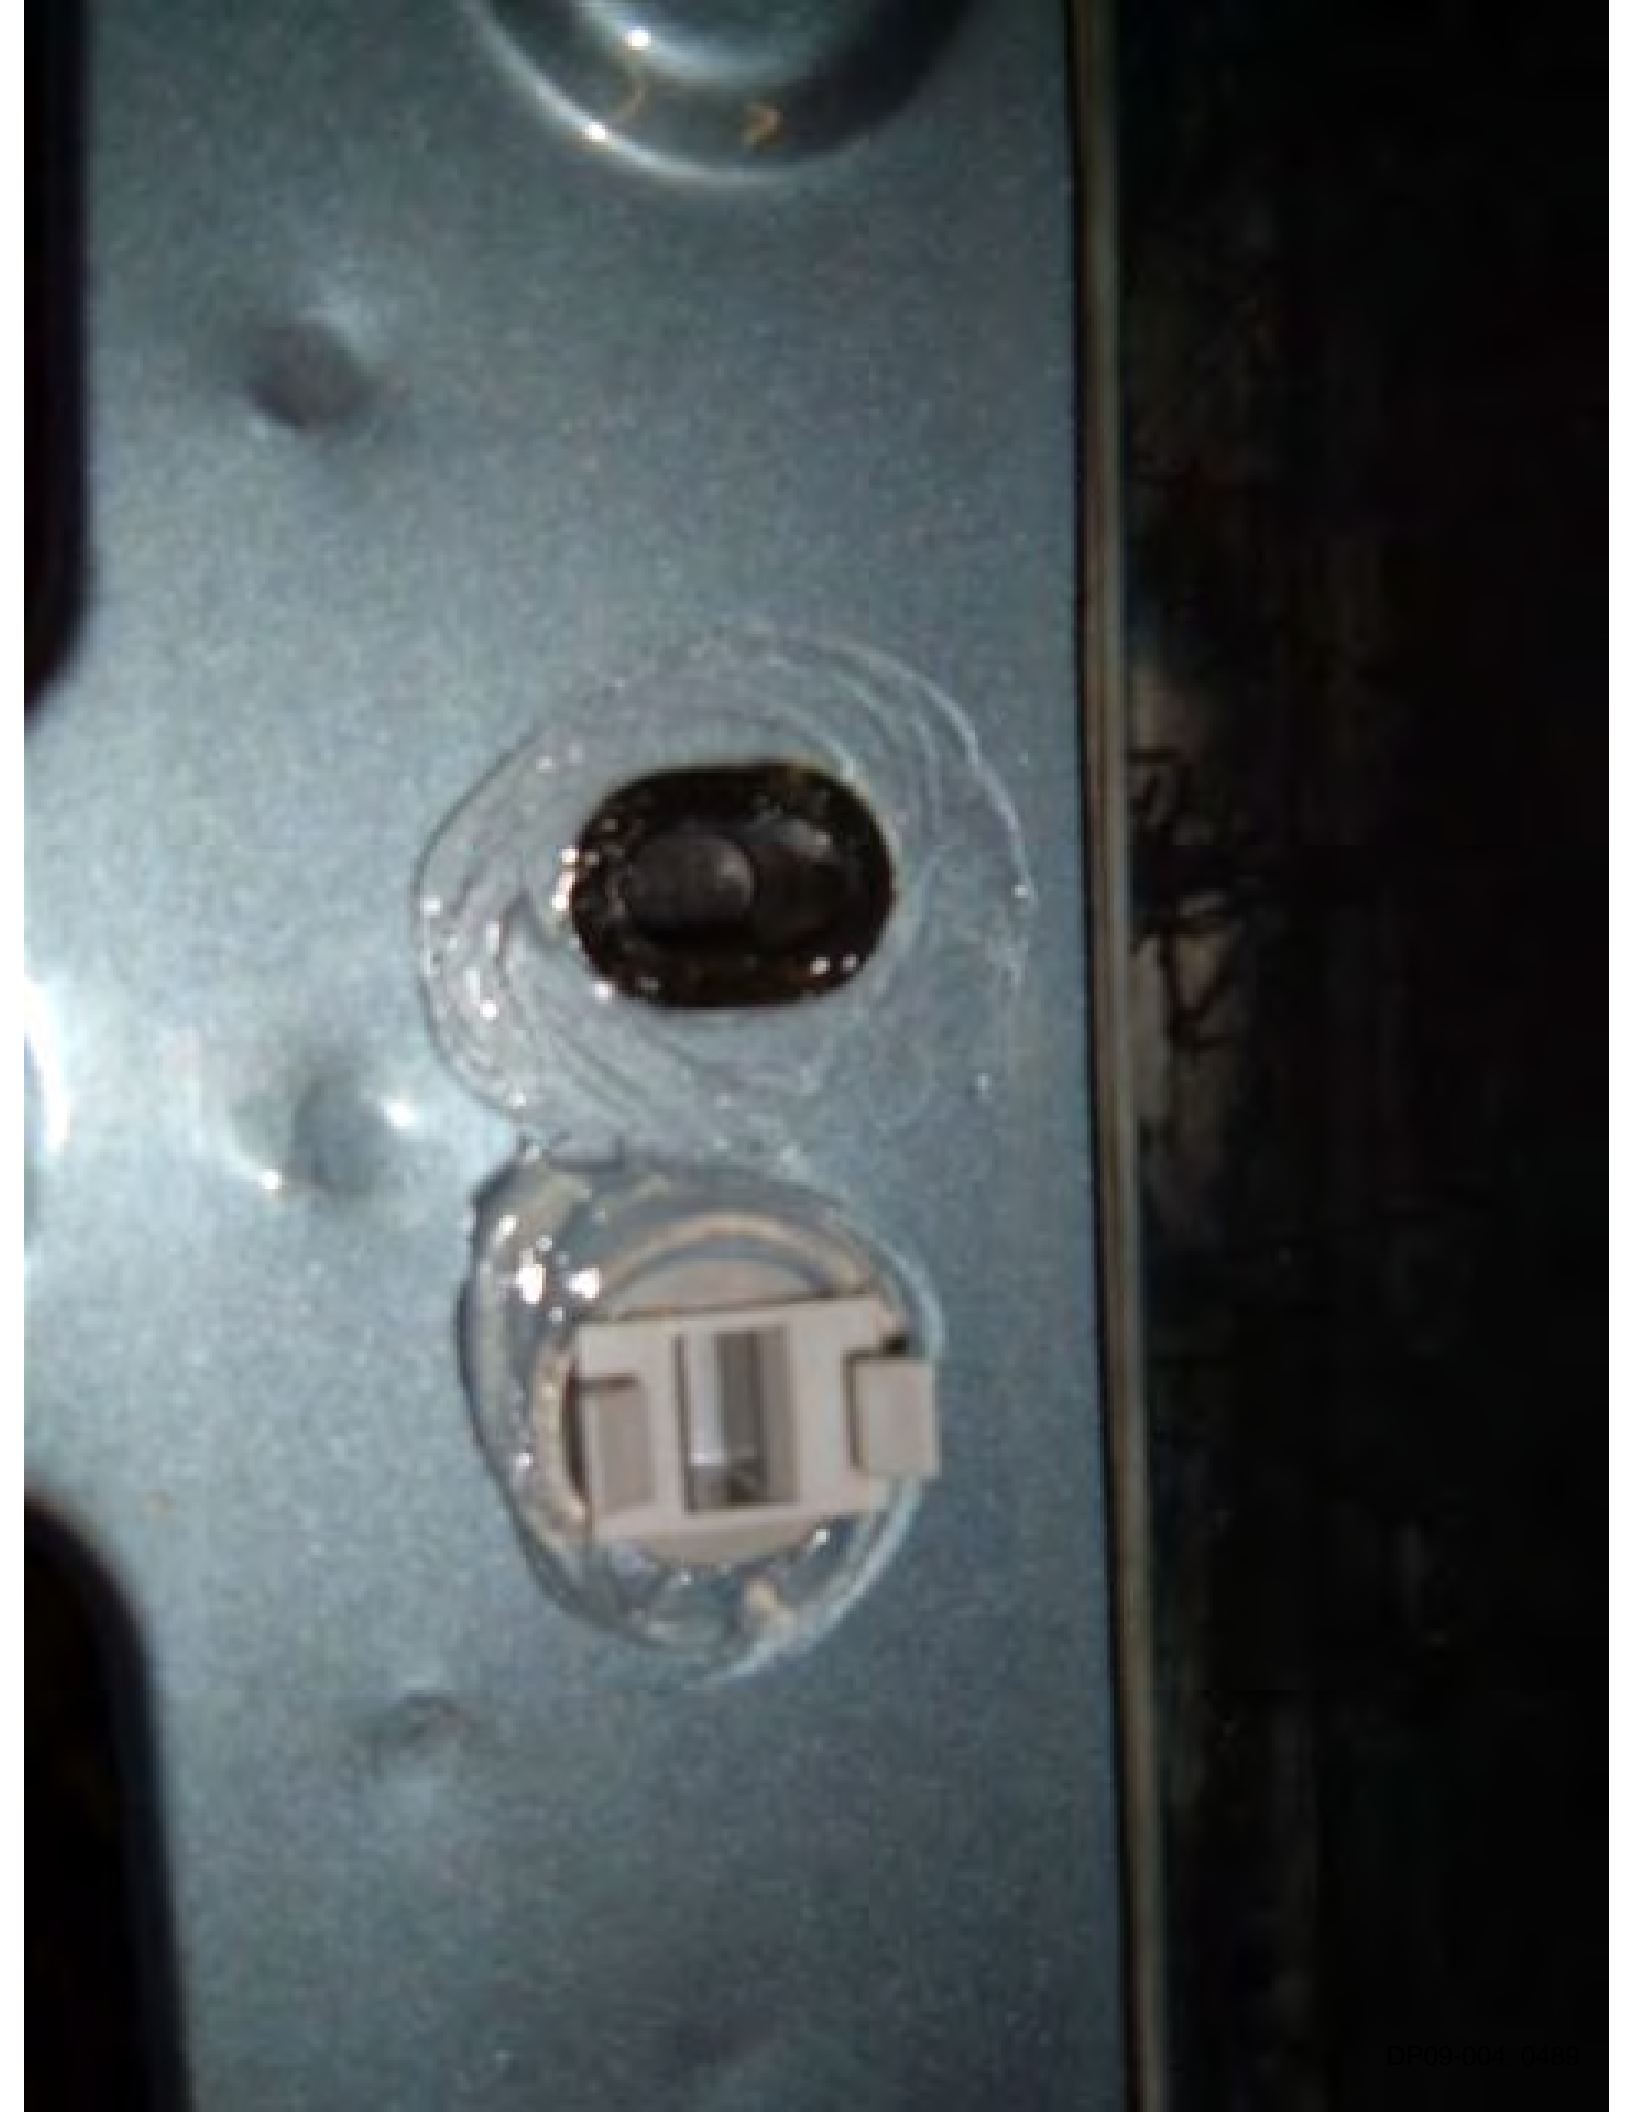
Here are the pictures you requested,any problems please let me know.tel;905-684-8791.
Roger Matthews.
