Description: Engine/Transmission Driveability Issues

Vehicles: Windstar, Freestar, Monterey

From: Kulkarni, Arvind (A.)
Sent: Wednesday, May 25, 2005 10:49 PM
To: Fang, Andy (A.); Stodola, Robert (R.J.); Tigchelaar, Doug (D.G.)
Cc: Nasar, John (H.S.); Cordeau, Roger (T.); Hearn, Mark (E.)
Subject: Analysis of CQIS data of water leak into PCM

V229 Wipe Cowl Module – Water Leak Paths

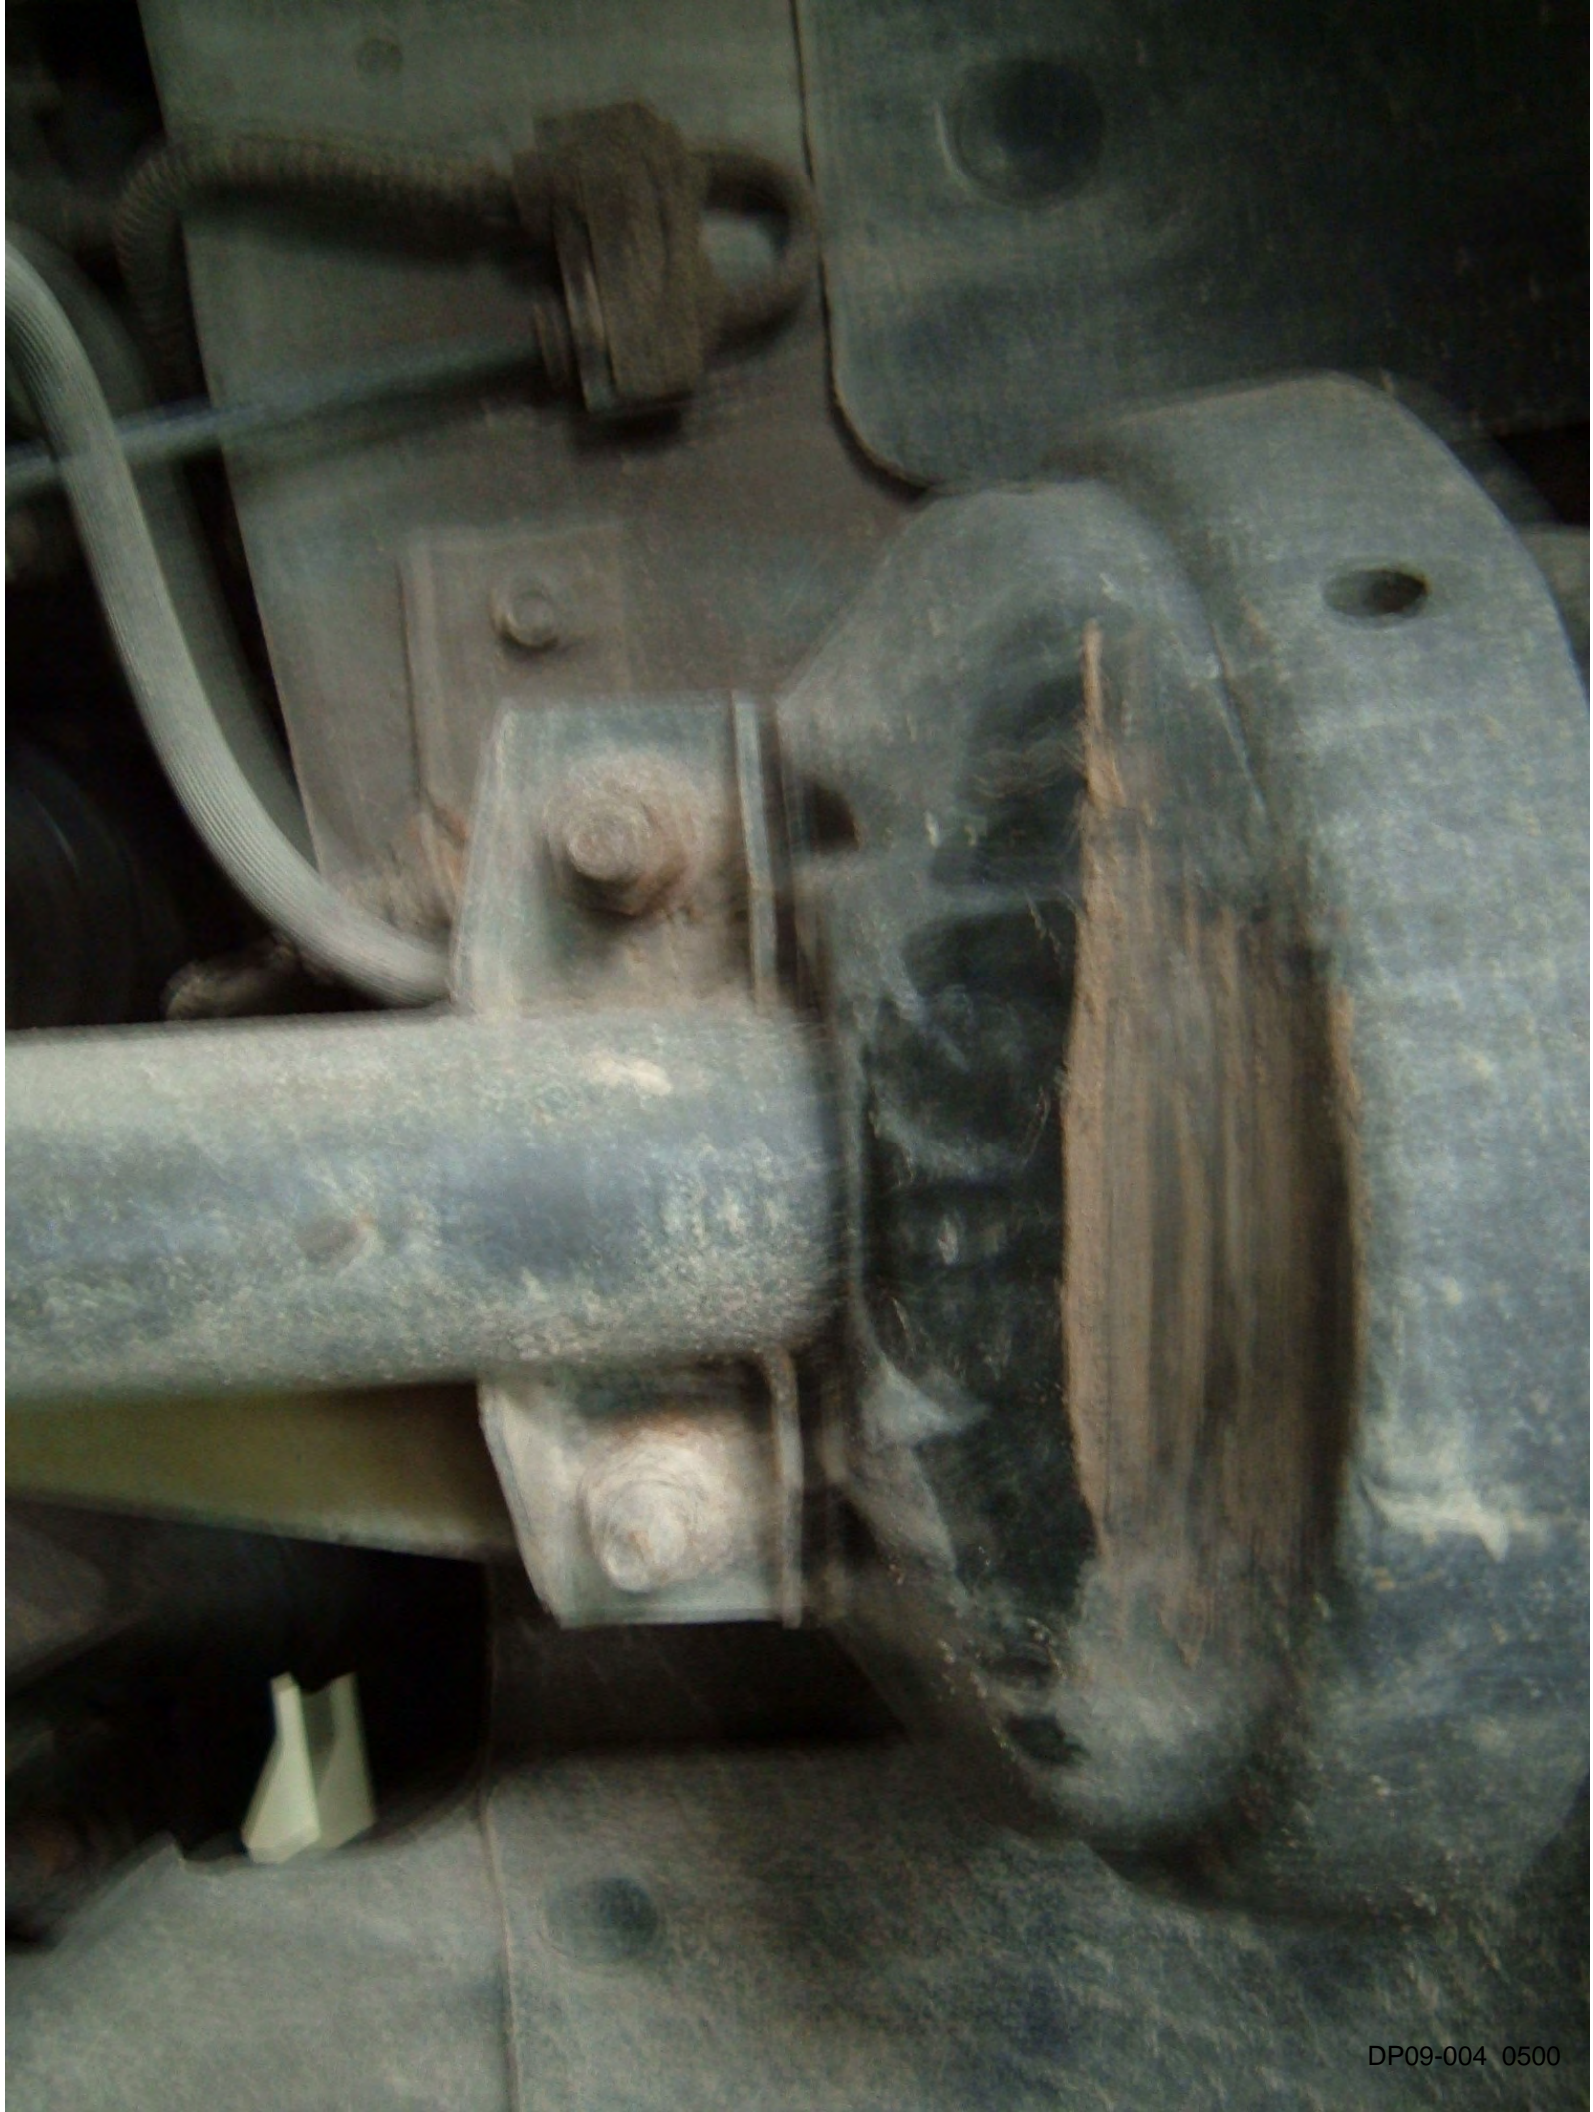
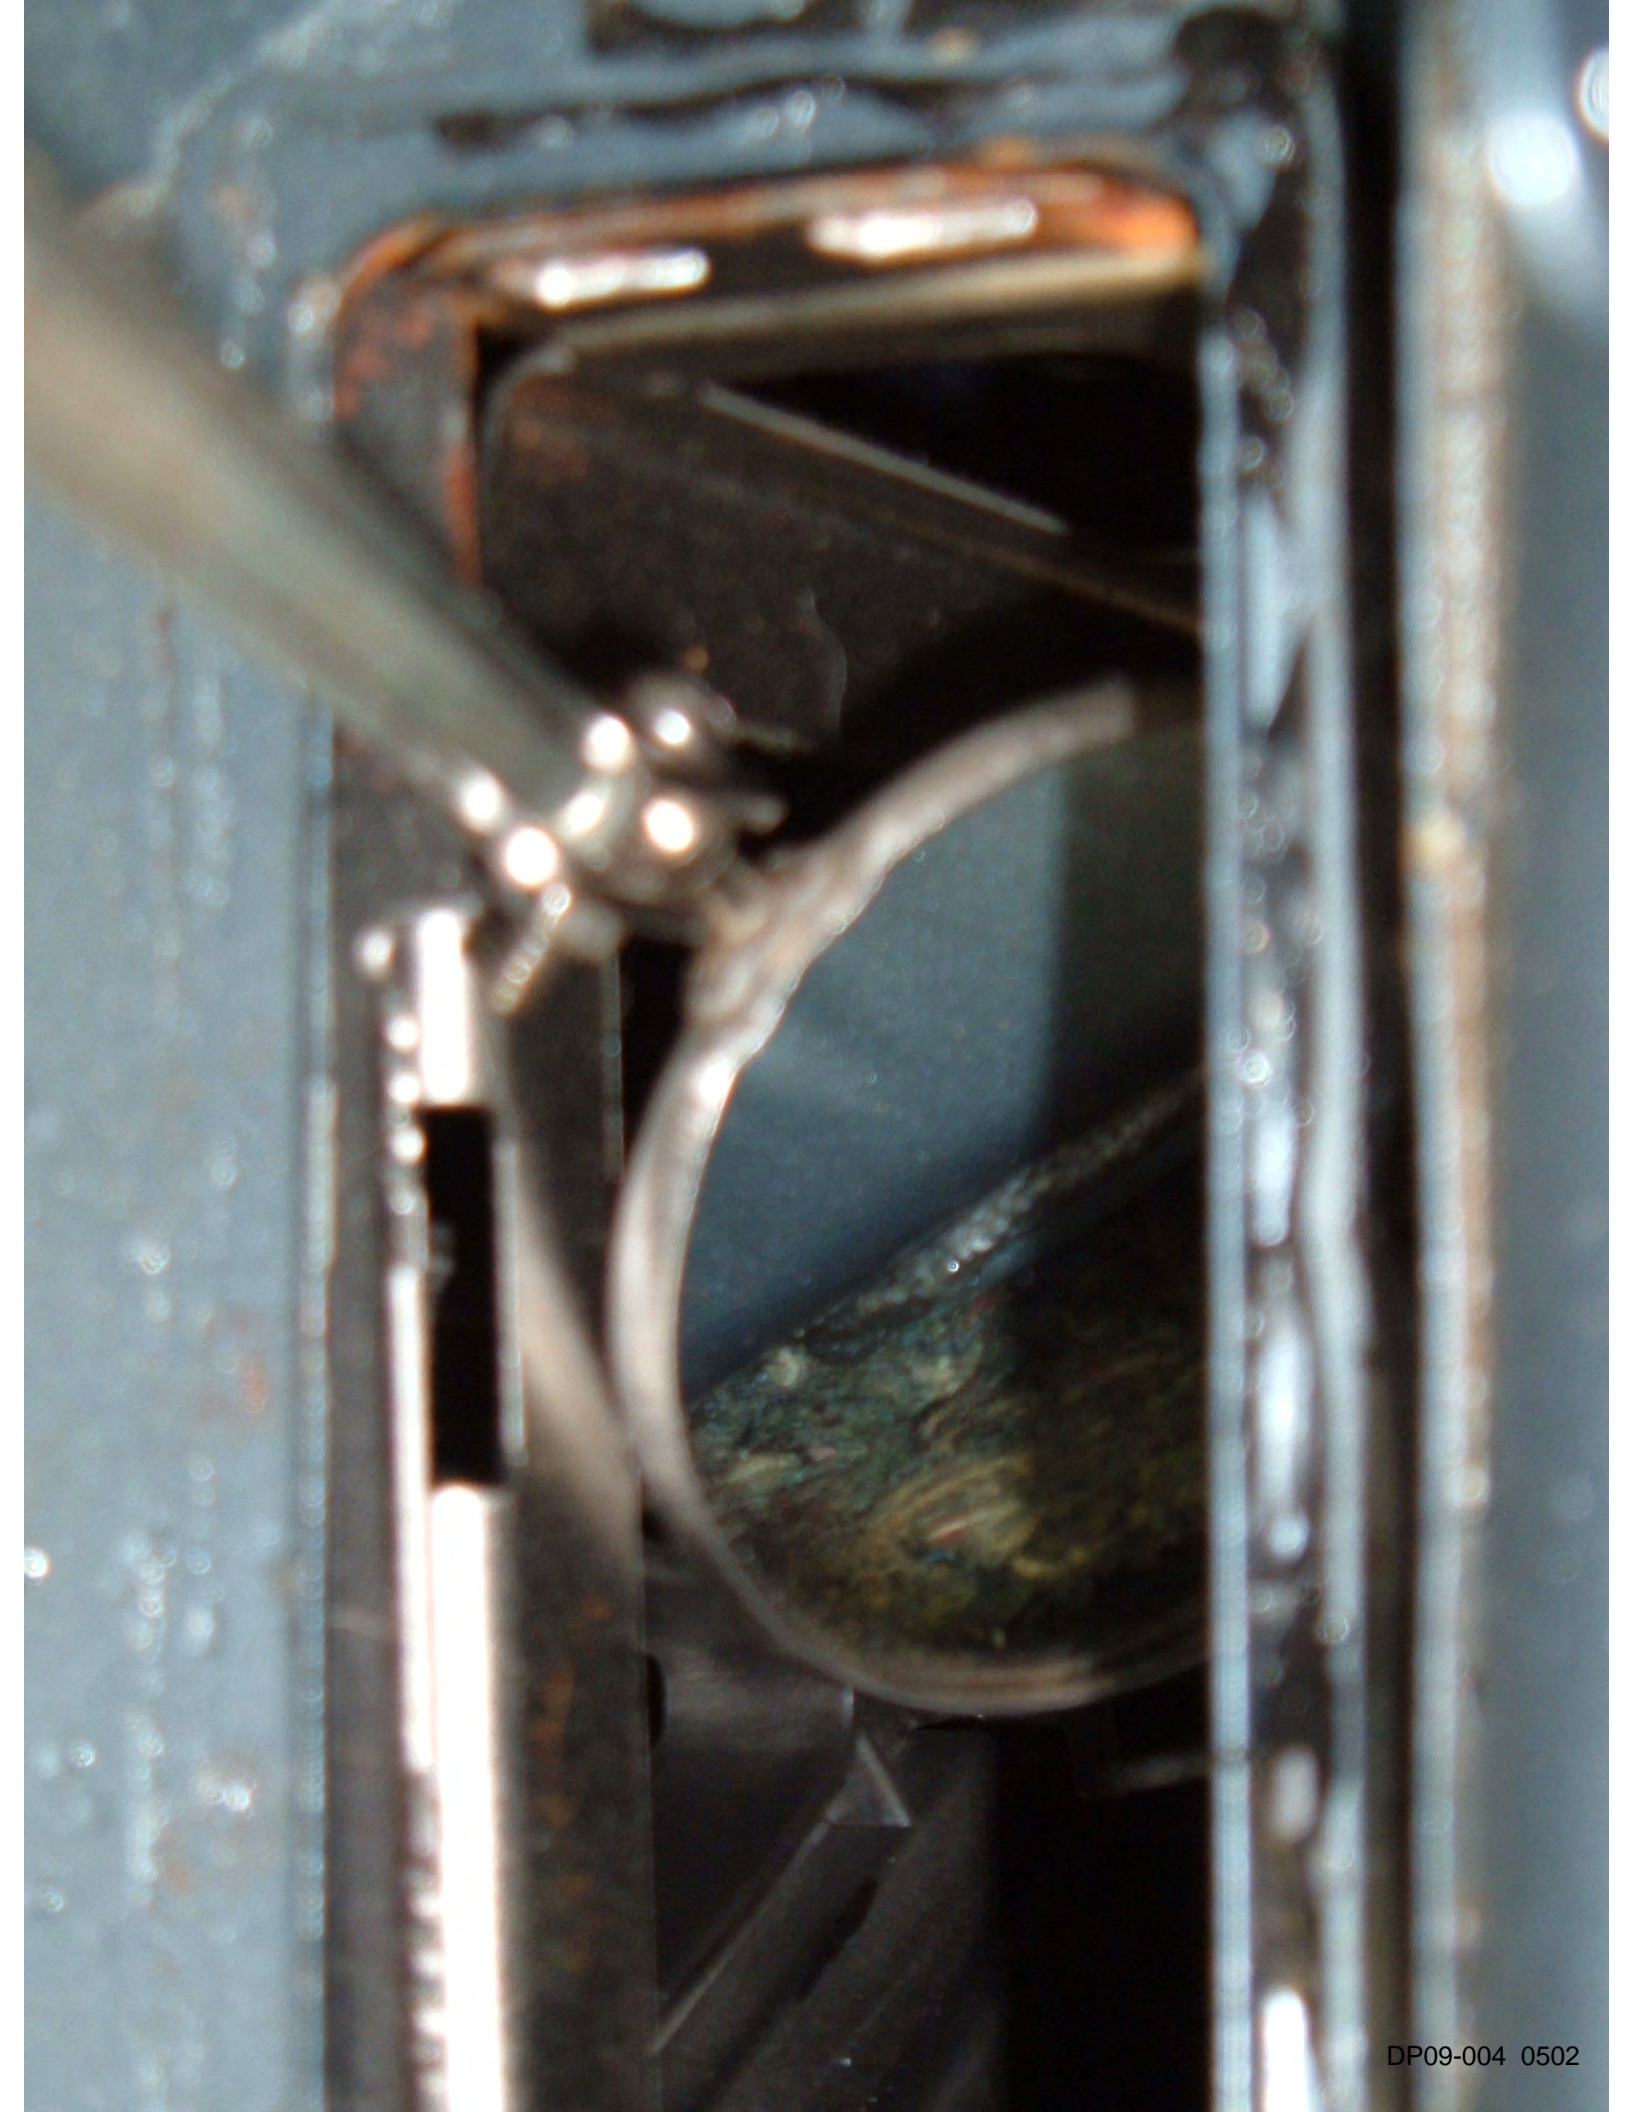
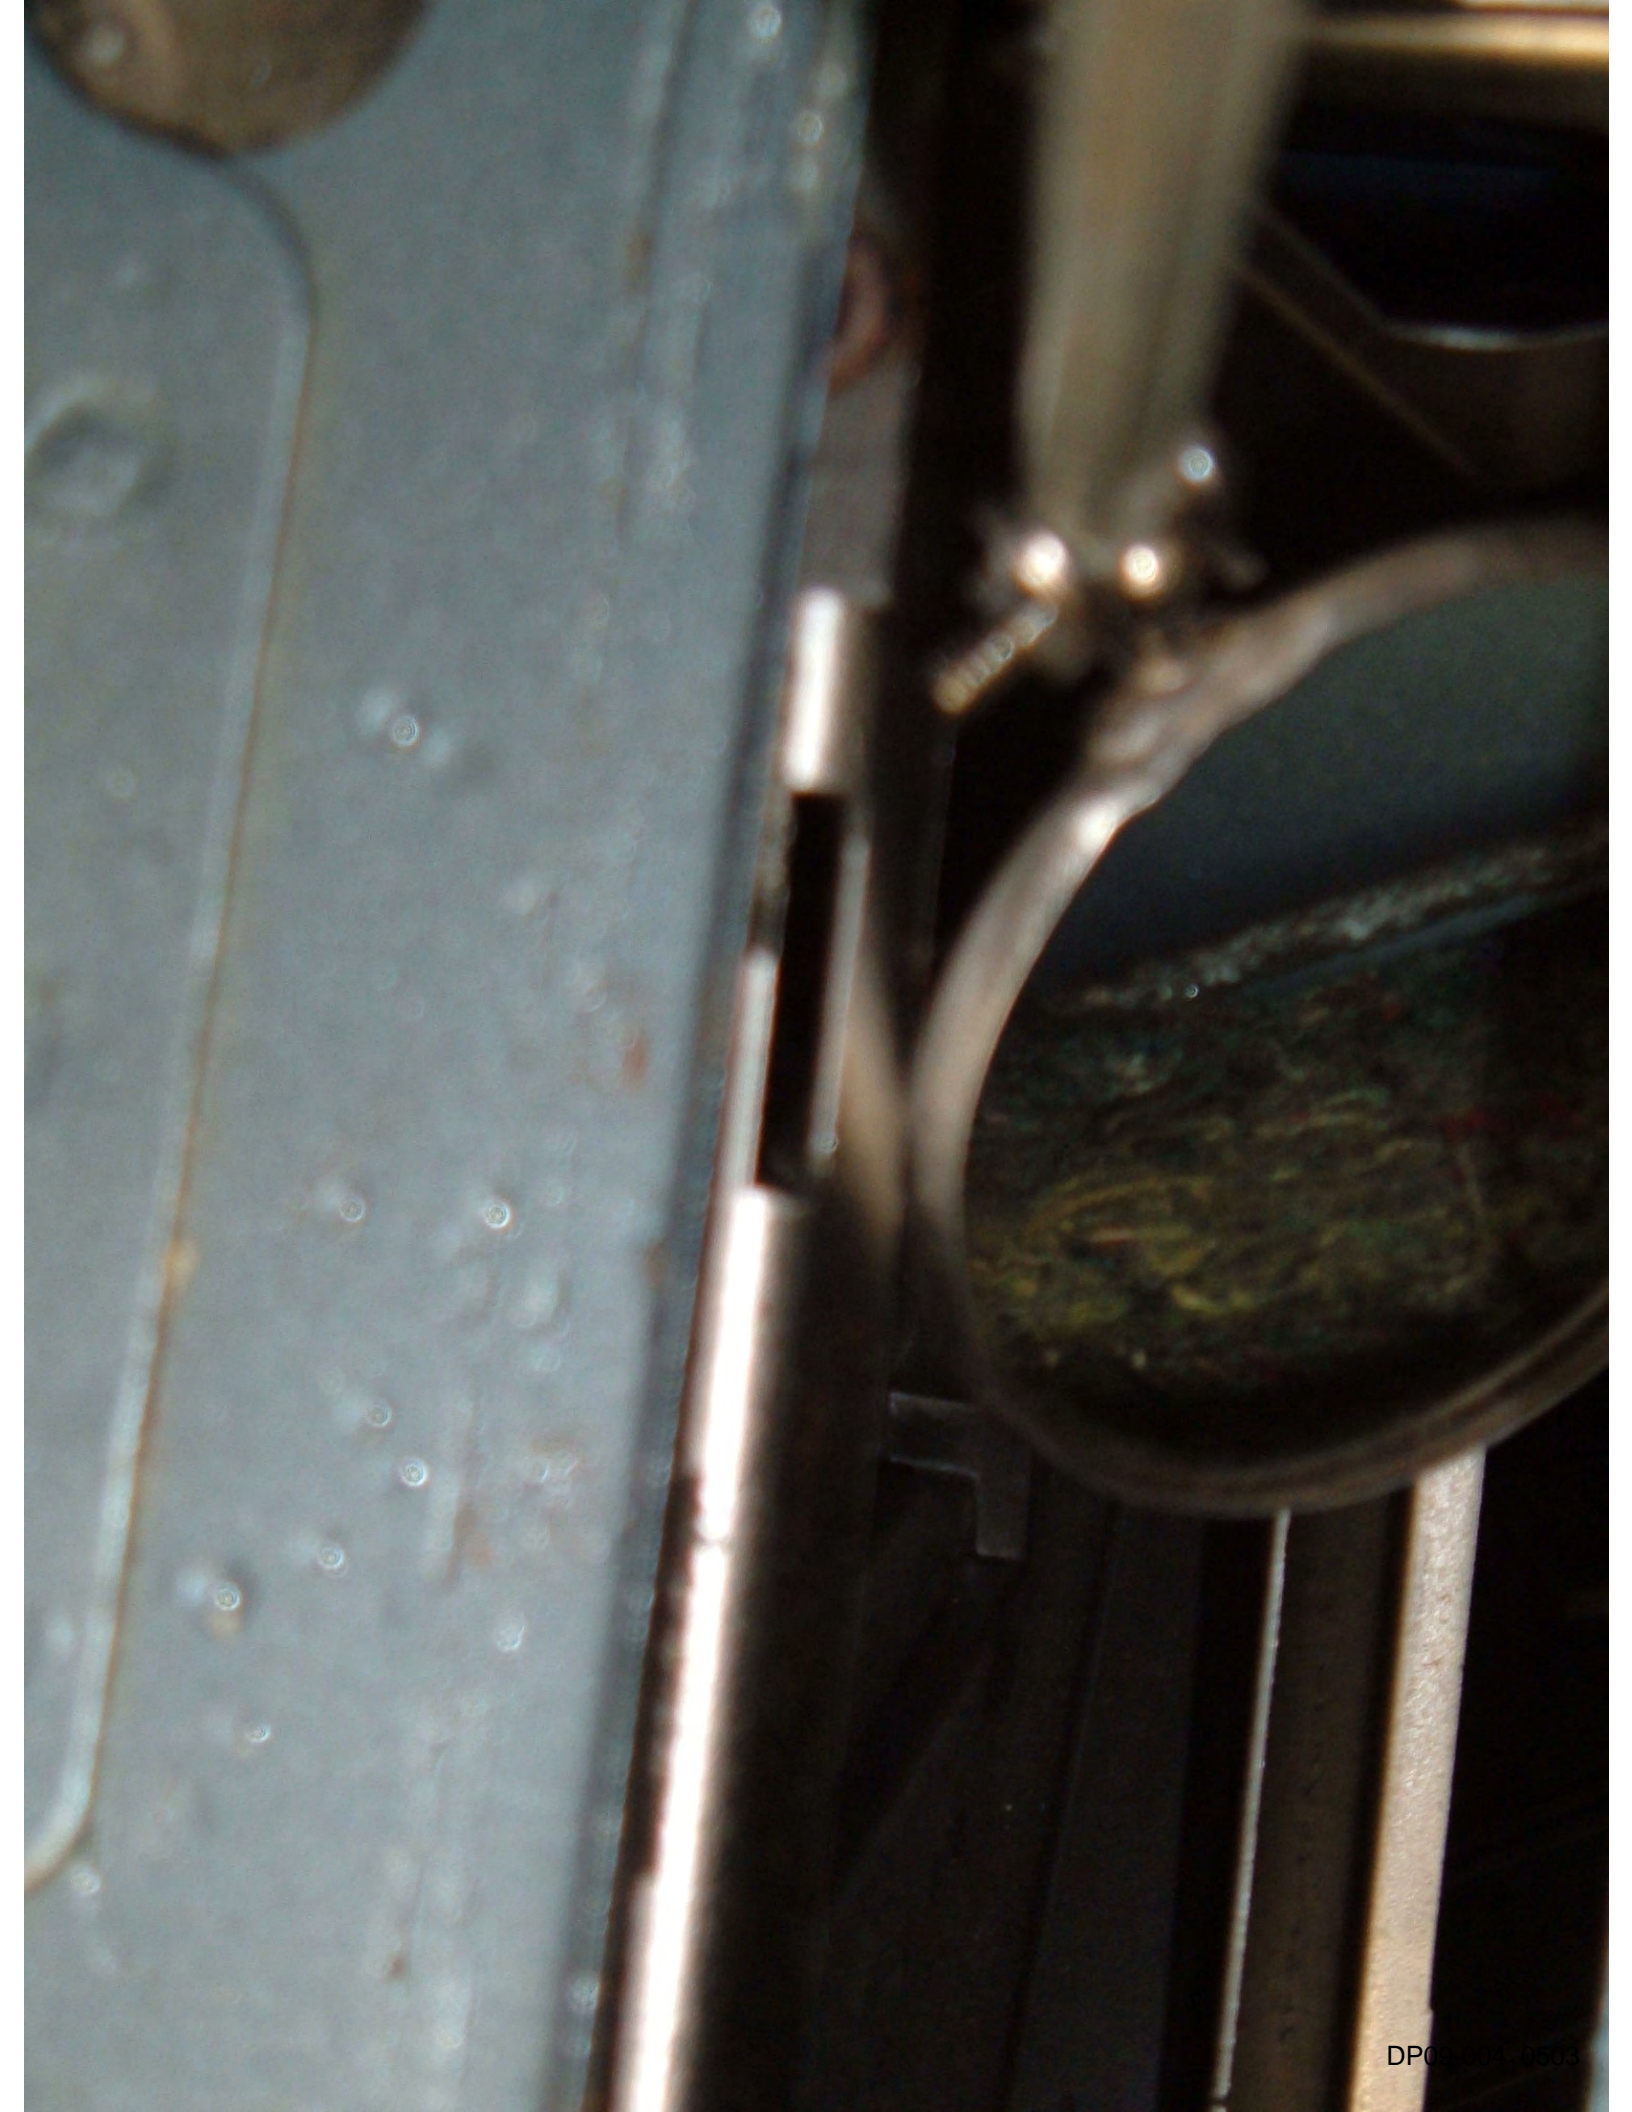
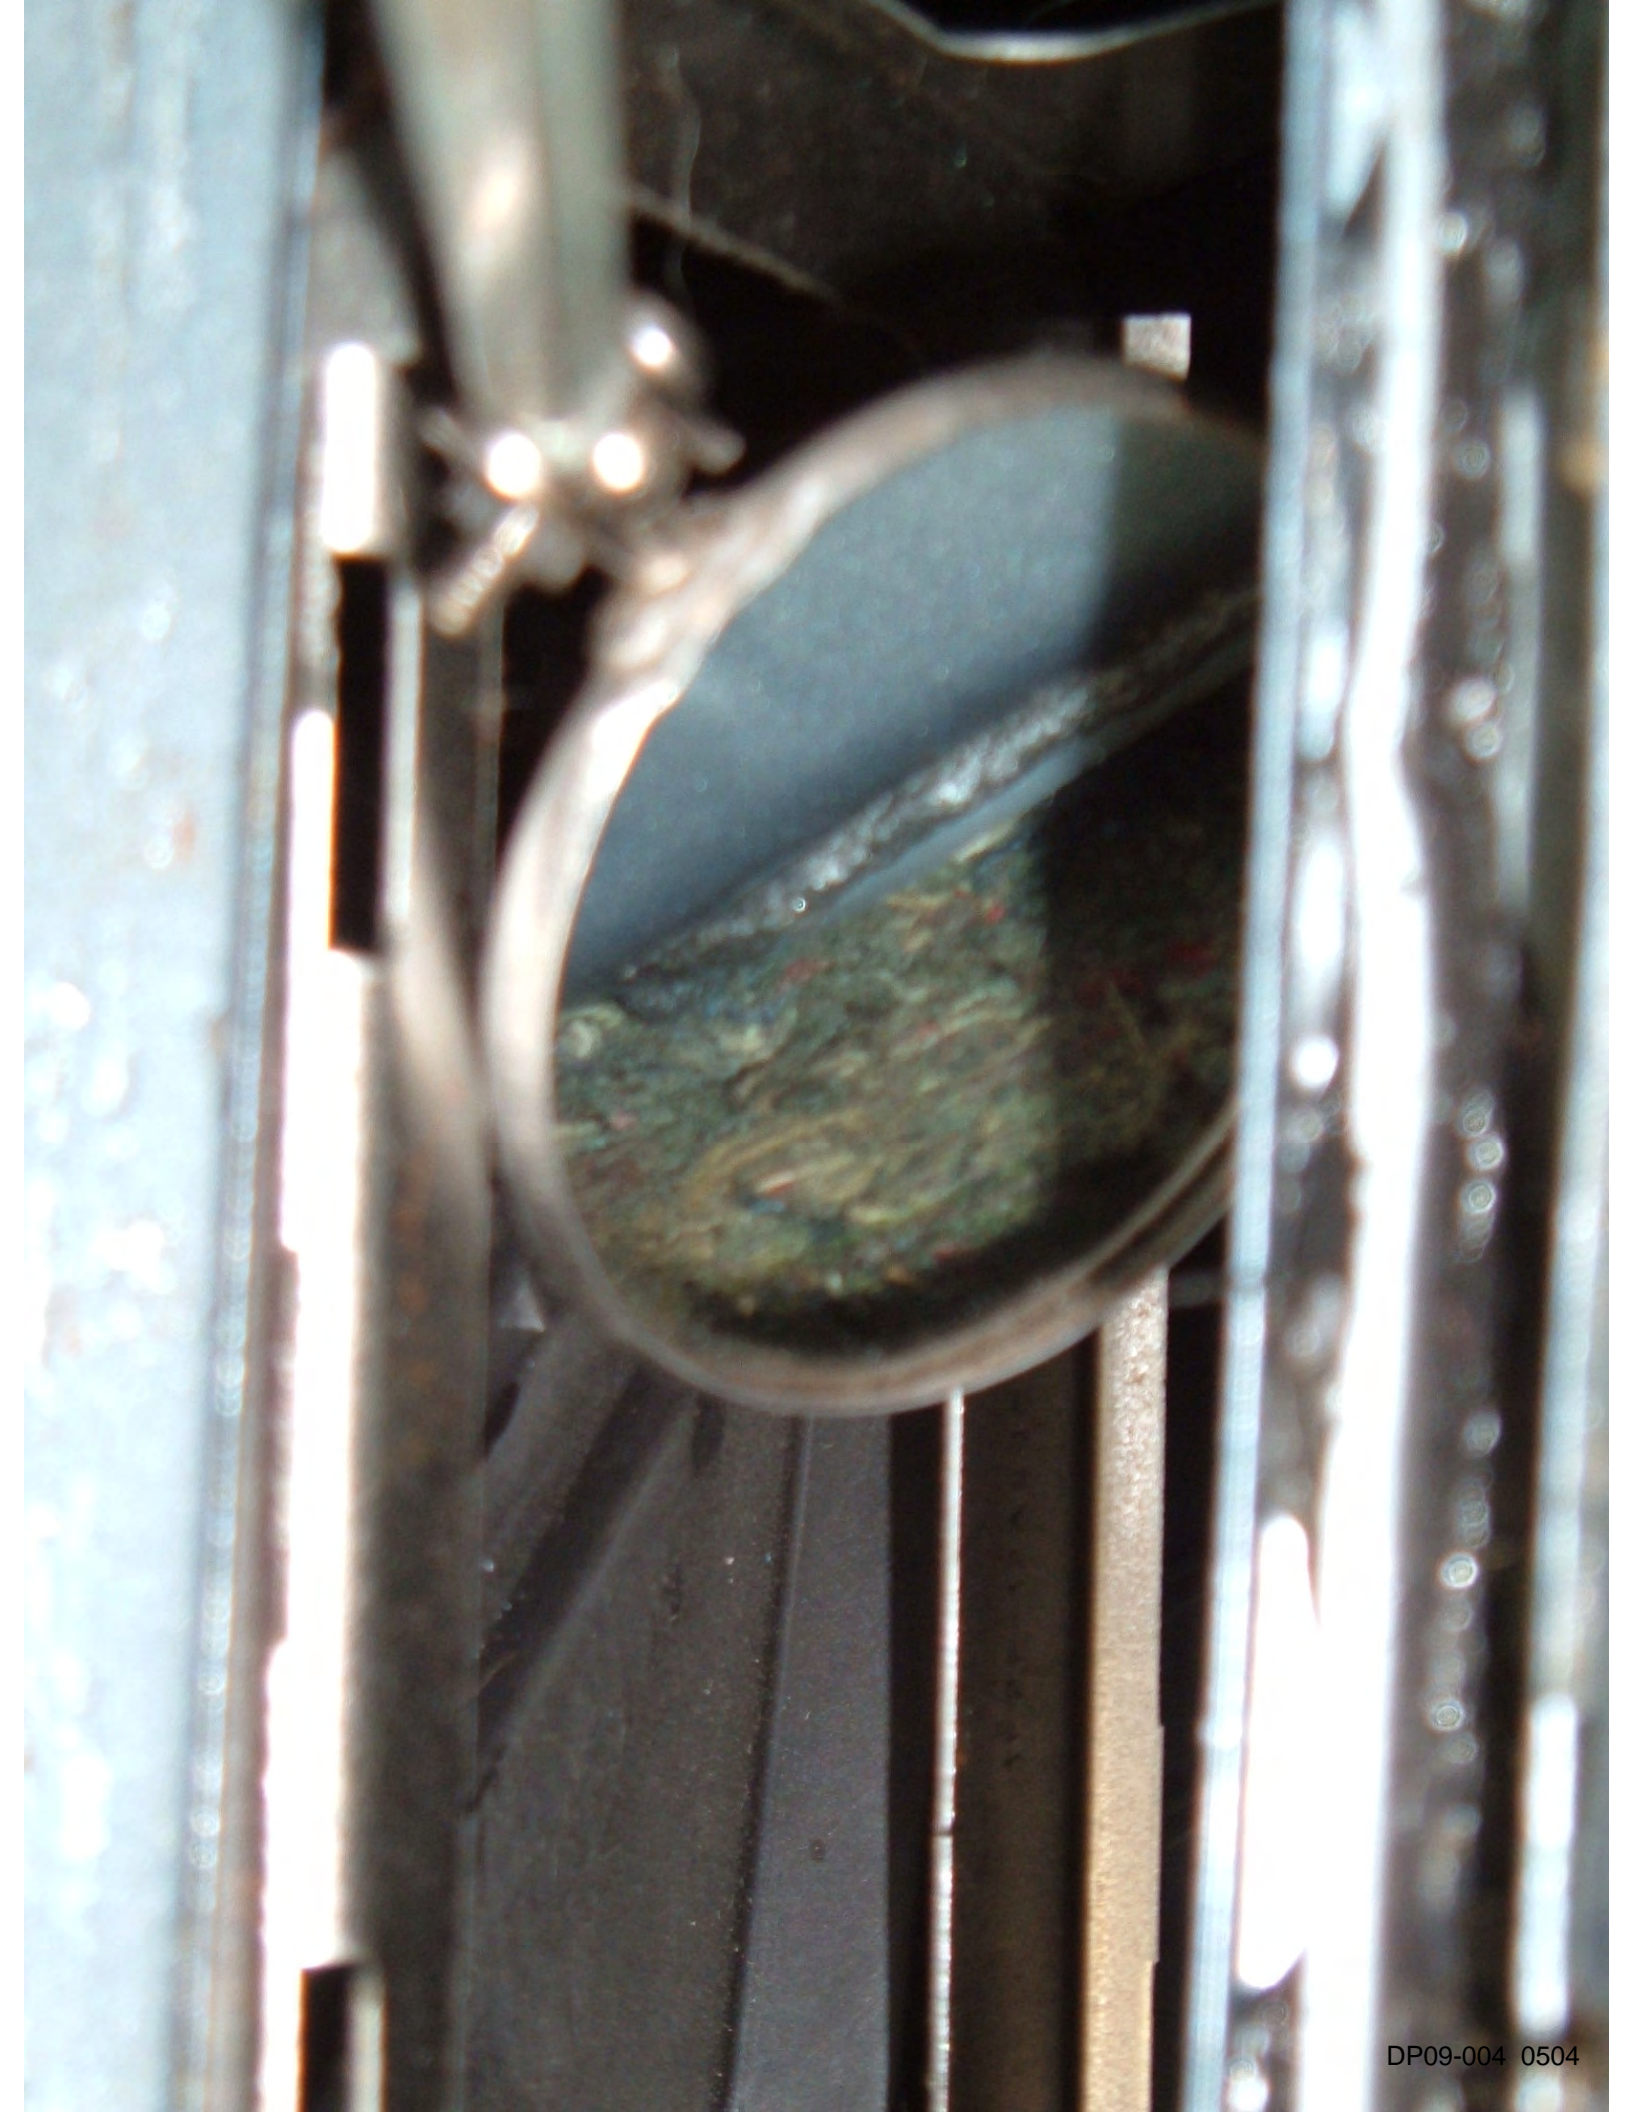
John, water in pcm....water soaked NVH foam report number 5JZCY002. Please keep me informed.

Dash is removed the steel reinforcement tube that is filled with foam is now soaked with water.that exposed area on the right is where the water is coming out and dripping on the pcm, a plastic cover was sealed over that area.Where the leak starts I don't know, I can reaseal the cover but that won't fix the leak.I'm still tring to find the source.Any recomendations would be helpful.
